OREGON STATE UNIVERSITY (OSU)

MAGRUDER HALL

ADA ASSESSMENT & SURVEY

Re: ADA Accessibility Survey and Assessment – Magruder Hall

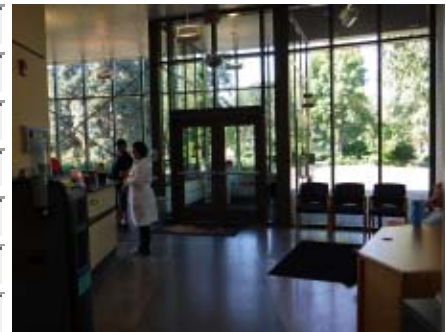
Field Date: 8/24/2017 Report Date: 8/24/2017 Barrier #: 3B
 Bldg Name: Magruder Hall Reference Dwg: 2 of 5
 Location: Floor 1 - Public Entry Vestibule 172
 X Coordinate: N/A Y Coordinate: N/A
 Barrier Area: Doors or Gates
 Barrier Type: Doormat
 Code: 2010 ADAS 302.2 & Advisory 302.2
 References:

Barrier Description: Doormat not anchored to floor (possible trip hazard)

Rec. Solution: Secure exiting doormat or replace

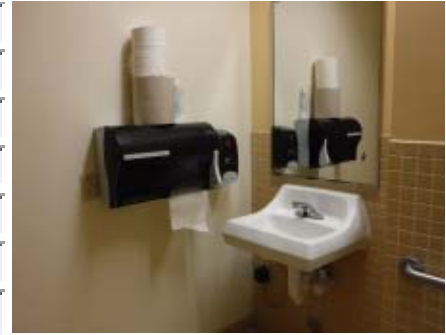
Field Date: 8/24/2017 Report Date: 8/24/2017 Barrier #: 6F
 Bldg Name: Magruder Hall Reference Dwg: 2 of 5
 Location: Floor 1 - Unisex Restroom 172A
 X Coordinate: N/A Y Coordinate: N/A
 Barrier Area: Restrooms
 Barrier Type: Coat Hook
 Code: 2010 ADAS 603.4
 References:

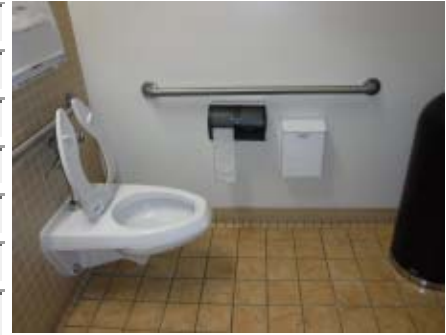
Field Date: 8/24/2017 Report Date: 8/24/2017 Barrier #: 6J
 Bldg Name: Magruder Hall Reference Dwg: 2 of 5
 Location: Floor 1 - Unisex Restroom 172A
 X Coordinate: N/A Y Coordinate: N/A
 Barrier Area: Restrooms
 Barrier Type: Toilet - Grab Bars
 Code: 2010 ADAS 609.3
 References:

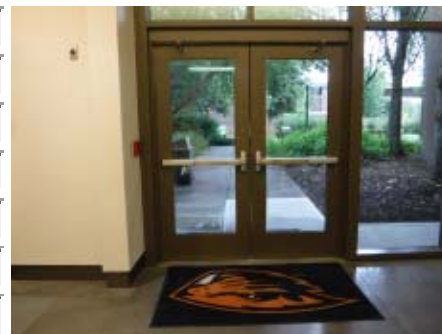
Field Date: 8/24/2017 Report Date: 8/24/2017 Barrier #: 9A
 Bldg Name: Magruder Hall Reference Dwg: 2 of 5
 Location: Floor 1 - Corridor 172
 X Coordinate: N/A Y Coordinate: N/A
 Barrier Area: Corridors
 Barrier Type: Door Mat
 Code: 2010 ADAS 302.2 & Advisory 302.2
 References:

Barrier Description: Recessed doormat not anchored to floor (possible trip hazard)

Rec. Solution: Replace door mat

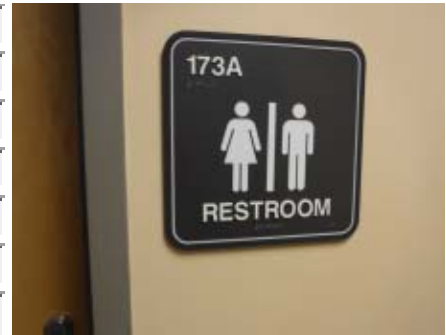
Field Date: 8/24/2017 Report Date: 8/24/2017 Barrier #: 11B
 Bldg Name: Magruder Hall Reference Dwg: 2 of 5
 Location: Floor 1 - Unisex Restroom 173A
 X Coordinate: N/A Y Coordinate: N/A
 Barrier Area: Restrooms
 Barrier Type: Sign - Pictograms Raised
 Code: 2010 ADAS 703.2.1
 References:

Rec. Solution: Replace signage

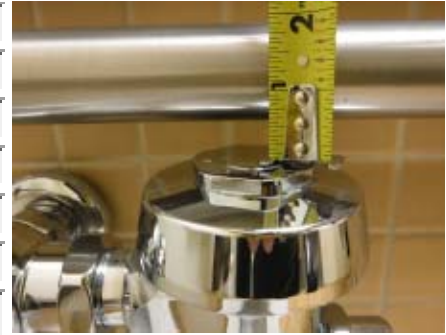
Field Date: 8/24/2017 Report Date: 8/24/2017 Barrier #: 11H
 Bldg Name: Magruder Hall Reference Dwg: 2 of 5
 Location: Floor 1 - Unisex Restroom 173A
 X Coordinate: N/A Y Coordinate: N/A
 Barrier Area: Restrooms
 Barrier Type: Toilet - Grab Bars
 Code: 2010 ADAS 609.3
 References:

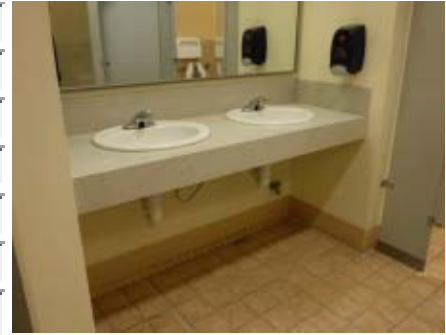
Field Date: 8/24/2017 Report Date: 8/24/2017 Barrier #: 16G
 Bldg Name: Magruder Hall Reference Dwg: 2 of 5
 Location: Floor 1 - Men's Multi-accommodation Toilet Room 105A
 X Coordinate: N/A Y Coordinate: N/A
 Barrier Area: Restrooms
 Barrier Type: Lavatory - Rim Height
 Code: 2010 ADAS 606.3
 References:

Rec. Solution: Replace lavatory

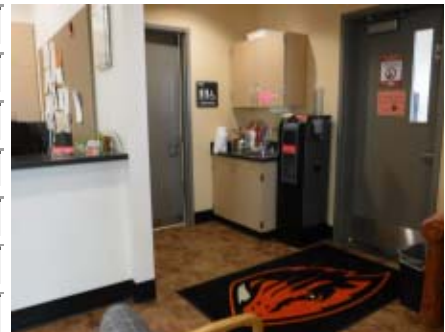
Field Date: 8/24/2017 Report Date: 8/24/2017 Barrier #: 28H
 Bldg Name: Magruder Hall Reference Dwg: 3 of 5
 Location: Floor 1 - Lobby 159
 X Coordinate: N/A Y Coordinate: N/A
 Barrier Area: Doors or Gates
 Barrier Type: Doormat
 Code: 2010 ADAS 302.2 & Advisory 302.2
 References:

Barrier Description: Doormat not anchored to floor (possible trip hazard)

Rec. Solution: Secure exiting doormat or replace

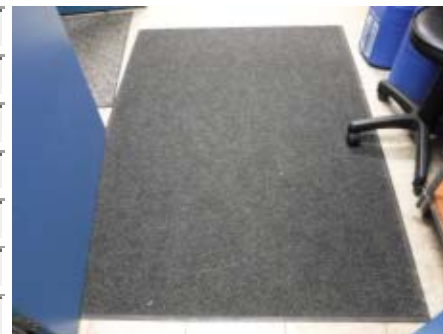
Field Date: 8/24/2017 Report Date: 8/24/2017 Barrier #: 31C
 Bldg Name: Magruder Hall Reference Dwg: 3 of 5
 Location: Floor 1 - Semen Room 160
 X Coordinate: N/A Y Coordinate: N/A
 Barrier Area: Doors or Gates
 Barrier Type: Doormat
 Code: 2010 ADAS 302.2 & Advisory 302.2
 References:

Barrier Description: Doormat not anchored to floor (possible trip hazard)

Rec. Solution: Secure exiting doormat or replace

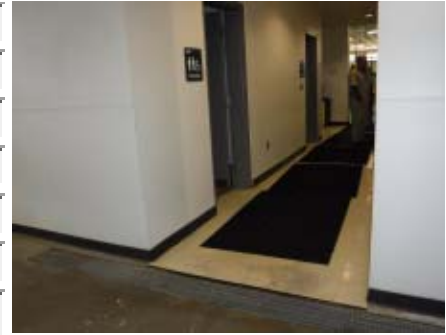
Field Date: 8/24/2017 Report Date: 8/24/2017 Barrier #: 33B
 Bldg Name: Magruder Hall Reference Dwg: 3 of 5
 Location: Floor 1 - Corridor 158
 X Coordinate: N/A Y Coordinate: N/A
 Barrier Area: Corridors
 Barrier Type: Door Mat
 Code: 2010 ADAS 302.2 & Advisory 302.2
 References:

Barrier Description: Recessed doormat not anchored to floor (possible trip hazard)

Rec. Solution: Replace door mat

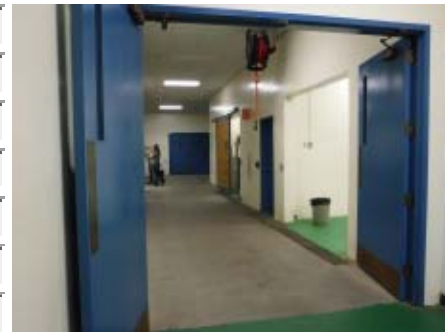
Field Date: 8/24/2017 Report Date: 8/24/2017 Barrier #: 46B
 Bldg Name: Magruder Hall Reference Dwg: 3 of 5
 Location: Floor 1 - Corridor 113
 X Coordinate: N/A Y Coordinate: N/A
 Barrier Area: Corridors
 Barrier Type: Door 10" Bottom Surface - Door Stop
 Code: 2010 ADAS 404.2.3
 References:

Barrier Description: Door stop at bottom of door creates trap condition for wheelchair footrests
