OREGON STATE UNIVERSITY (OSU)

CHILD CARE CENTER

ADA ASSESSMENT & SURVEY

Re: ADA Accessibility Survey and Assessment – Child Care Center

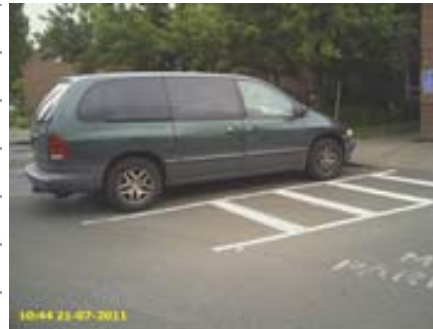
Field Date: 7/21/2011 Report Date: 7/21/2011 Barrier #: 950
 Bldg Name: Child Care Center Reference Dwg: 1 of 3
 Location: Exterior - Parking Lot
 X Coordinate: 7479849.726 Y Coordinate: 339289.58
 Barrier Area: Parking
 Barrier Type: Stall Signage Height
 Code: 2010 ADAS 502.6
 References:

Performance Standard: No Quantity: EACH As-built : 250

Rec. Solution: Replace sign with bottom edge at min. 60"

Barrier Severity: 2 Recommended Cost Est \$0.00 Facility Function: Public Status: Open

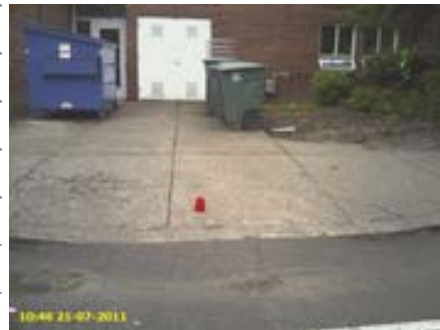
Barrier Description: Surface is not firm and stable (cracked, broken or loose soil, etc.)

Findings: Cracked and broken concrete

Rec. Solution: Repair surface to make firm and stable

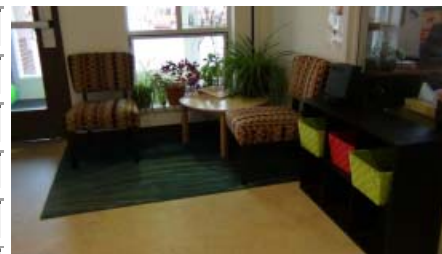
Field Date: 11/9/2015 Report Date: 12/1/2015 Barrier #: 2B
 Bldg Name: Child Care Center Reference Dwg: 2 of 3
 Location: Floor 1 - Entry Lobby
 X Coordinate: N/A Y Coordinate: N/A
 Barrier Area: Corridors
 Barrier Type: Carpet - Firmly Attached
 Code: 2010 ADAS 302.2
 References:

Performance Standard: No Quantity: SF As-built : 1

Rec. Solution: Fasten carpet or tiles firmly to floor. remove or replace

Barrier Severity: 2 Recommended Cost Est: \$12.00 Facility Function: Public Status: Open

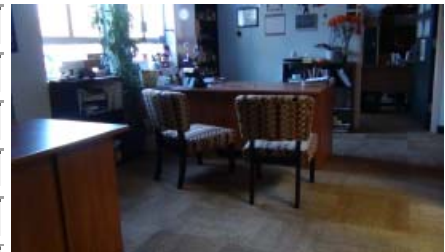
Field Date: 11/9/2015 Report Date: 12/1/2015 Barrier #: 3C
 Bldg Name: Child Care Center Reference Dwg: 2 of 3
 Location: Floor 1 - Director's Office
 X Coordinate: N/A Y Coordinate: N/A
 Barrier Area: Counters and Tables
 Barrier Type: Desk - Knee Clearance
 Code: 2010 ADAS 902.3
 References:

Performance Standard: No Quantity: EACH As-built : 0

Rec. Solution: No remediation recommended for public use

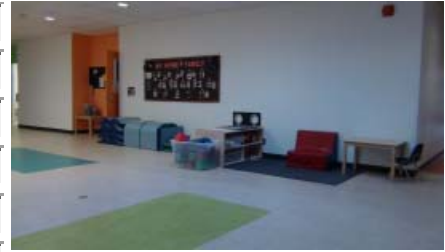
Field Date: 11/9/2015 Report Date: 12/1/2015 Barrier #: 4B
 Bldg Name: Child Care Center Reference Dwg: 2 of 3
 Location: Floor 1 - Central Common Area
 X Coordinate: N/A Y Coordinate: N/A
 Barrier Area: Counters and Tables
 Barrier Type: Table - Knee Clearance
 Code: 2010 ADAS 305.3
 References:

Performance Standard: No Quantity: EACH As-built : 2

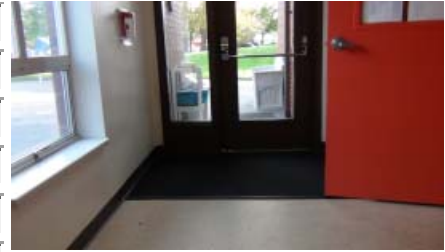
Field Date: 11/9/2015 Report Date: 12/1/2015 Barrier #: 5C
 Bldg Name: Child Care Center Reference Dwg: 2 of 3
 Location: Floor 1 - West Corridor
 X Coordinate: N/A Y Coordinate: N/A
 Barrier Area: Doors or Gates
 Barrier Type: Doormat
 Code: 2010 ADAS 302.2 & Advisory 302.2
 References:

Performance Standard: No Quantity: EACH As-built : 2

Rec. Solution: Secure exiting doormat or replace

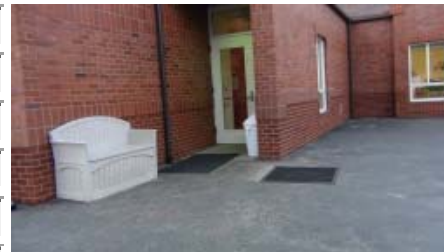
Field Date: 11/9/2015 Report Date: 12/1/2015 Barrier #: 5H
 Bldg Name: Child Care Center Reference Dwg: 2 of 3
 Location: Floor 1 - West Corridor
 X Coordinate: N/A Y Coordinate: N/A
 Barrier Area: Doors or Gates
 Barrier Type: Doormat
 Code: 2010 ADAS 302.2 & Advisory 302.2
 References:

Performance Standard: No Quantity: EACH As-built : 1

Rec. Solution: Secure exiting doormat or replace

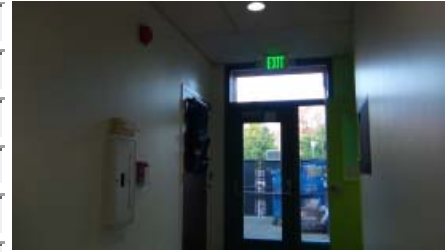
Field Date: 11/9/2015 Report Date: 12/1/2015 Barrier #: 7I
 Bldg Name: Child Care Center Reference Dwg: 2 of 3
 Location: Floor 1 - East Corridor
 X Coordinate: N/A Y Coordinate: N/A
 Barrier Area: Signage
 Barrier Type: Tactile Exit Signs - Door
 Code: 2010 ADAS 216.4.1
 References:

Performance Standard: No Quantity: EACH As-built : 1

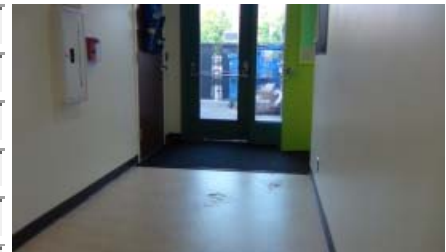
Field Date: 11/9/2015 Report Date: 12/1/2015 Barrier #: 7J
 Bldg Name: Child Care Center Reference Dwg: 2 of 3
 Location: Floor 1 - East Corridor
 X Coordinate: N/A Y Coordinate: N/A
 Barrier Area: Corridors
 Barrier Type: Electrical Outlets - Hi/Low Reach
 Code: 2010 ADAS 205.1 & 309.3
 References:

Performance Standard: No Quantity: LF As-built : 2

Barrier Severity: 2 Recommended Cost Est: \$450.00 Facility Function: Public Status: Open

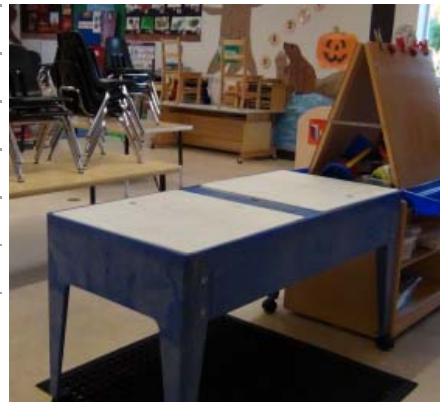
Performance Standard: No Quantity: EACH As-built : 1

Barrier Severity: 2 Recommended Cost Est: \$450.00 Facility Function: Public Status: Open

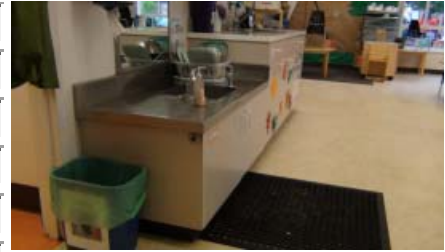
Field Date: 11/9/2015 Report Date: 12/1/2015 Barrier #: 8N
 Bldg Name: Child Care Center Reference Dwg: 2 of 3
 Location: Floor 1 - Preschool Room 107
 X Coordinate: N/A Y Coordinate: N/A
 Barrier Area: Classrooms
 Barrier Type: Sink - Rim or Countertop
 Code: 2010 ADAS 606.3
 References:

Performance Standard: No Quantity: LF As-built : 3

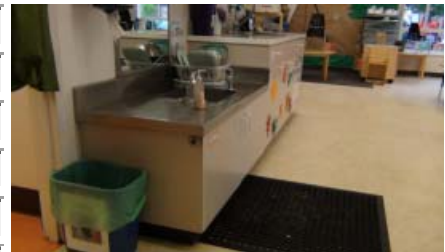
Field Date: 11/9/2015 Report Date: 12/1/2015 Barrier #: 80
 Bldg Name: Child Care Center Reference Dwg: 2 of 3
 Location: Floor 1 - Preschool Room 107
 X Coordinate: N/A Y Coordinate: N/A
 Barrier Area: Drinking Fountains
 Barrier Type: Knee Clearance
 Code: 2010 ADAS 306.3
 References:

Performance Standard: No Quantity: EACH As-built : 1

Rec. Solution: Replace drinking fountain with accessible unit or remount existing

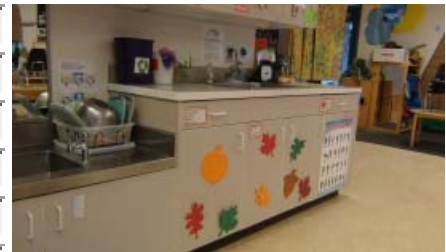
Field Date: 11/9/2015 Report Date: 12/1/2015 Barrier #: 8U
 Bldg Name: Child Care Center Reference Dwg: 2 of 3
 Location: Floor 1 - Preschool Room 107
 X Coordinate: N/A Y Coordinate: N/A
 Barrier Area: Classrooms
 Barrier Type: Sink - Knee Clearance
 Code: 2010 ADAS 606.2 & 306
 References:

Performance Standard: No Quantity: EACH As-built : 0

Rec. Solution: Replace cabinet and remount sink

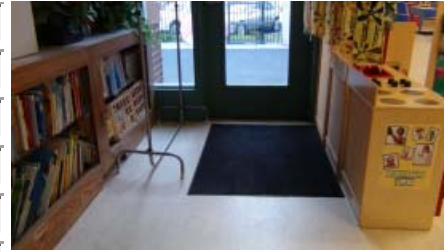
Performance Standard: No Quantity: EACH As-built : 1

Findings: Door stop at bottom of door can create trapping condition

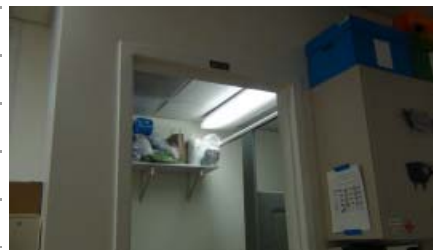
Field Date: 11/11/2015 Report Date: 12/1/2015 Barrier #: 20A
 Bldg Name: Child Care Center Reference Dwg: 2 of 3
 Location: Floor 1 - Pre-Kindergarten Restroom Room 147
 X Coordinate: N/A Y Coordinate: N/A
 Barrier Area: Restrooms
 Barrier Type: Protruding Hazard
 Code: 2010 ADAS 307.2
 References:

Performance Standard: No Quantity: JOB As-built : 1
