OREGON STATE UNIVERSITY (OSU)

PHARMACY BUILDING

ADA ASSESSMENT & SURVEY

Re: ADA Accessibility Survey and Assessment – Pharmacy Building

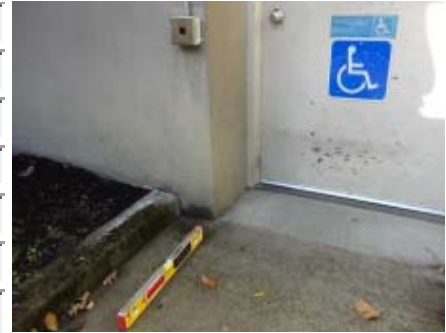
Field Date: 10/29/2015 Report Date: 11/16/2015 Barrier #: 1C
 Bldg Name: Pharmacy Building Reference Dwg: 2 of 6
 Location: Floor 1 - Southeast Accessible Entrance
 X Coordinate: N/A Y Coordinate: N/A
 Barrier Area: Doors or Gates
 Barrier Type: Automatic Doors - Actuation Clear Floor Space
 Code: 2010 ADAS 404.3.5 & 305.3
 References:

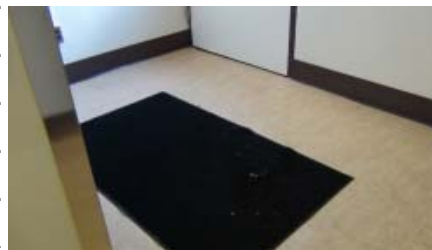
Field Date: 10/29/2015 Report Date 11/16/2015 Barrier #: 1H
 Bldg Name: Pharmacy Building Reference Dwg: 2 of 6
 Location: Floor 1 - Southeast Accessible Entrance
 X Coordinate: N/A Y Coordinate: N/A
 Barrier Area: Doors or Gates
 Barrier Type: Doormat
 Code: 2010 ADAS 302.2 & Advisory 302.2
 References:

Barrier Description: Doormat not anchored to floor (possible trip hazard)

Rec. Solution: Secure exiting doormat or replace

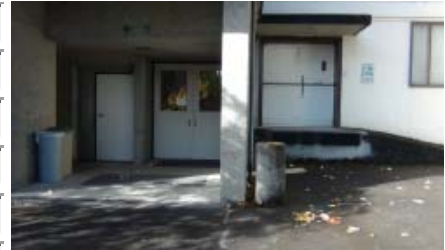
Field Date: 10/29/2015 Report Date 11/16/2015 Barrier #: 2B
 Bldg Name: Pharmacy Building Reference Dwg: 2 of 6
 Location: Floor 1 - Northeast Entrance
 X Coordinate: N/A Y Coordinate: N/A
 Barrier Area: Doors or Gates
 Barrier Type: Doormat
 Code 2010 ADAS 302.2 & Advisory 302.2
 References:

Barrier Description: Doormat not anchored to floor (possible trip hazard)

Rec. Solution: Secure exiting doormat or replace

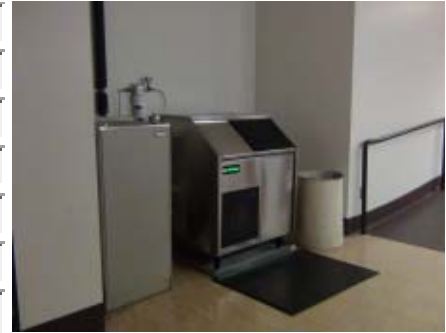
Field Date: 10/29/2015 Report Date: 11/16/2015 Barrier #: 4K
 Bldg Name: Pharmacy Building Reference Dwg: 2 of 6
 Location: Floor 1 - Central Corridor
 X Coordinate: N/A Y Coordinate: N/A
 Barrier Area: Drinking Fountains
 Barrier Type: Knee Clearance
 Code: 2010 ADAS 306.3
 References:

Rec. Solution: Replace drinking fountain with accessible unit or remount existing

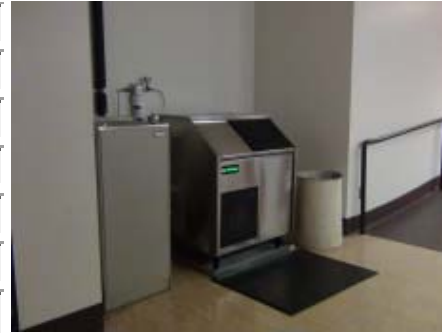
Field Date: 10/29/2015 Report Date 11/16/2015 Barrier #: 4M
 Bldg Name: Pharmacy Building Reference Dwg: 2 of 6
 Location: Floor 1 - Central Corridor
 X Coordinate: N/A Y Coordinate: N/A
 Barrier Area: Drinking Fountains
 Barrier Type: Operation - Replacement
 Code: 2010 ADAS 602.3
 References:

Rec. Solution: Replace drinking fountain with accessible hi-low unit

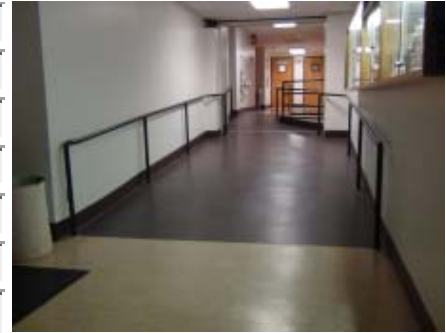
Field Date: 10/29/2015 Report Date 11/16/2015 Barrier #: 40
 Bldg Name: Pharmacy Building Reference Dwg: 2 of 6
 Location: Floor 1 - Central Corridor
 X Coordinate: N/A Y Coordinate: N/A
 Barrier Area: Ramps
 Barrier Type: Running Slope - Existing (>9.5% or more)
 Code 2010 ADAS 405.3
 References:

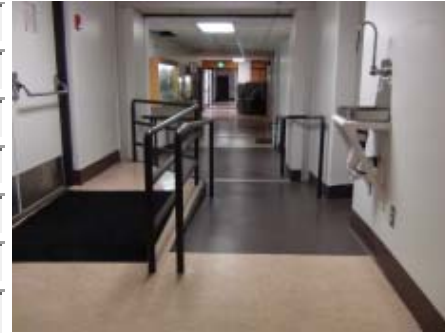
Field Date: 10/29/2015 Report Date 11/16/2015 Barrier #: 4S
 Bldg Name: Pharmacy Building Reference Dwg: 2 of 6
 Location: Floor 1 - Central Corridor
 X Coordinate: N/A Y Coordinate: N/A
 Barrier Area: Doors or Gates
 Barrier Type: Landing - Existing (≥ 5.0%)
 Code: 2010 ADAS 404.2.4.4
 References:

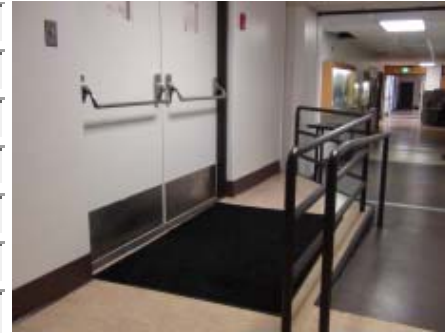
Field Date: 10/29/2015 Report Date 11/16/2015 Barrier #: 5B
 Bldg Name: Pharmacy Building Reference Dwg: 2 of 6
 Location: Floor 1 - Exit Stairway
 X Coordinate: N/A Y Coordinate: N/A
 Barrier Area: Doors or Gates
 Barrier Type: Door Closer - Interior Adjustment
 Code: 2010 ADAS 404.2.9
 References:

Rec. Solution: Replace or adjust existing closer

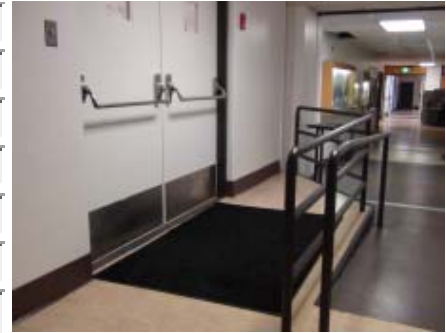
Field Date: 10/29/2015 Report Date 11/16/2015 Barrier #: 5D
 Bldg Name: Pharmacy Building Reference Dwg: 2 of 6
 Location: Floor 1 - Exit Stairway
 X Coordinate: N/A Y Coordinate: N/A
 Barrier Area: Doors or Gates
 Barrier Type: Doormat
 Code: 2010 ADAS 302.2 & Advisory 302.2
 References:

Barrier Description: Doormat not anchored to floor (possible trip hazard)

Rec. Solution: Secure exiting doormat or replace

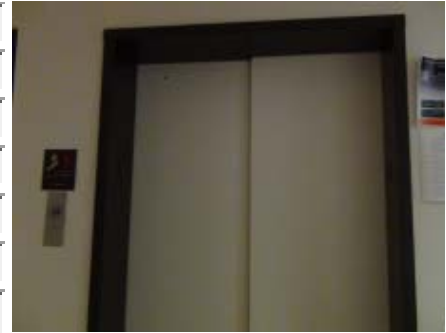
Field Date: 10/29/2015 Report Date 11/16/2015 Barrier #: 6A
 Bldg Name: Pharmacy Building Reference Dwg: 2 of 6
 Location: Floor 1 - Elevator
 X Coordinate: N/A Y Coordinate: N/A
 Barrier Area: Elevators
 Barrier Type: Car Control Buttons - Location
 Code: 2010 ADAS 407.4.6.1 & 409.4.6
 References:

Rec. Solution: Replace control panel

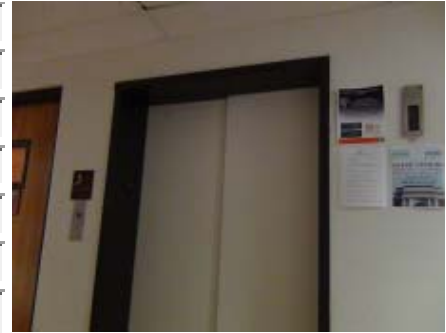
Field Date: 10/29/2015 Report Date 11/16/2015 Barrier #: 6C
 Bldg Name: Pharmacy Building Reference Dwg: 2 of 6
 Location: Floor 1 - Elevator
 X Coordinate: N/A Y Coordinate: N/A
 Barrier Area: Elevators
 Barrier Type: Hall lanterns - Audible Direction
 Code: 2010 ADAS 407.2.2.2
 References:

Rec. Solution: Replace hall lanterns

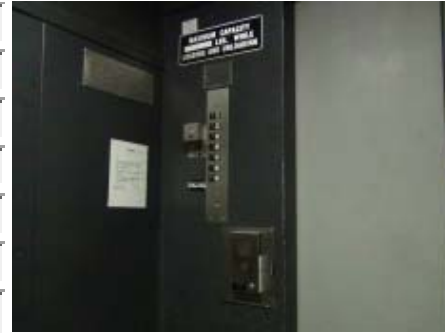
Field Date: 10/29/2015 Report Date 11/16/2015 Barrier #: 6I
 Bldg Name: Pharmacy Building Reference Dwg: 2 of 6
 Location: Floor 1 - Elevator
 X Coordinate: N/A Y Coordinate: N/A
 Barrier Area: Elevators
 Barrier Type: Car Control Buttons - Illumination
 Code: 2010 ADAS 407.4.8
 References:

Rec. Solution: Replace car controls

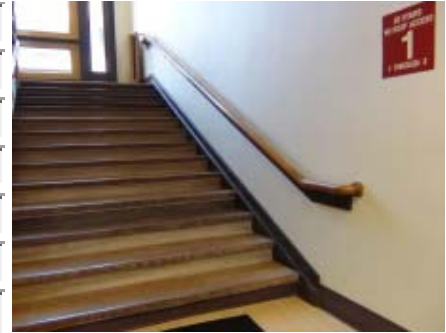
Field Date: 10/30/2015 Report Date: 11/16/2015 Barrier #: 8B
 Bldg Name: Pharmacy Building Reference Dwg: 2 of 6
 Location: Floor 1 - East Stairway
 X Coordinate: N/A Y Coordinate: N/A
 Barrier Area: Stairways
 Barrier Type: Sign - Enclosed Exit Stairway Discharge
 Code: ICC A117.1
 References:

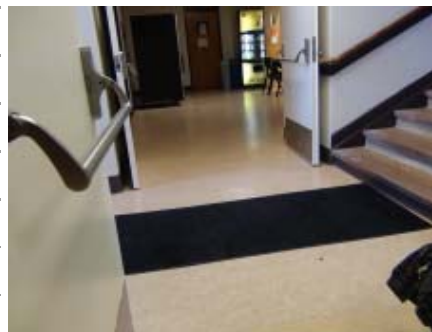
Field Date: 10/30/2015 Report Date: 11/16/2015 Barrier #: 8E
 Bldg Name: Pharmacy Building Reference Dwg: 2 of 6
 Location: Floor 1 - East Stairway
 X Coordinate: N/A Y Coordinate: N/A
 Barrier Area: Doors or Gates
 Barrier Type: Doormat
 Code: 2010 ADAS 302.2 & Advisory 302.2
 References:

Barrier Description: Doormat not anchored to floor (possible trip hazard)

Rec. Solution: Secure exiting doormat or replace

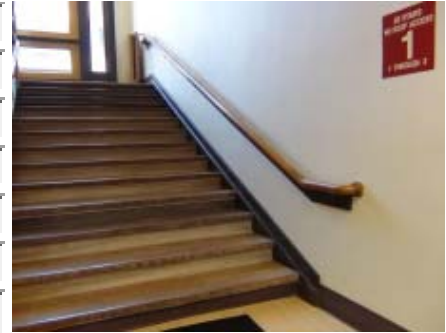
Field Date: 10/30/2015 Report Date 11/16/2015 Barrier #: 8H
 Bldg Name: Pharmacy Building Reference Dwg: 2 of 6
 Location: Floor 1 - East Stairway
 X Coordinate: N/A Y Coordinate: N/A
 Barrier Area: Stairways
 Barrier Type: Handrail - Both Sides
 Code: ADAAG 4.9.4* & 2010 ADAS 505.10.2
 References:

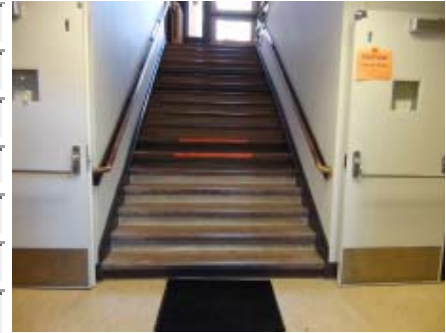
Field Date: 10/30/2015 Report Date 11/16/2015 Barrier #: 9A
 Bldg Name: Pharmacy Building Reference Dwg: 2 of 6
 Location: Floor 1 - West Stairway
 X Coordinate: N/A Y Coordinate: N/A
 Barrier Area: Stairways
 Barrier Type: Sign - Enclosed Exit Stairway Level
 Code: ICC A117.1
 References:

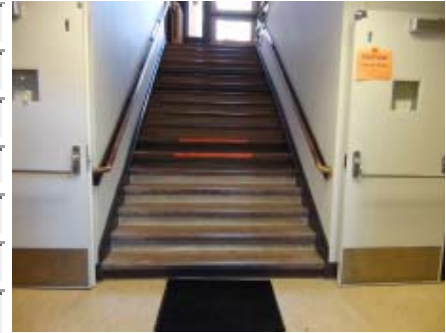
Field Date: 10/30/2015 Report Date 11/16/2015 Barrier #: 9C
 Bldg Name: Pharmacy Building Reference Dwg: 2 of 6
 Location: Floor 1 - West Stairway
 X Coordinate: N/A Y Coordinate: N/A
 Barrier Area: Stairways
 Barrier Type: Contrasting Color - ADA
 Code: 2010 ADAS Advisory 504.4
 References:

Rec. Solution: Recommended: Consider providing contrasting color on each tread

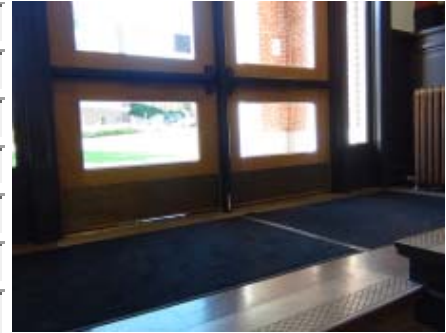
Field Date: 10/30/2015 Report Date 11/16/2015 Barrier #: 9E
 Bldg Name: Pharmacy Building Reference Dwg: 2 of 6
 Location: Floor 1 - West Stairway
 X Coordinate: N/A Y Coordinate: N/A
 Barrier Area: Doors or Gates
 Barrier Type: Doormat
 Code: 2010 ADAS 302.2 & Advisory 302.2
 References:

Barrier Description: Doormat not anchored to floor (possible trip hazard)

Rec. Solution: Secure exiting doormat or replace

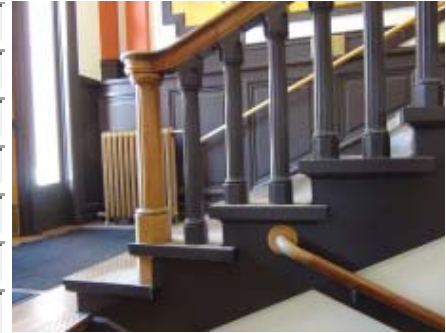
Field Date: 10/30/2015 Report Date: 11/16/2015 Barrier #: 9G
 Bldg Name: Pharmacy Building Reference Dwg: 2 of 6
 Location: Floor 1 - West Stairway
 X Coordinate: N/A Y Coordinate: N/A
 Barrier Area: Stairways
 Barrier Type: Handrail Grip
 Code: 2010 ADAS 505.10.2
 References:

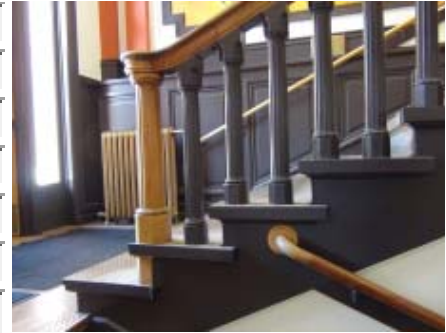
Field Date: 10/30/2015 Report Date 11/16/2015 Barrier #: 9I
 Bldg Name: Pharmacy Building Reference Dwg: 2 of 6
 Location: Floor 1 - West Stairway
 X Coordinate: N/A Y Coordinate: N/A
 Barrier Area: Stairways
 Barrier Type: Handrail Extension
 Code: 2010 ADAS 505.10.2
 References:

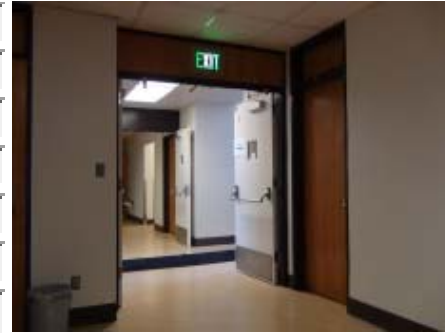
Field Date: 10/30/2015 Report Date 11/16/2015 Barrier #: 10A
 Bldg Name: Pharmacy Building Reference Dwg: 2 of 6
 Location: Floor 1 - Southeast Corridor
 X Coordinate: N/A Y Coordinate: N/A
 Barrier Area: Signage
 Barrier Type: Permanent Room/Space - Tactile Characters
 Code: 2010 ADAS 216.2
 References:

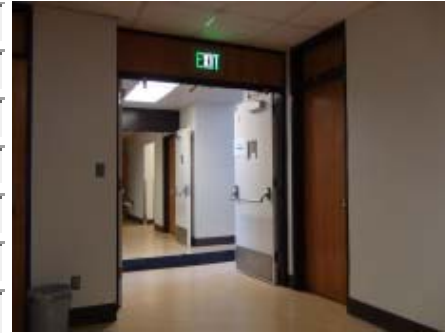
Field Date: 10/30/2015 Report Date 11/16/2015 Barrier #: 10C
 Bldg Name: Pharmacy Building Reference Dwg: 2 of 6
 Location: Floor 1 - Southeast Corridor
 X Coordinate: N/A Y Coordinate: N/A
 Barrier Area: Doors or Gates
 Barrier Type: Door Closer - Interior Adjustment
 Code: 2010 ADAS 404.2.9
 References:

Rec. Solution: Replace or adjust existing closer

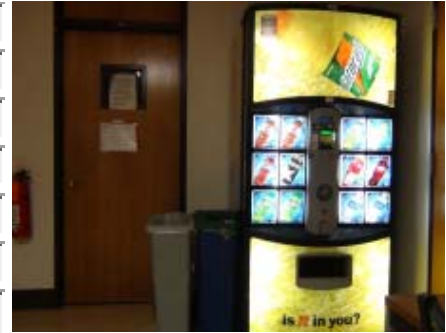
Field Date: 10/30/2015 Report Date 11/16/2015 Barrier #: 10G
 Bldg Name: Pharmacy Building Reference Dwg: 2 of 6
 Location: Floor 1 - Southeast Corridor
 X Coordinate: N/A Y Coordinate: N/A
 Barrier Area: Controls and Mechanisms
 Barrier Type: Vending Machine - High Reach Range
 Code 2010 ADAS 305.3
 References:

Rec. Solution: Contact vendor to obtain replacement

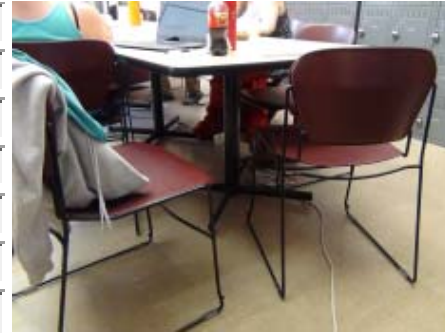
Field Date: 10/30/2015 Report Date: 11/16/2015 Barrier #: 11E
 Bldg Name: Pharmacy Building Reference Dwg: 2 of 6
 Location: Floor 1 - Self-learning Lounge 101
 X Coordinate: N/A Y Coordinate: N/A
 Barrier Area: Counters and Tables
 Barrier Type: Table - Pedestal Base
 Code: 2010 ADAS 306.2.2 & 306.2.3
 References:

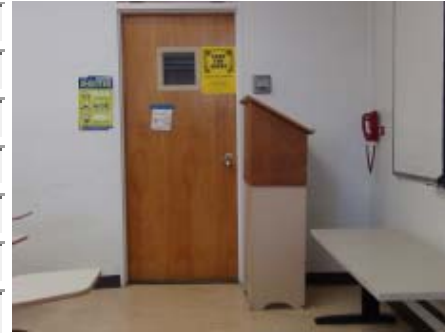
Field Date: 10/30/2015 Report Date: 11/16/2015 Barrier #: 12D
 Bldg Name: Pharmacy Building Reference Dwg: 2 of 6
 Location: Floor 1 - Classroom 107
 X Coordinate: N/A Y Coordinate: N/A
 Barrier Area: Classrooms
 Barrier Type: Podium - Surface Height
 Code: 2010 ADAS 504.2
 References:

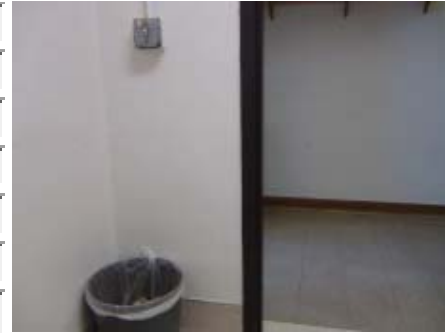
Field Date: 10/30/2015 Report Date 11/16/2015 Barrier #: 14C
 Bldg Name: Pharmacy Building Reference Dwg: 2 of 6
 Location: Floor 1 - Men's Accessible Restroom 109B
 X Coordinate: N/A Y Coordinate: N/A
 Barrier Area: Restrooms
 Barrier Type: Door Clearance - SEC Blocked
 Code: 2010 ADAS Figure 404.2.4.3
 References:

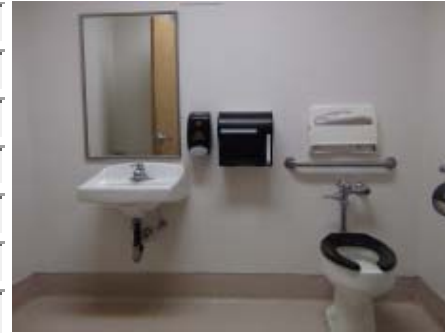
Field Date: 10/30/2015 Report Date 11/16/2015 Barrier #: 14E
 Bldg Name: Pharmacy Building Reference Dwg: 2 of 6
 Location: Floor 1 - Men's Accessible Restroom 109B
 X Coordinate: N/A Y Coordinate: N/A
 Barrier Area: Restrooms
 Barrier Type: Lavatory - Drainpipes
 Code: 2010 ADAS 606.5
 References:

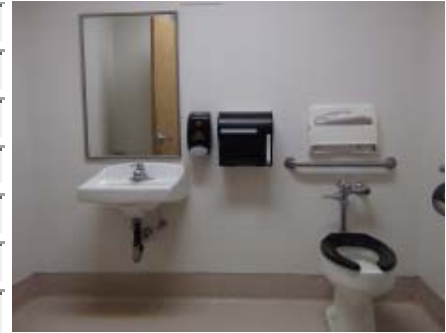
Field Date: 10/30/2015 Report Date 11/16/2015 Barrier #: 14G
 Bldg Name: Pharmacy Building Reference Dwg: 2 of 6
 Location: Floor 1 - Men's Accessible Restroom 109B
 X Coordinate: N/A Y Coordinate: N/A
 Barrier Area: Restrooms
 Barrier Type: Dispensers - Protruding Object
 Code: 2010 ADAS 307.2
 References:

Barrier Description: Protruding dispenser creates protruding hazard in path of travel

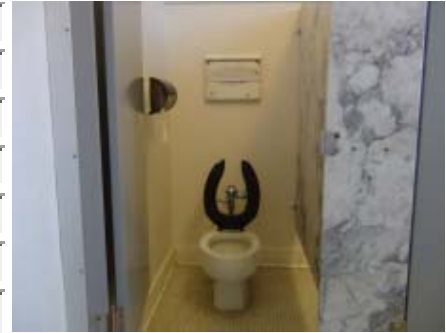
Performance Standard: No Quantity: EACH As-built : 1
 Barrier Description: Toilet tissue dispenser not within 7" to 9" from front edge of toilet
