**CAMPUS PEDESTRIAN FACILITIES  
ADA ASSESSMENT & SURVEY**

OREGON STATE UNIVERSITY (OSU)

Re: OSU Campus Accessibility Survey and Assessment – Pedestrian Facilities

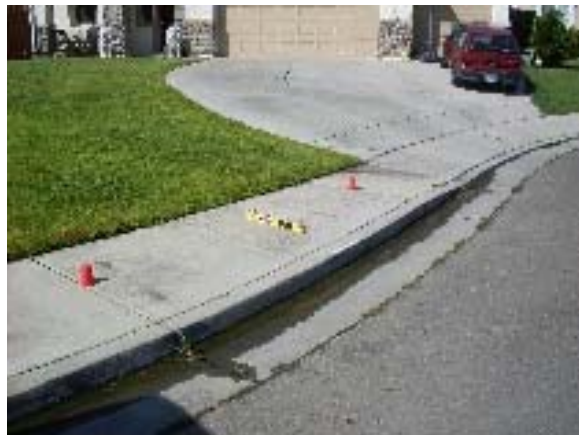
First, the field investigators observe the general slope of the pedestrian surface and place the digital level on the pavement at the steepest point parallel to the direction of the slope in the center of the pedestrian route. Measurements for cross slope are made perpendicular to the path of travel with measurements of running (longitudinal) slope being made parallel to the path of travel. Measurements are taken in 4-foot increments by placing the digital level in 5-point locations within the element.

When an area is identified with a slope that is not within standards, we placed a red marker 3" x 5" in size at the location to be seen within the frame of the digital photo taken of the location to provide visual confirmation of the exact location at which the actual measurement was taken.

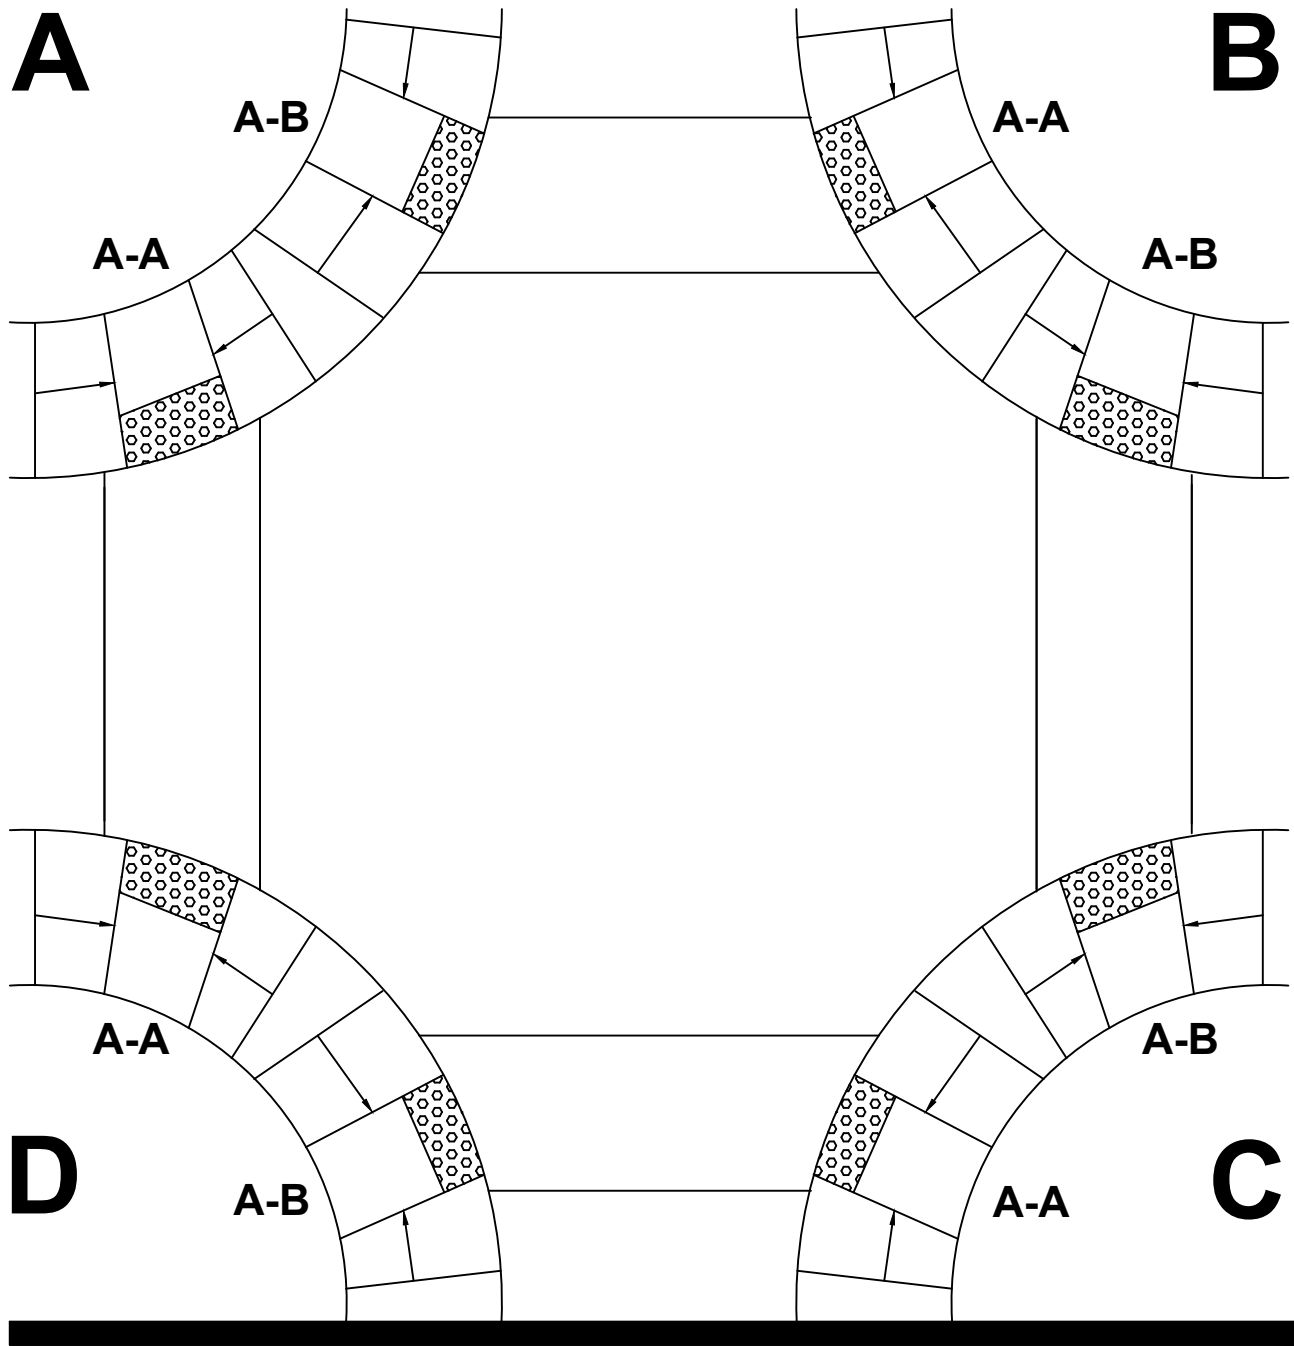
INTERSECTION CORNER DESIGNATION

When measuring curb ramps/blended transitions, the numbering system indicated above was used to identify each ramp run and pan (landing) as individual elements at each intersection.

Corners are designated as Corner A, etc. where one curb ramp or blended transition exists or Corner A A-A or A A-B for corners with more than one curb ramp or blended transition.
