# WEATHERFORD HALL

## ADA ASSESSMENT & SURVEY

OREGON STATE UNIVERSITY (OSU)

January 14, 2015

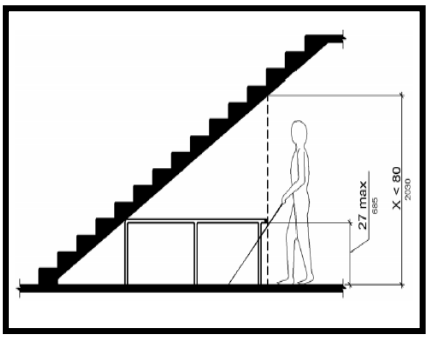
Stairways in the building appeared to have original handrails that lacked accessible extensions and accessible grip height. Doors at stairway entrances were not identified as accessible and lacked accessible view panels and opening force. Tactile exit signs indicating where doors lead to exits, including exit stairways are also recommended in this building. The stairways lacked level identification signage for the visually impaired and no contrasting color was identified at the stairway treads which can be important to those with low vision. As a performance standard, it is highly recommended to provide contrasting color at stairway treads to improve visibility for all users. At the ground level of exit stairways in this building, the lowest level was identified with areas where no detectable warning was provided in locations where the underside of the stairway created a protruding hazard. In some locations, a gate was provided but the gate did not have a leading edge at maximum 27" above the floor that would enable a person using a white cane to detect it before making body contact (see the diagram at right).

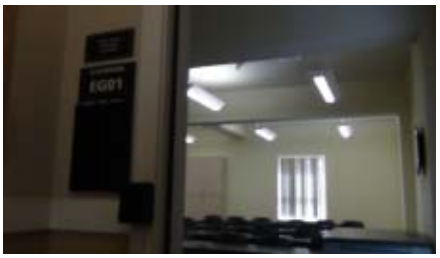
| Field Date: | 4/4/2014 | Report Date | 9/30/2014 | Barrier #: | 3B |

| Notes: | Storage room door EG02 included. Also, braille not 3/8" and max. 1/2" directly below the tactile characters |

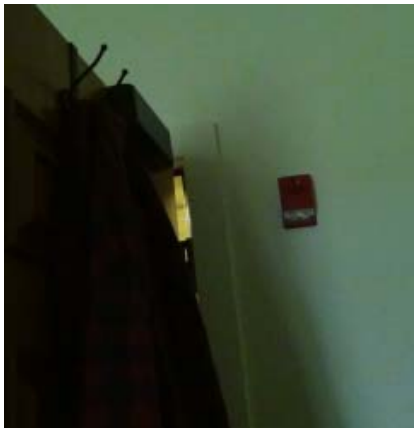
Barrier Type: Coat Hook - Height

Barrier Description: Clothing hooks not max. 48" high AFF

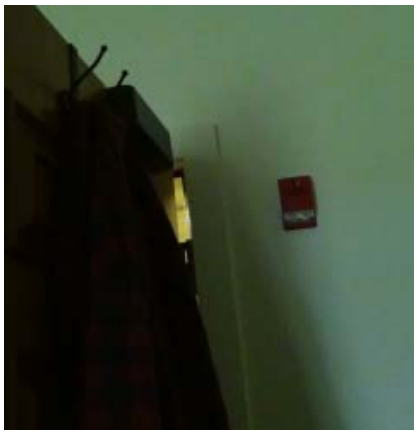
Barrier Description: Strobe not mounted at 80" AFF or 96" high, whichever is lower

Findings: 77" high

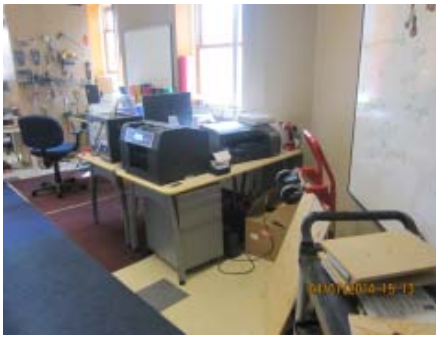
Barrier Type: Desk - Clear Floor Space

Barrier Description: Clear floor space 30" x 48" not provided at desk

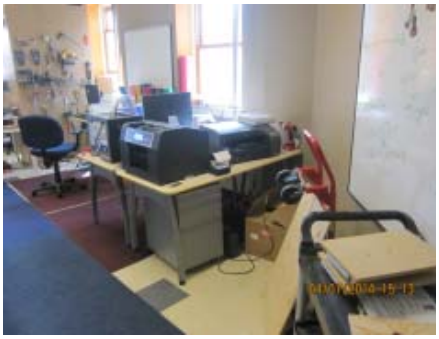
Barrier Type: Carpet/Rug

Barrier Description: Carpet/rug not anchored to floor (possible trip hazard)

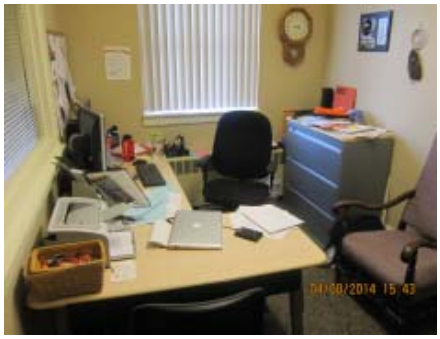
Barrier Type: Horn/Strobe - Staff Area

Barrier Description: No horn/strobe in staff areas

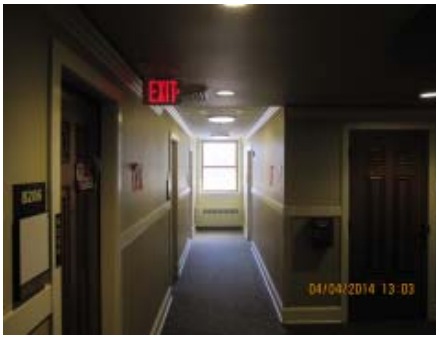
Barrier Type: Strobe Height - 80" on Wall

Barrier Description: Strobe not mounted at 80" AFF or 96" high, whichever is lower

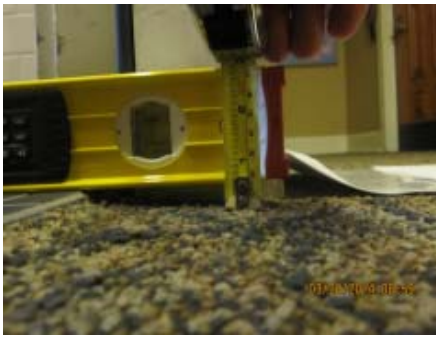
Barrier Type: Landing - Existing (2.1% to 3.0%)

Barrier Description: Door or gate lacks landing on both sides of door

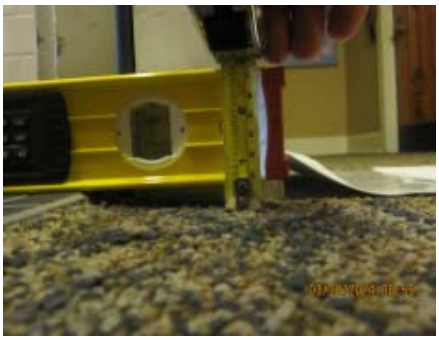
Barrier Type: Threshold - Height exceeding 1/4" without bevel

Barrier Description: Door/Gate threshold exceeds 1/4" in height without a bevel
