OREGON STATE UNIVERSITY (OSU)

MAGRUDER HALL

ADA ASSESSMENT & SURVEY

Re: ADA Accessibility Survey and Assessment – Magruder Hall

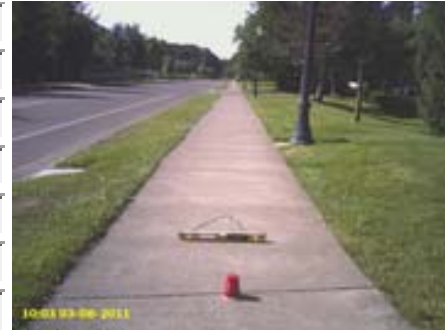
Field Date: 8/3/2011 Report Date: 8/3/2011 Barrier #: 2706
 Bldg Name: Magruder Hall Reference Dwg: 1 of 5
 Location: Exterior - SW 30th St - West
 X Coordinate: 7476457.772 Y Coordinate: 338758.916
 Barrier Area: Walkways
 Barrier Type: Cross Slope - Existing (3.1% to 4.0%)
 Code: OSSC 1103.2.4.3 and 2010 ADAS 403.3
 References:

Barrier Description: Cross slope exceeds 2.0% (3.1% to 4.0%)

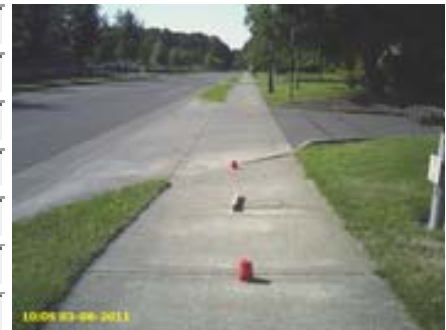
Field Date: 8/3/2011 Report Date: 8/3/2011 Barrier #: 2707
 Bldg Name: Magruder Hall Reference Dwg: 1 of 5
 Location: Exterior - SW 30th St - West
 X Coordinate: 7476453.779 Y Coordinate: 338651.99
 Barrier Area: Walkways
 Barrier Type: Running Slope - Existing (5.0% - 8.2%)
 Code: OSSC 1103.2.4.3 and 2010 ADAS 403.3
 References:

Barrier Description: Walkway running slope exceeds 5.0% (5.0% - 5.5%)

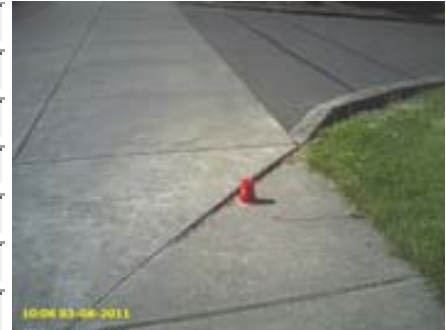
Field Date: 8/3/2011 Report Date: 8/3/2011 Barrier #: 2708
 Bldg Name: Magruder Hall Reference Dwg: 1 of 5
 Location: Exterior - SW 30th St - West
 X Coordinate: 7476452.064 Y Coordinate: 338636.741
 Barrier Area: Walkways
 Barrier Type: Abrupt Change in Level
 Code: OSSC 1103.2.4.5 and 2010 ADAS 303.3
 References:

Performance Standard: No Quantity: LF As-built : 45
 Barrier Description: Change in level greater or equal to 1/2" without a 1:2 bevel

Findings: 1" lip in walkway surface

Rec. Solution: Grind or repair to remove trip hazard

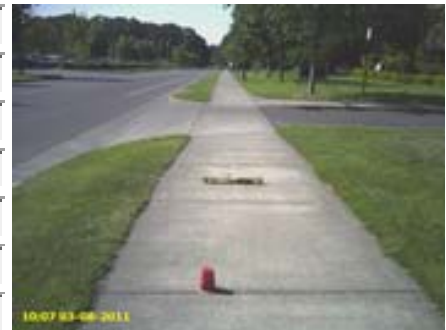
Field Date: 8/3/2011 Report Date: 8/3/2011 Barrier #: 2709
 Bldg Name: Magruder Hall Reference Dwg: 1 of 5
 Location: Exterior - SW 30th St - West
 X Coordinate: 7476450.451 Y Coordinate: 338542.048
 Barrier Area: Walkways
 Barrier Type: Cross Slope - Existing (5.0% or more)
 Code: OSSC 1103.2.4.3 and 2010 ADAS 403.3
 References:

Barrier Description: Cross slope exceeds 2.0% (5.0% or more)

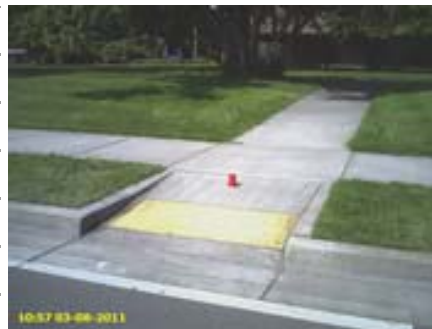
Field Date: 8/3/2011 Report Date: 8/3/2011 Barrier #: 2724
 Bldg Name: Magruder Hall Reference Dwg: 1 of 5
 Location: Exterior - SW 30th St - Corner A
 X Coordinate: 7476444.353 Y Coordinate: 338282.623
 Barrier Area: Curb Ramps
 Barrier Type: Running Slope - New Construction
 Code: OSSC 1103.2.2.1 and 2010 ADAS 406.1
 References:

Barrier Description: Ramp run slope exceeds 2.0%

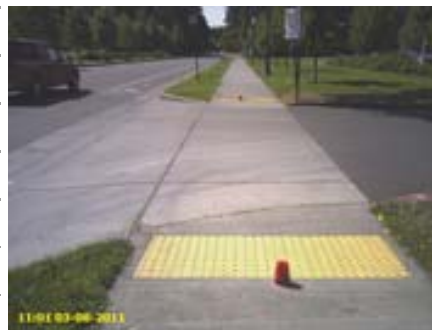
Field Date: 8/3/2011 Report Date: 8/3/2011 Barrier #: 2726
 Bldg Name: Magruder Hall Reference Dwg: 1 of 5
 Location: Exterior - SW 30th St - West
 X Coordinate: 7476433.601 Y Coordinate: 338132.237
 Barrier Area: Sidewalks
 Barrier Type: Detectable Warnings - Incorrect Application
 Code: Performance Standard
 References:

Barrier Description: Detectable warning (truncated domes) incorrectly installed at driveway

Rec. Solution: Remove truncated domes where no hazardous situation exists

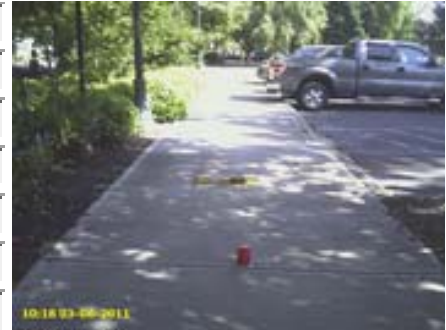
Field Date: 8/3/2011 Report Date 8/3/2011 Barrier #: 2712
 Bldg Name: Magruder Hall Reference Dwg: 1 of 5
 Location: Exterior - Northeast Walkway
 X Coordinate: 7476355.211 Y Coordinate: 338522.481
 Barrier Area: Walkways
 Barrier Type: Cross Slope - Existing (2.1% to 3.0%)
 Code
 References: OSSC 1103.2.4.3 and 2010 ADAS 403.3

Barrier Description: Cross slope exceeds 2.0% (2.1% to 3.0%)

Rec. Solution: Low severity barrier - no remediation recommended

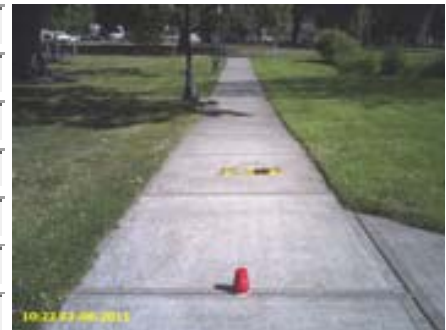
Field Date: 8/3/2011 Report Date 8/3/2011 Barrier #: 2713
 Bldg Name: Magruder Hall Reference Dwg: 1 of 5
 Location: Exterior - Northeast Walkway
 X Coordinate: 7476293.825 Y Coordinate: 338729.641
 Barrier Area: Walkways
 Barrier Type: Cross Slope - Existing (3.1% to 4.0%)
 Code
 References: OSSC 1103.2.4.3 and 2010 ADAS 403.3

Barrier Description: Cross slope exceeds 2.0% (3.1% to 4.0%)

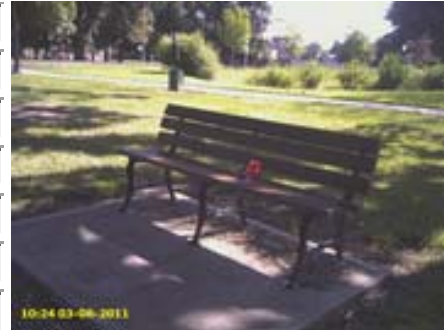
Field Date: 8/3/2011 Report Date: 8/3/2011 Barrier #: 2714A
 Bldg Name: Magruder Hall Reference Dwg: 1 of 5
 Location: Exterior - Northeast Walkway
 X Coordinate: 7476261.468 Y Coordinate: 338769.7
 Barrier Area: Street Furniture
 Barrier Type: Bench - Seat Height
 Code: 2010 ADAS 903.3
 References:

Barrier Description: Bench seat not 20" to 24" deep

Rec. Solution: Recommended: Ensure that 5% of all benches are accessible

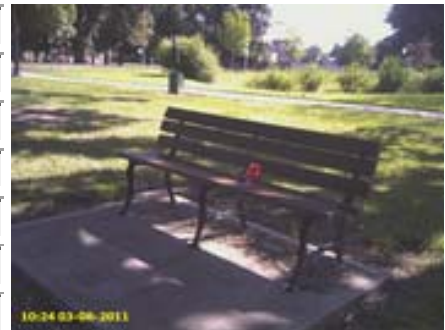
Field Date: 8/3/2011 Report Date: 8/3/2011 Barrier #: 2714B
 Bldg Name: Magruder Hall Reference Dwg: 1 of 5
 Location: Exterior - Northeast Walkway
 X Coordinate: 7476261.468 Y Coordinate: 338769.7
 Barrier Area: Street Furniture
 Barrier Type: Bench - Clear Space
 Code: 2010 ADAS 903.2 and PROWAG R211
 References:

Barrier Description: No clear space provided at side of bench for wheelchair user

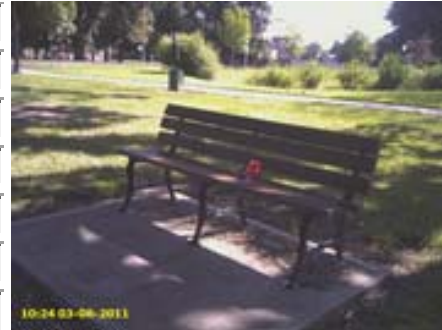
Field Date: 8/3/2011 Report Date: 8/3/2011 Barrier #: 2714C
 Bldg Name: Magruder Hall Reference Dwg: 1 of 5
 Location: Exterior - Northeast Walkway
 X Coordinate: 7476261.468 Y Coordinate: 338769.7
 Barrier Area: Street Furniture
 Barrier Type: Bench - Acc Route
 Code: 2010 ADAS 903.3 and PROWAG R211
 References:

Barrier Description: No accessible route provided to bench

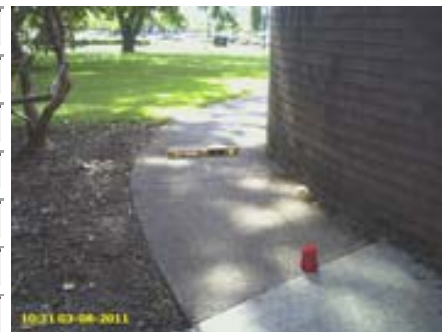
Field Date: 8/3/2011 Report Date: 8/3/2011 Barrier #: 2715
 Bldg Name: Magruder Hall Reference Dwg: 1 of 5
 Location: Exterior - Southeast Walkway
 X Coordinate: 7476290.086 Y Coordinate: 338266.722
 Barrier Area: Walkways
 Barrier Type: Cross Slope - Existing (3.1% to 4.0%)
 Code: OSSC 1103.2.4.3 and 2010 ADAS 403.3
 References:

Barrier Description: Cross slope exceeds 2.0% (3.1% to 4.0%)

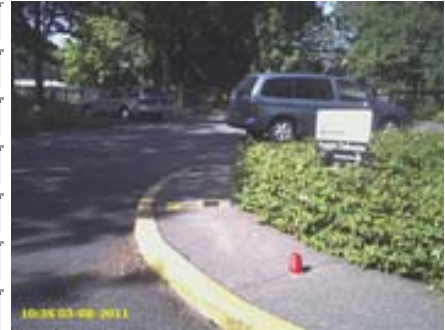
Field Date: 8/3/2011 Report Date: 8/3/2011 Barrier #: 2716
 Bldg Name: Magruder Hall Reference Dwg: 1 of 5
 Location: Exterior - Southeast Walkway
 X Coordinate: 7476263.645 Y Coordinate: 338207.462
 Barrier Area: Walkways
 Barrier Type: Cross Slope - Existing (3.1% to 4.0%)
 Code: OSSC 1103.2.4.3 and 2010 ADAS 403.3
 References:

Barrier Description: Cross slope exceeds 2.0% (3.1% to 4.0%)

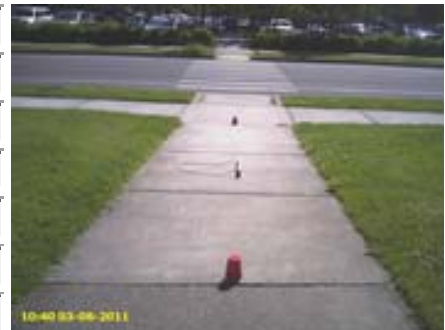
Field Date: 8/3/2011 Report Date: 8/3/2011 Barrier #: 2717
 Bldg Name: Magruder Hall Reference Dwg: 1 of 5
 Location: Exterior - East Walkway to 30th St
 X Coordinate: 7476421.157 Y Coordinate: 338283.257
 Barrier Area: Walkways
 Barrier Type: Running Slope - New Construction
 Code: OSSC 1103.2.4.3 and 2010 ADAS 403.3
 References:

Barrier Description: Walkway running slope exceeds 5.0%

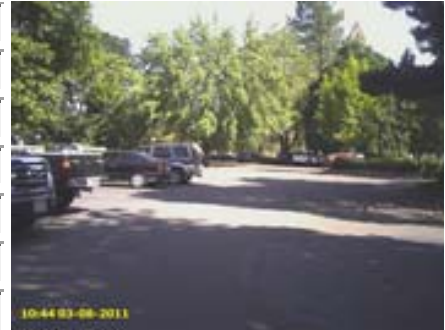
Field Date: 8/3/2011 Report Date: 8/3/2011 Barrier #: 2718
 Bldg Name: Magruder Hall Reference Dwg: 1 of 5
 Location: Exterior - Magruder Hall NE Parking Lot
 X Coordinate: 7476386.207 Y Coordinate: 338540.891
 Barrier Area: Parking
 Barrier Type: Ratio of Accessible Stalls - 51-75
 Code: OSSC 1104.1, ORS 447.233.2.(a) and 2010 ADAS 208.2
 References:

Barrier Description: Minimum 3 accessible stall not provided in lot/structure

Notes: 65 total stalls, 1 accessible stall & 1 van accessible stall

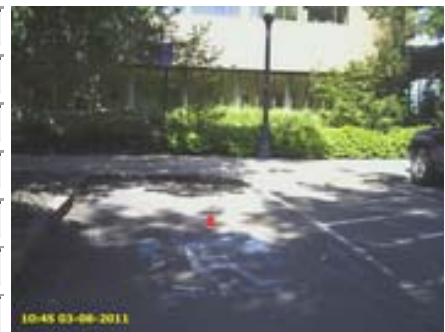
Field Date: 8/3/2011 Report Date: 8/3/2011 Barrier #: 2719A
 Bldg Name: Magruder Hall Reference Dwg: 1 of 5
 Location: Exterior - Magruder Hall NE Parking Lot
 X Coordinate: 7476371.963 Y Coordinate: 338533.768
 Barrier Area: Parking
 Barrier Type: Stall Dimensions
 Code: OSSC 1104.1 and ORS 447.233.2.(c)
 References:

Barrier Description: Accessible stall not min. 9' x 18"

Barrier Severity: 2 Recommended Cost Est \$0.00 Facility Function: Public Status: Open

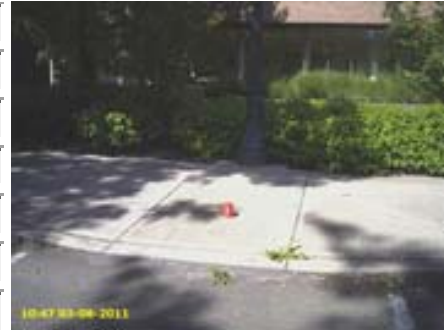
Field Date: 8/3/2011 Report Date 8/3/2011 Barrier #: 2720B
 Bldg Name: Magruder Hall Reference Dwg: 1 of 5
 Location: Exterior - Magruder Hall NE Parking Lot
 X Coordinate: 7476358.069 Y Coordinate: 338541.593
 Barrier Area: Curb Ramps
 Barrier Type: Running Slope - Existing (9.0% to 9.4%)
 Code: OSSC 1103.2.2.1 and 2010 ADAS 406.1
 References:

Barrier Description: Ramp running slope exceeds 8.3% (9.0% to 9.4%)

Barrier Severity: 2 Recommended Cost Est \$0.00 Facility Function: Public Status: Open

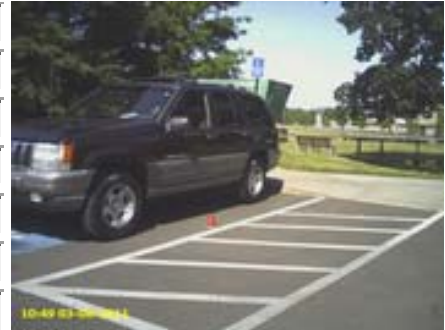
Field Date: 8/3/2011 Report Date: 8/3/2011 Barrier #: 2721B
 Bldg Name: Magruder Hall Reference Dwg: 1 of 5
 Location: Exterior - Magruder Hall NE Parking Lot
 X Coordinate: 7476311.044 Y Coordinate: 338711.381
 Barrier Area: Parking
 Barrier Type: Accessible Stall Aisle
 Code: OSSC 1104.1 and ORS 447.233.2.(c)
 References:

Barrier Description: No min. 6' wide access aisle provided

Notes: 65 total stalls, 1 accessible stall & 1 van accessible stall

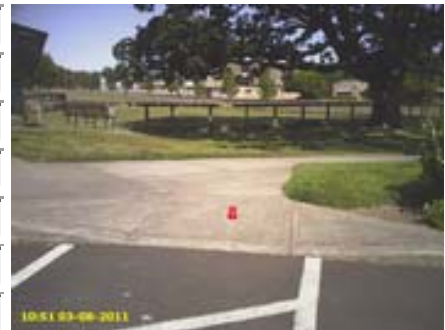
Field Date: 8/3/2011 Report Date: 8/3/2011 Barrier #: 2722A
 Bldg Name: Magruder Hall Reference Dwg: 1 of 5
 Location: Exterior - Magruder Hall NE Parking Lot
 X Coordinate: 7476304.482 Y Coordinate: 338722.876
 Barrier Area: Curb Ramps
 Barrier Type: Perpendicular Ramp Landing (4.1% to 4.9%)
 Code: OSSC 1103.2.4.3 and 2010 ADAS 406.4
 References:

Barrier Description: Curb ramp top landing not level (4.1% to 4.9%)

Barrier Severity: 2 Recommended Cost Est: \$0.00 Facility Function: Public Status: Open

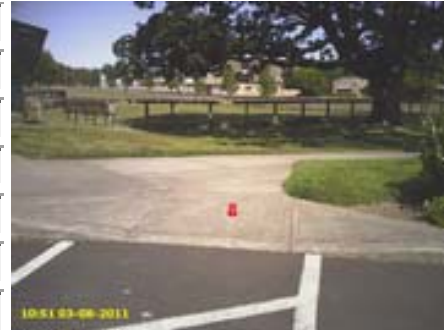
Field Date: 8/3/2011 Report Date: 8/3/2011 Barrier #: 2722B
 Bldg Name: Magruder Hall Reference Dwg: 1 of 5
 Location: Exterior - Magruder Hall NE Parking Lot
 X Coordinate: 7476304.482 Y Coordinate: 338722.876
 Barrier Area: Curb Ramps
 Barrier Type: Detectable Warnings - Incorrect Application
 Code: Performance Standard
 References:

Barrier Description: Detectable warning (mesh imprint) incorrectly installed

Barrier Severity: 2 Recommended Cost Est: \$0.00 Facility Function: Public Status: Open

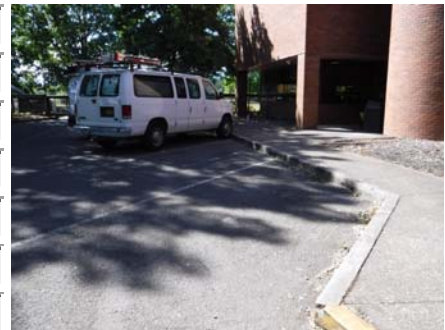
Field Date: 8/24/2017 Report Date: 8/24/2017 Barrier #: 1A
 Bldg Name: Magruder Hall Reference Dwg: 1 of 5
 Location: Exterior - Parking at Vet Diagnostic Lab
 X Coordinate: 7478936.986 Y Coordinate: 339699.892
 Barrier Area: Parking
 Barrier Type: Van Accessible Stall
 Code: 2010 ADAS 208.2.4
 References:

Barrier Description: No van accessible stall provided in parking lot/structure

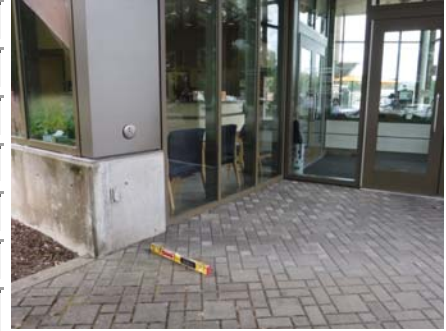
Field Date: 8/24/2017 Report Date: 8/24/2017 Barrier #: 2A
 Bldg Name: Magruder Hall Reference Dwg: 1 of 5
 Location: Floor 1 - North Public Entrance
 X Coordinate: N/A Y Coordinate: N/A
 Barrier Area: Doors or Gates
 Barrier Type: Automatic Doors - Actuation Device Landing
 Code: 2010 ADAS 404.2.4.4
 References:

Barrier Description: Actuation control not located on a level landing

Rec. Solution: Relocate actuation device or repair paver surface to provide a level landing

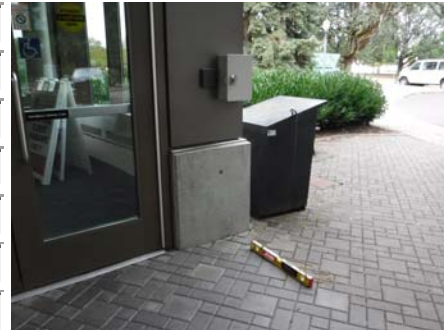
Field Date: 8/24/2017 Report Date: 8/24/2017 Barrier #: 2B
 Bldg Name: Magruder Hall Reference Dwg: 1 of 5
 Location: Floor 1 - North Public Entrance
 X Coordinate: N/A Y Coordinate: N/A
 Barrier Area: Clear Floor Space
 Barrier Type: Clear Floor Space - Wheelchair Use
 Code: 2010 ADAS 305
 References:

Barrier Description: Clear floor space of min. 30" by 48" not provided

Barrier Severity: 2 Recommended Cost Est: \$2,625.00 Facility Function: Public Status: Open

Rec. Solution: Repair paver surface to provide a level landing within accessible wheelchair space

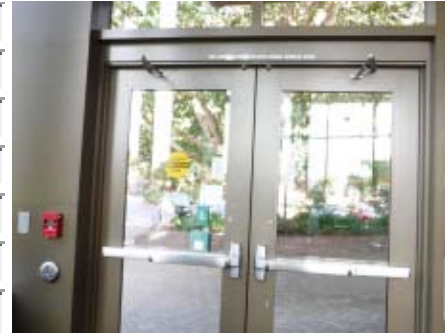
Field Date: 8/24/2017 Report Date: 8/24/2017 Barrier #: 3A
 Bldg Name: Magruder Hall Reference Dwg: 2 of 5
 Location: Floor 1 - Public Entry Vestibule 172
 X Coordinate: N/A Y Coordinate: N/A
 Barrier Area: Signage
 Barrier Type: Tactile Exit Signs - Door
 Code: 2010 ADAS 216.4.1
 References:

Barrier Description: Ground floor doors that exit to exterior lacks tactile exit sign

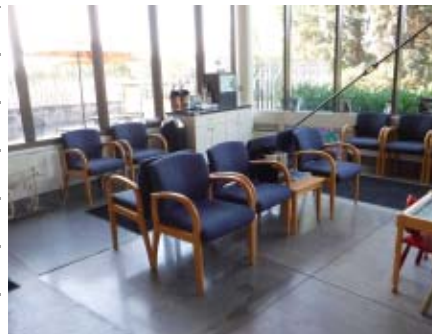
Field Date: 8/24/2017 Report Date: 8/24/2017 Barrier #: 4E
 Bldg Name: Magruder Hall Reference Dwg: 2 of 5
 Location: Floor 1 - Lobby 170
 X Coordinate: N/A Y Coordinate: N/A
 Barrier Area: Controls and Mechanisms
 Barrier Type: Actuator/Control - Side Reach High Unobstructed
 Code: 2010 ADAS 305.3
 References:

Barrier Description: Control or mechanism not at min. 15" or max. 48" high

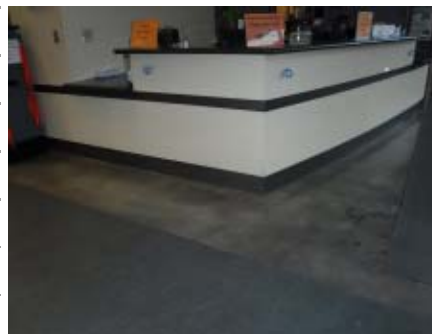
Field Date: 8/24/2017 Report Date: 8/24/2017 Barrier #: 4F
 Bldg Name: Magruder Hall Reference Dwg: 2 of 5
 Location: Floor 1 - Lobby 170
 X Coordinate: N/A Y Coordinate: N/A
 Barrier Area: Counters and Tables
 Barrier Type: Counter - Surface Blocked
 Code: 2010 ADAS 305.3
 References:

Barrier Description: Accessible counter use blocked by stored items

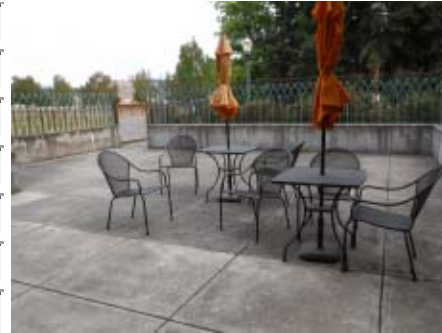
Field Date: 8/24/2017 Report Date: 8/24/2017 Barrier #: 5E
 Bldg Name: Magruder Hall Reference Dwg: 2 of 5
 Location: Floor 1 - Patio at Lobby
 X Coordinate: N/A Y Coordinate: N/A
 Barrier Area: Counters and Tables
 Barrier Type: Table - Pedestal Base
 Code: 2010 ADAS 306.2.2 & 306.2.3
 References:

Barrier Description: Knee clearance not min. 27" high, 19" deep or 30" wide

Barrier Severity: 2 Recommended Cost Est \$900.00 Facility Function: Public Status: Open

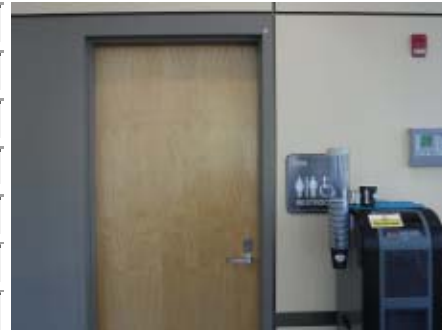
Field Date: 8/24/2017 Report Date: 8/24/2017 Barrier #: 6A
 Bldg Name: Magruder Hall Reference Dwg: 2 of 5
 Location: Floor 1 - Unisex Restroom 172A
 X Coordinate: N/A Y Coordinate: N/A
 Barrier Area: Restrooms
 Barrier Type: Sign - Approach
 Code: 2010 ADAS 703.2.3
 References:

Barrier Description: Approach to sign not within 18" x 18" due to protruding object

Rec. Solution: Relocate sign or replace

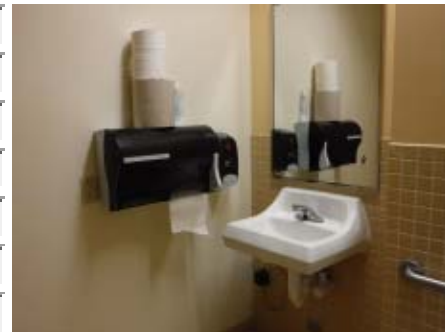
Field Date: 8/24/2017 Report Date: 8/24/2017 Barrier #: 6G
 Bldg Name: Magruder Hall Reference Dwg: 2 of 5
 Location: Floor 1 - Unisex Restroom 172A
 X Coordinate: N/A Y Coordinate: N/A
 Barrier Area: Restrooms
 Barrier Type: Dispensers - Protruding Object
 Code: 2010 ADAS 307.2
 References:

Barrier Description: Protruding dispenser creates protruding object in path of travel

Barrier Severity: 2 Recommended Cost Est: \$550.00 Facility Function: Public Status: Open

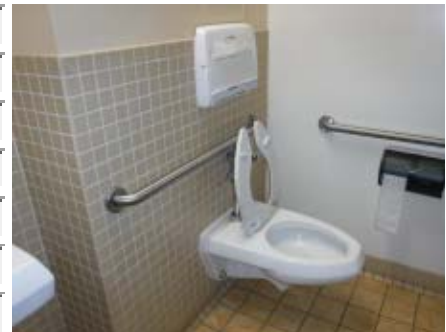
Field Date: 8/24/2017 Report Date: 8/24/2017 Barrier #: 6K
 Bldg Name: Magruder Hall Reference Dwg: 2 of 5
 Location: Floor 1 - Unisex Restroom 172A
 X Coordinate: N/A Y Coordinate: N/A
 Barrier Area: Restrooms
 Barrier Type: Seat Cover Dispenser
 Code: 2010 ADAS 307.2
 References:

Barrier Description: Seat cover dispenser not located on an accessible route. Blocked by water closet

Barrier Severity: 2 Recommended Cost Est: \$125.00 Facility Function: Public Status: Open

Rec. Solution: Replace or remount dispenser on an accessible route with clear floor space

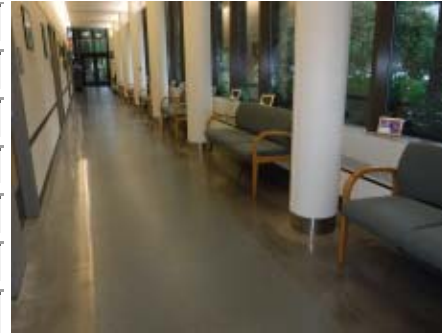
Field Date: 8/24/2017 Report Date: 8/24/2017 Barrier #: 8B
 Bldg Name: Magruder Hall Reference Dwg: 2 of 5
 Location: Floor 1 - Central Corridor
 X Coordinate: N/A Y Coordinate: N/A
 Barrier Area: Corridors
 Barrier Type: Bench - Wheelchair Space at Side
 Code: 2010 ADAS 903.2
 References:

Barrier Description: No level clear space provided at side of bench for wheelchair user

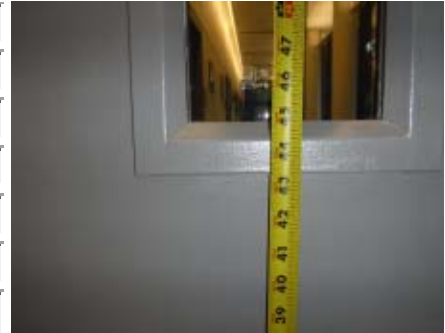
Field Date: 8/24/2017 Report Date: 8/24/2017 Barrier #: 9B
 Bldg Name: Magruder Hall Reference Dwg: 2 of 5
 Location: Floor 1 - Corridor 172
 X Coordinate: N/A Y Coordinate: N/A
 Barrier Area: Corridors
 Barrier Type: Vision Lights in Doors
 Code: 2010 ADAS 404.2.11
 References:

Barrier Description: Doors or gates with view panels or side lights adjacent to doors not max. 43" high

Rec. Solution: Replace door or vision panel in door

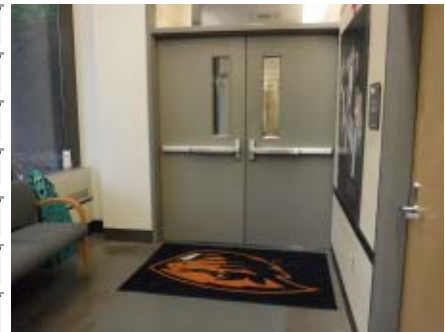
Field Date: 8/24/2017 Report Date: 8/24/2017 Barrier #: 9C
 Bldg Name: Magruder Hall Reference Dwg: 2 of 5
 Location: Floor 1 - Corridor 172
 X Coordinate: N/A Y Coordinate: N/A
 Barrier Area: Corridors
 Barrier Type: Door Closer - Exterior Automatic Door
 Code: Performance Standard
 References:

Barrier Description: Door opening force exceeds 8.5 lbf

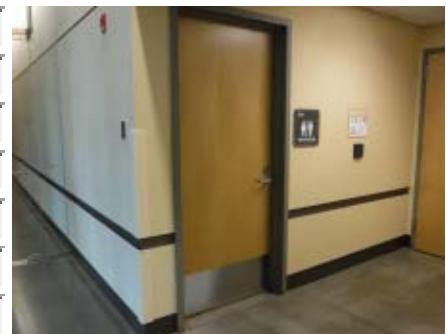
Field Date: 8/24/2017 Report Date: 8/24/2017 Barrier #: 11C
 Bldg Name: Magruder Hall Reference Dwg: 2 of 5
 Location: Floor 1 - Unisex Restroom 173A
 X Coordinate: N/A Y Coordinate: N/A
 Barrier Area: Doors or Gates
 Barrier Type: Door Closer - Interior Automatic Door
 Code: 2010 ADAS 404.2.9
 References:

Barrier Description: Door opening force exceeds 5 lbf

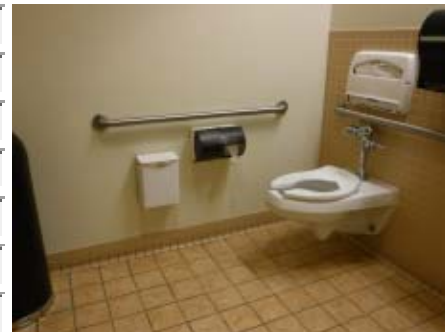
Field Date: 8/24/2017 Report Date: 8/24/2017 Barrier #: 11I
 Bldg Name: Magruder Hall Reference Dwg: 2 of 5
 Location: Floor 1 - Unisex Restroom 173A
 X Coordinate: N/A Y Coordinate: N/A
 Barrier Area: Restrooms
 Barrier Type: Toilet Transfer - Wall-mounted
 Code: 2010 ADAS 604.8.1.1
 References:

Barrier Description: Min. 60" wide x 56" deep clear floor space not provided at wall-mounted fixture

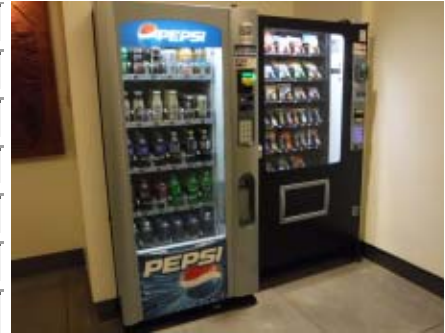
Field Date: 8/24/2017 Report Date: 8/24/2017 Barrier #: 12B
 Bldg Name: Magruder Hall Reference Dwg: 2 of 5
 Location: Floor 1 - Hall 101
 X Coordinate: N/A Y Coordinate: N/A
 Barrier Area: Controls and Mechanisms
 Barrier Type: Vending Machine - High Reach Range
 Code: 2010 ADAS 305.3
 References:

Barrier Description: Vending machine point of control not at max. 48" high for side reach

Rec. Solution: Contact vendor to obtain replacement

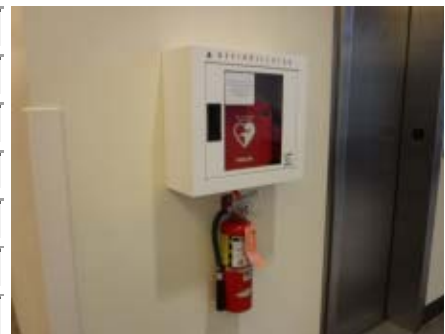
Field Date: 8/24/2017 Report Date: 8/24/2017 Barrier #: 12C
 Bldg Name: Magruder Hall Reference Dwg: 2 of 5
 Location: Floor 1 - Hall 101
 X Coordinate: N/A Y Coordinate: N/A
 Barrier Area: Corridors
 Barrier Type: Protruding Object
 Code: 2010 ADAS 307
 References:

Barrier Description: Protruding object in in circulation path protrudes more than 4" between 27" and 80" high

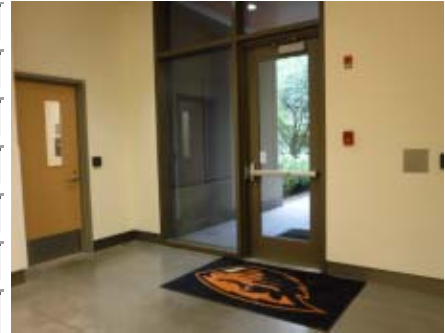
Field Date: 8/24/2017 Report Date: 8/24/2017 Barrier #: 12J
 Bldg Name: Magruder Hall Reference Dwg: 2 of 5
 Location: Floor 1 - Hall 101
 X Coordinate: N/A Y Coordinate: N/A
 Barrier Area: Doors or Gates
 Barrier Type: Door Closer - Exterior Sweep Period
 Code: 2010 ADAS 404.2.8.1
 References:

Barrier Description: Door closer lacks min. 5 second sweep period

Rec. Solution: Replace or adjust existing closer

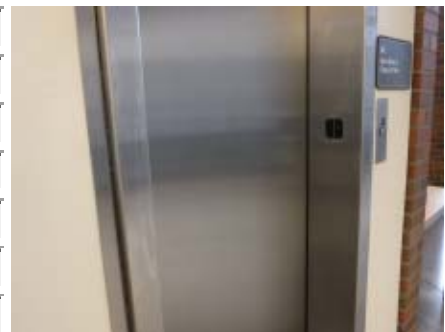
Field Date: 8/24/2017 Report Date: 8/24/2017 Barrier #: 13A
 Bldg Name: Magruder Hall Reference Dwg: 2 of 5
 Location: Floor 1 - Elevator 1
 X Coordinate: N/A Y Coordinate: N/A
 Barrier Area: Elevators
 Barrier Type: Doorjamb marking - Height
 Code: 2010 ADAS 407.2.3.1
 References:

Barrier Description: Elevator landing door jamb signage not located 60" on center on both jamb panels

Rec. Solution: Replace door jamb signage

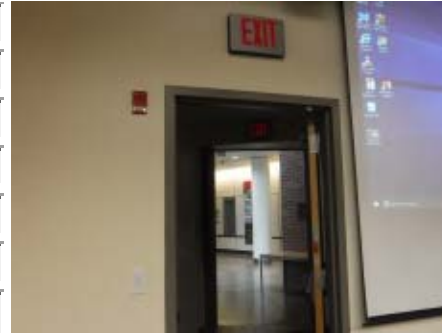
Field Date: 8/24/2017 Report Date: 8/24/2017 Barrier #: 14C
 Bldg Name: Magruder Hall Reference Dwg: 2 of 5
 Location: Floor 1 - Classroom 102
 X Coordinate: N/A Y Coordinate: N/A
 Barrier Area: Signage
 Barrier Type: Tactile Exit Signs - Passage
 Code: Performance Standard
 References:

Barrier Description: Exit thru an exit enclosure/exit passageway lacks tactile exit sign

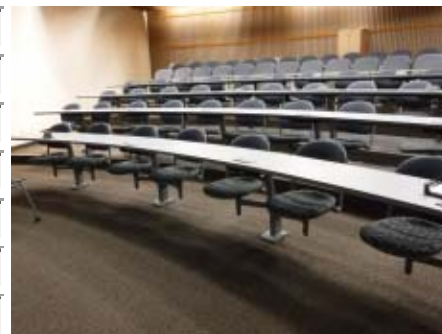
Field Date: 8/24/2017 Report Date: 8/24/2017 Barrier #: 14D
 Bldg Name: Magruder Hall Reference Dwg: 2 of 5
 Location: Floor 1 - Classroom 102
 X Coordinate: N/A Y Coordinate: N/A
 Barrier Area: Classrooms
 Barrier Type: Desk - Ratio
 Code: 2010 ADAS 902
 References:

Barrier Description: At least 1 desk or 5% of all desks not accessible

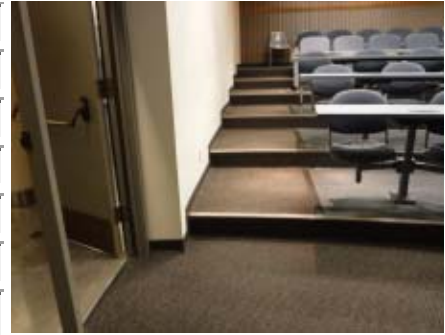
Field Date: 8/24/2017 Report Date: 8/24/2017 Barrier #: 14E
 Bldg Name: Magruder Hall Reference Dwg: 2 of 5
 Location: Floor 1 - Classroom 102
 X Coordinate: N/A Y Coordinate: N/A
 Barrier Area: Classrooms
 Barrier Type: Stairway Handrail - Both Sides
 Code: 2010 ADAS 306.3.2
 References:

Barrier Description: No handrail provided at both sides of stairway

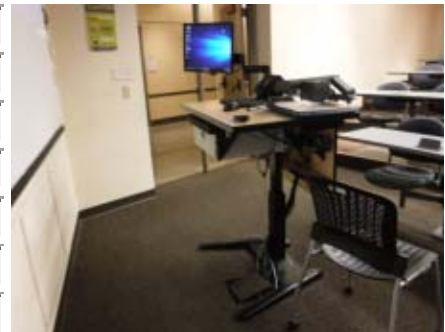
Field Date: 8/24/2017 Report Date: 8/24/2017 Barrier #: 14F
 Bldg Name: Magruder Hall Reference Dwg: 2 of 5
 Location: Floor 1 - Classroom 102
 X Coordinate: N/A Y Coordinate: N/A
 Barrier Area: Classrooms
 Barrier Type: Podium - Toe Clearance
 Code: 2010 ADAS 902.3
 References:

Barrier Description: Podium toe clearance not 9" above floor and at least 17" to 25" deep

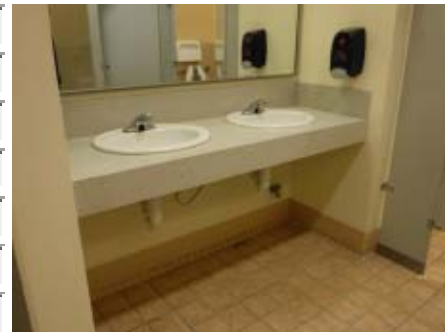
Field Date: 8/24/2017 Report Date: 8/24/2017 Barrier #: 16H
 Bldg Name: Magruder Hall Reference Dwg: 2 of 5
 Location: Floor 1 - Men's Multi-accommodation Toilet Room 105A
 X Coordinate: N/A Y Coordinate: N/A
 Barrier Area: Restrooms
 Barrier Type: Mirror
 Code: 2010 ADAS 603.3
 References:

Barrier Description: Mirror at lavatory/countertop not max. 40" AFF at edge of reflecting surface

Rec. Solution: Replace or remount mirror

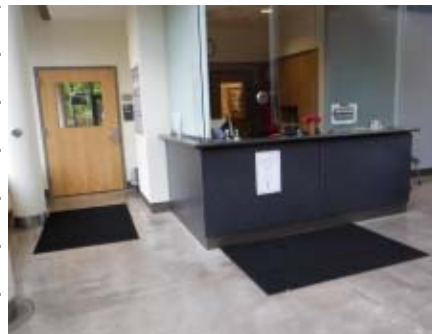
Field Date: 8/24/2017 Report Date: 8/24/2017 Barrier #: 17D
 Bldg Name: Magruder Hall Reference Dwg: 2 of 5
 Location: Floor 1 - Lobby 101
 X Coordinate: N/A Y Coordinate: N/A
 Barrier Area: Corridors
 Barrier Type: Carpet - Firmly Attached
 Code: 2010 ADAS 302.2
 References:

Barrier Description: Carpet, carpet tile or exposed edges of carpet not securely attached or fastened to floor

Rec. Solution: Fasten carpet or tiles firmly to floor, remove or replace

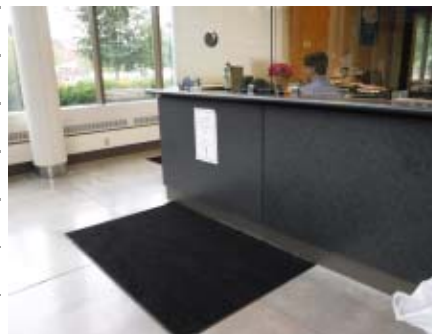
Field Date: 8/24/2017 Report Date: 8/24/2017 Barrier #: 17E
 Bldg Name: Magruder Hall Reference Dwg: 2 of 5
 Location: Floor 1 - Lobby 101
 X Coordinate: N/A Y Coordinate: N/A
 Barrier Area: Corridors
 Barrier Type: Sign - Lobby Info Sign
 Code: Performance Standard
 References:

Barrier Description: No lobby informational sign with location of accessible elements

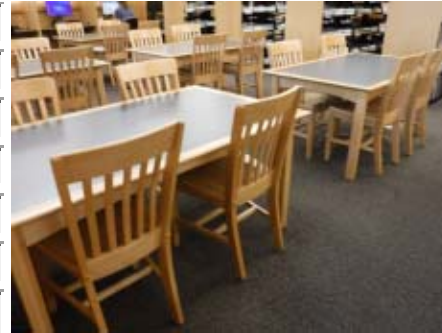
Field Date: 8/24/2017 Report Date: 8/24/2017 Barrier #: 19E
 Bldg Name: Magruder Hall Reference Dwg: 2 of 5
 Location: Floor 1 - Library 101
 X Coordinate: N/A Y Coordinate: N/A
 Barrier Area: Counters and Tables
 Barrier Type: Table - Ratio
 Code: 2010 ADAS 902
 References:

Barrier Description: At least 1 table or 5% of all tables are not accessible

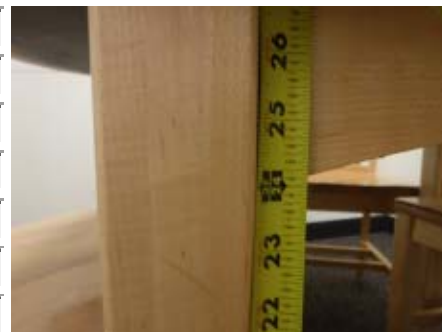
Field Date: 8/24/2017 Report Date: 8/24/2017 Barrier #: 19F
 Bldg Name: Magruder Hall Reference Dwg: 2 of 5
 Location: Floor 1 - Library 101
 X Coordinate: N/A Y Coordinate: N/A
 Barrier Area: Counters and Tables
 Barrier Type: Table - Knee Clearance
 Code: 2010 ADAS 305.3
 References:

Barrier Description: Knee clearance not min. 27" high, 19" deep or 30" wide

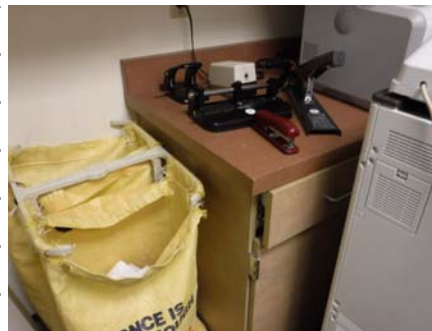
Field Date:	8/24/2017	Report Date	8/24/2017	Barrier #:	22E
Bldg Name:	Magruder Hall		Reference Dwg:	2 of 5	
Location:	Floor 1 - Library Conference Room 101A				
X Coordinate:	N/A	Y Coordinate:	N/A		
Barrier Area:	Counters and Tables				
Barrier Type:	Counter - Clear Floor Space				
Code	2010 ADAS 305.3				
References:

Barrier Description:	Clear floor space 30" x 48" not provided at counter
----------------------	---

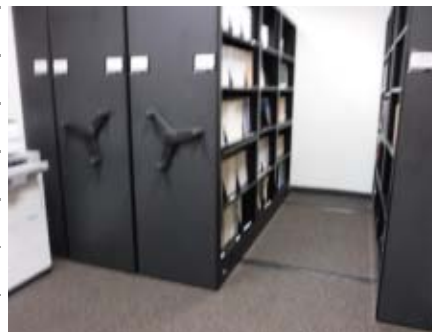
Field Date:	8/24/2017	Report Date	8/24/2017	Barrier #:	22F
Bldg Name:	Magruder Hall		Reference Dwg:	2 of 5	
Location:	Floor 1 - Library Conference Room 101A				
X Coordinate:	N/A	Y Coordinate:	N/A		
Barrier Area:	Classrooms				
Barrier Type:	Shelves or Cabinets				
Code	2010 ADAS 603.4				
References:

Barrier Description:	Shelf or cabinet not mounted between 40" and 48" above floor or ground
----------------------	--

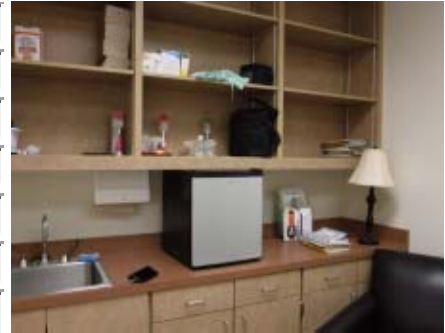
Field Date: 8/24/2017 Report Date: 8/24/2017 Barrier #: 231
 Bldg Name: Magruder Hall Reference Dwg: 2 of 5
 Location: Floor 1 - Library Lactation Room 101B
 X Coordinate: N/A Y Coordinate: N/A
 Barrier Area: Controls and Mechanisms
 Barrier Type: Actuator/Control - Hi/low Reach
 Code: 2010 ADAS 308.2.2
 References:

Barrier Description: Use of control involves low reach of less than 15" above floor or more than 48" high

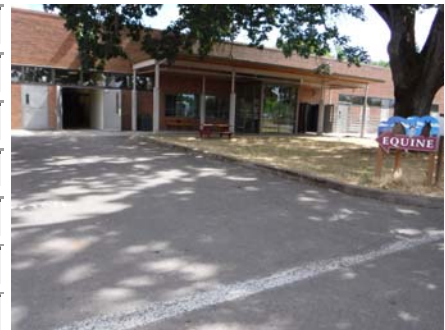
Field Date: 8/24/2017 Report Date: 8/24/2017 Barrier #: 24A
 Bldg Name: Magruder Hall Reference Dwg: 2 of 5
 Location: Exterior - Parking at Large Animal Clinic (Equine)
 X Coordinate: N/A Y Coordinate: N/A
 Barrier Area: Parking
 Barrier Type: Van Accessible Stall
 Code: 2010 ADAS 208.2.4
 References:

Barrier Description: No van accessible stall provided in parking lot/structure

Notes: Stalls are not marked in area used for parking and loading zones for horses

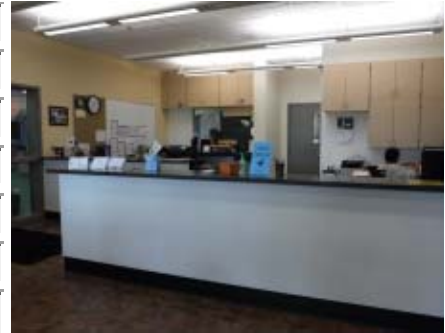
Field Date: 8/24/2017 Report Date: 8/24/2017 Barrier #: 28A
 Bldg Name: Magruder Hall Reference Dwg: 3 of 5
 Location: Floor 1 - Lobby 159
 X Coordinate: N/A Y Coordinate: N/A
 Barrier Area: Counters and Tables
 Barrier Type: Counter - Surface Height
 Code: 2010 ADAS 902.3
 References:

Barrier Description: No section at least 3 feet long between 28" and 34" provided at existing counter

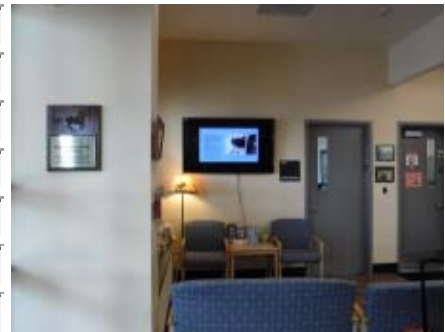
Field Date: 8/24/2017 Report Date: 8/24/2017 Barrier #: 28B
 Bldg Name: Magruder Hall Reference Dwg: 3 of 5
 Location: Floor 1 - Lobby 159
 X Coordinate: N/A Y Coordinate: N/A
 Barrier Area: Corridors
 Barrier Type: Sign - Lobby Info Sign
 Code: Performance Standard
 References:

Barrier Description: No lobby informational sign with location of accessible elements

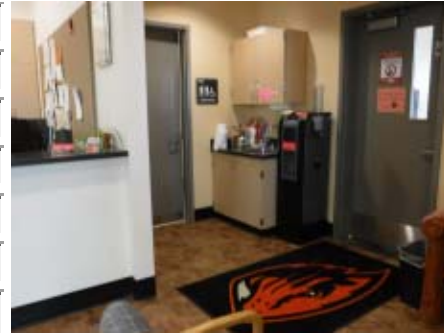
Field Date: 8/24/2017 Report Date: 8/24/2017 Barrier #: 28G
 Bldg Name: Magruder Hall Reference Dwg: 3 of 5
 Location: Floor 1 - Lobby 159
 X Coordinate: N/A Y Coordinate: N/A
 Barrier Area: Doors or Gates
 Barrier Type: Vision Lights - Existing
 Code: 2010 ADAS 404.2.11
 References:

Barrier Description: View panels in or adjacent to doors or gates not max. 43" above floor or ground

Rec. Solution: Replace door/gate or vision panel

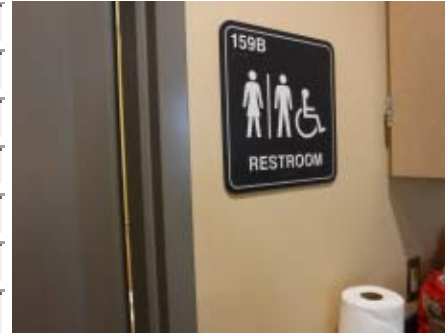
Field Date: 8/24/2017 Report Date: 8/24/2017 Barrier #: 29C
 Bldg Name: Magruder Hall Reference Dwg: 3 of 5
 Location: Floor 1 - Unisex Toilet Room 159B
 X Coordinate: N/A Y Coordinate: N/A
 Barrier Area: Signage
 Barrier Type: Pictograms - Raised Characters
 Code: 2010 ADAS 703.2.1
 References:

Barrier Description: Lettering or pictograms not raised

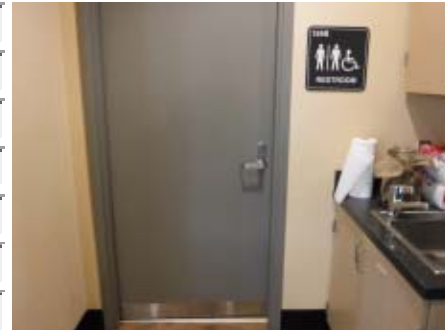
Field Date: 8/24/2017 Report Date: 8/24/2017 Barrier #: 29D
 Bldg Name: Magruder Hall Reference Dwg: 3 of 5
 Location: Floor 1 - Unisex Toilet Room 159B
 X Coordinate: N/A Y Coordinate: N/A
 Barrier Area: Doors or Gates
 Barrier Type: Door Closer - Interior Automatic Door
 Code: 2010 ADAS 404.2.9
 References:

Barrier Description: Door opening force exceeds 5 lbf

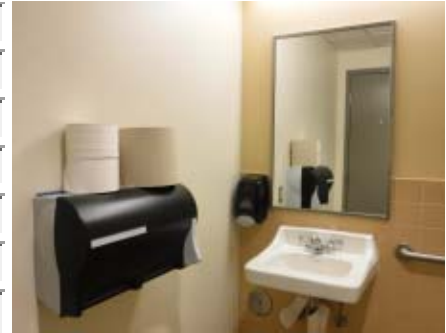
Field Date: 8/24/2017 Report Date: 8/24/2017 Barrier #: 29I
 Bldg Name: Magruder Hall Reference Dwg: 3 of 5
 Location: Floor 1 - Unisex Toilet Room 159B
 X Coordinate: N/A Y Coordinate: N/A
 Barrier Area: Restrooms
 Barrier Type: Mirror
 Code: 2010 ADAS 603.3
 References:

Barrier Description: Mirror at lavatory/countertop not max. 40" AFF at edge of reflecting surface

Rec. Solution: Replace or remount mirror

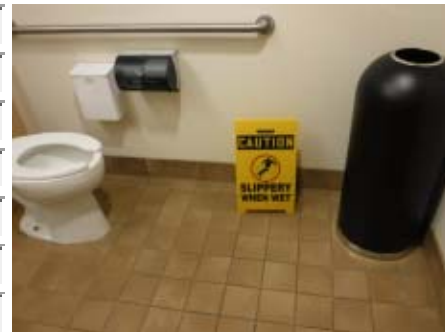
Field Date: 8/24/2017 Report Date: 8/24/2017 Barrier #: 29J
 Bldg Name: Magruder Hall Reference Dwg: 3 of 5
 Location: Floor 1 - Unisex Toilet Room 159B
 X Coordinate: N/A Y Coordinate: N/A
 Barrier Area: Restrooms
 Barrier Type: Toilet Transfer - Wall-mounted
 Code: 2010 ADAS 604.8.1.1
 References:

Barrier Description: Min. 60" wide x 56" deep clear floor space not provided at wall-mounted fixture

Findings: 34-1/4" between rim and trash bin

Barrier Severity: 2 Recommended Cost Est: \$0.00 Facility Function: Public Status: Open

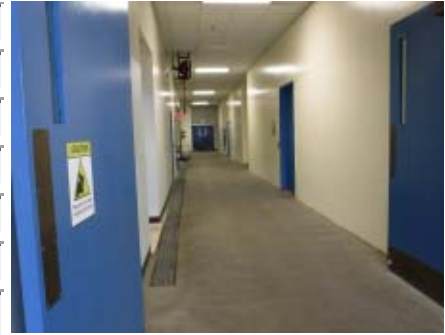
Field Date: 8/24/2017 Report Date: 8/24/2017 Barrier #: 30C
 Bldg Name: Magruder Hall Reference Dwg: 3 of 5
 Location: Floor 1 - Livestock Treatment Area H118
 X Coordinate: N/A Y Coordinate: N/A
 Barrier Area: Corridors
 Barrier Type: Vision Lights in Doors
 Code: 2010 ADAS 404.2.11
 References:

Barrier Description: Doors or gates with view panels or side lights adjacent to doors not max. 43" high

Rec. Solution: Replace door or vision panel in door

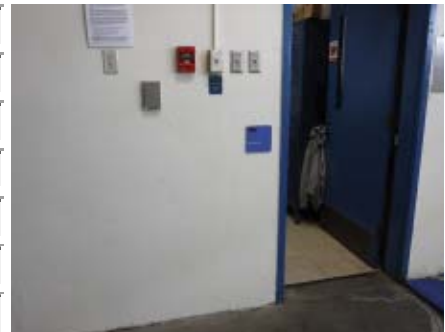
Field Date: 8/24/2017 Report Date: 8/24/2017 Barrier #: 30D
 Bldg Name: Magruder Hall Reference Dwg: 3 of 5
 Location: Floor 1 - Livestock Treatment Area H118
 X Coordinate: N/A Y Coordinate: N/A
 Barrier Area: Corridors
 Barrier Type: Fire Alarm - Pull Actuator Height
 Code: 2010 ADAS 308.2.2
 References:

Barrier Description: Fire pulls not between 42" and 48" high

Rec. Solution: Replace fire pull when remodeling

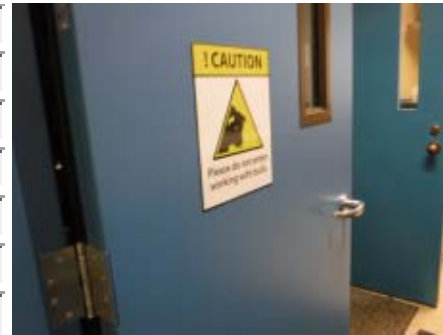
Field Date: 8/24/2017 Report Date: 8/24/2017 Barrier #: 31B
 Bldg Name: Magruder Hall Reference Dwg: 3 of 5
 Location: Floor 1 - Semen Room 160
 X Coordinate: N/A Y Coordinate: N/A
 Barrier Area: Doors or Gates
 Barrier Type: Vision Lights - New Construction
 Code: 2010 ADAS 404.2.11
 References:

Barrier Description: View panels in or adjacent to doors or gates not max. 43" above floor or ground

Barrier Severity: 2 Recommended Cost Est: \$2,250.00 Facility Function: Public Status: Open

Rec. Solution: Replace door/gate or vision panel

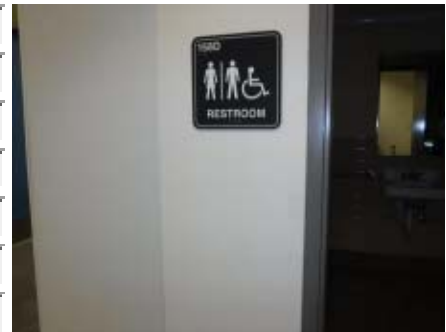
Field Date: 8/24/2017 Report Date: 8/24/2017 Barrier #: 34A
 Bldg Name: Magruder Hall Reference Dwg: 3 of 5
 Location: Floor 1 - Unisex Toilet Room 158D
 X Coordinate: N/A Y Coordinate: N/A
 Barrier Area: Signage
 Barrier Type: Braille - Multi-lined Braille
 Code: 2010 ADAS .2.3.2
 References:

Barrier Description: Braille not placed below all multi-lined tactile characters in one line

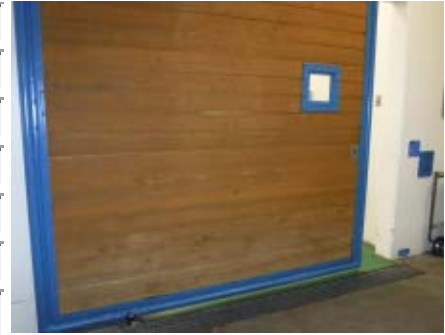
Field Date: 8/24/2017 Report Date: 8/24/2017 Barrier #: 36C
 Bldg Name: Magruder Hall Reference Dwg: 3 of 5
 Location: Floor 1 - Surgery Room 155
 X Coordinate: N/A Y Coordinate: N/A
 Barrier Area: Doors or Gates
 Barrier Type: Vision Lights - New Construction
 Code: 2010 ADAS 404.2.11
 References:

Barrier Description: View panels in or adjacent to doors or gates not max. 43" above floor or ground

Barrier Severity: 2 Recommended Cost Est: \$4,500.00 Facility Function: Public Status: Open

Rec. Solution: Replace door/gate or vision panel

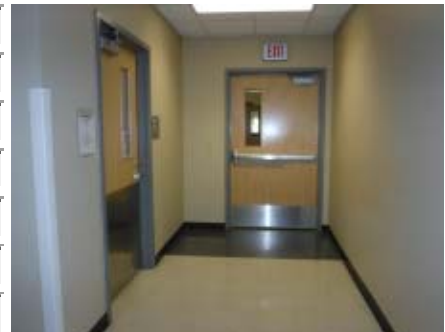
Field Date: 8/24/2017 Report Date: 8/24/2017 Barrier #: 37A
 Bldg Name: Magruder Hall Reference Dwg: 3 of 5
 Location: Floor 1 - Corridor 104
 X Coordinate: N/A Y Coordinate: N/A
 Barrier Area: Signage
 Barrier Type: Tactile Exit Signs - To Exit Door
 Code: Performance Standard
 References:

Barrier Description: Exit door leading directly to an exit to the exterior lacks tactile exit sign

Barrier Severity: 2 Recommended Cost Est: \$250.00 Facility Function: Public Status: Open

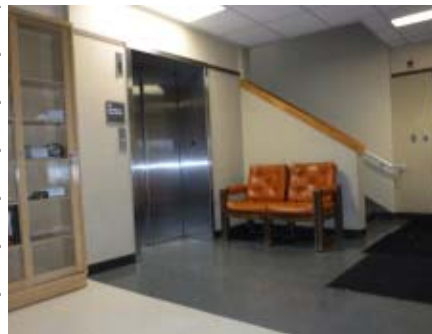
Field Date:	8/24/2017	Report Date	8/24/2017	Barrier #:	39A
Bldg Name:	Magruder Hall		Reference Dwg:	3 of 5	
Location:	Floor 1 - Elevator 2				
X Coordinate:	N/A	Y Coordinate:	N/A		
Barrier Area:	Elevators				
Barrier Type:	Doorjamb marking - Height				
Code	2010 ADAS 407.2.3.1				
References:

Barrier Description:	Elevator landing door jamb signage not located 60" on center on both jamb panels
----------------------	--

Barrier Severity:	2 Recommended	Cost Est	\$250.00	Facility Function:	Public	Status:	Open
-------------------	---------------	----------	----------	--------------------	--------	---------	------

Rec. Solution:	Replace door jamb signage
----------------	---------------------------

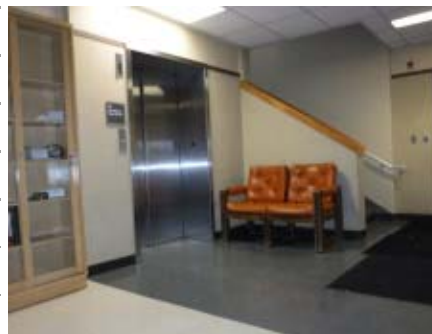
Field Date:	8/24/2017	Report Date	8/24/2017	Barrier #:	39B
Bldg Name:	Magruder Hall		Reference Dwg:	3 of 5	
Location:	Floor 1 - Elevator 2				
X Coordinate:	N/A	Y Coordinate:	N/A		
Barrier Area:	Elevators				
Barrier Type:	Doorjamb marking - Braille				
Code	2010 ADAS 407.2.3.1				
References:

Barrier Description:	Braille not placed below the corresponding raised characters on both door jambs
----------------------	---

Findings:	Braille placed at side
-----------	------------------------

Rec. Solution:	Replace door jamb signage
----------------	---------------------------

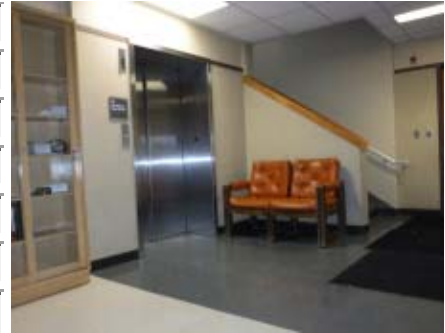
Field Date: 8/24/2017 Report Date: 8/24/2017 Barrier #: 39C
 Bldg Name: Magruder Hall Reference Dwg: 3 of 5
 Location: Floor 1 - Elevator 2
 X Coordinate: N/A Y Coordinate: N/A
 Barrier Area: Elevators
 Barrier Type: Doorjamb marking - Raised Star
 Code: 2010 ADAS 407.2.3.1
 References:

Barrier Description: Elevator landing door jamb signage at grade level lacks a raised five pointed star

Rec. Solution: Replace door jamb signage

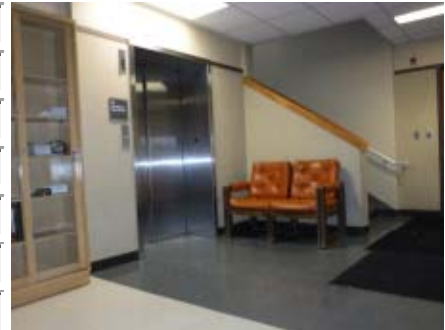
Field Date: 8/24/2017 Report Date: 8/24/2017 Barrier #: 39D
 Bldg Name: Magruder Hall Reference Dwg: 3 of 5
 Location: Floor 1 - Elevator 2
 X Coordinate: N/A Y Coordinate: N/A
 Barrier Area: Elevators
 Barrier Type: Evacuation Sign
 Code: Performance Standard & 2010 ADAS 703.1
 References:

Barrier Description: Sign stating "IN FIRE EMERGENCY, DO NOT USE ELEVATOR. USE EXIT STAIRS" not provided with tactile information

Rec. Solution: Replace sign

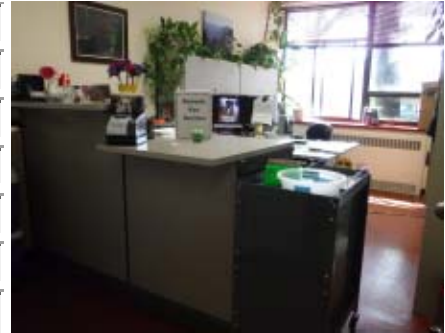
Barrier Description: Clear floor space 30" x 48" not provided at counter

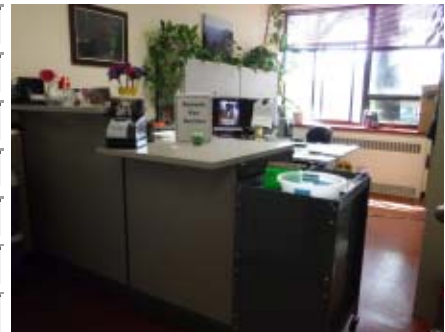
Barrier Description: Counter or table in route of travel protrudes more than 4" above 27" high

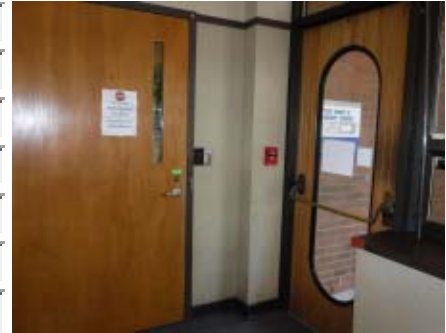
Barrier Description: Fire pulls not between 42" and 48" high

Rec. Solution: Replace fire pull when remodeling

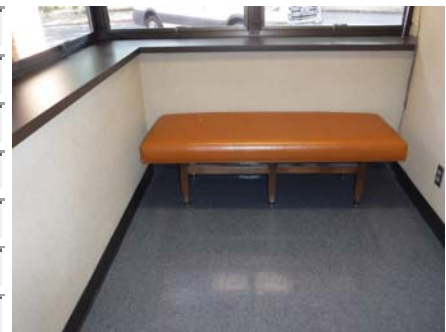
Barrier Description: No level clear space provided at side of bench for wheelchair user

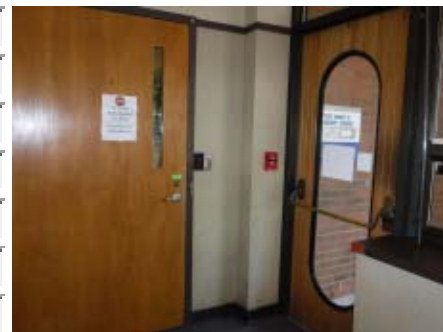
Barrier Description: Ground floor doors that exit to exterior lacks tactile exit sign

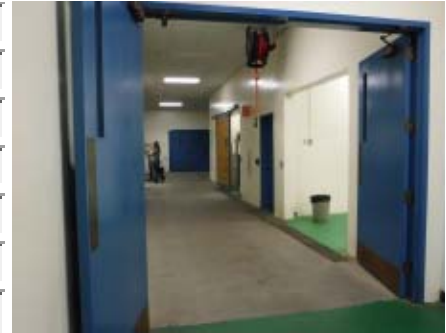
Field Date: 8/24/2017 Report Date: 8/24/2017 Barrier #: 46A
 Bldg Name: Magruder Hall Reference Dwg: 3 of 5
 Location: Floor 1 - Corridor 113
 X Coordinate: N/A Y Coordinate: N/A
 Barrier Area: Corridors
 Barrier Type: Vision Lights in Doors
 Code: 2010 ADAS 404.2.11
 References:

Barrier Description: Doors or gates with view panels or side lights adjacent to doors not max. 43" high

Rec. Solution: Replace door or vision panel in door

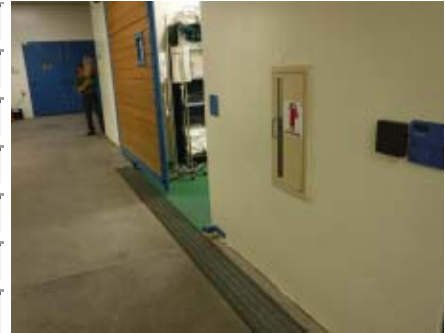
Field Date: 8/24/2017 Report Date: 8/24/2017 Barrier #: 46C
 Bldg Name: Magruder Hall Reference Dwg: 3 of 5
 Location: Floor 1 - Corridor 113
 X Coordinate: N/A Y Coordinate: N/A
 Barrier Area: Alarms
 Barrier Type: Fire Extinguisher - Clear Floor Space
 Code: 2010 ADAS 308.2.2
 References:

Barrier Description: Fire extinguisher or cabinet lacks clear floor space

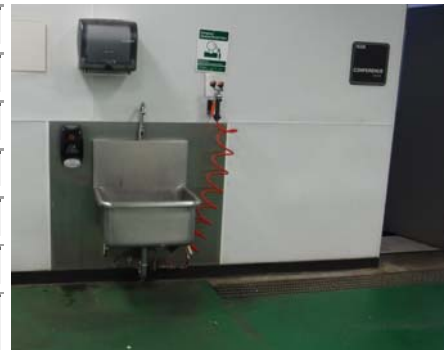
Field Date: 8/24/2017 Report Date: 8/24/2017 Barrier #: 47A
 Bldg Name: Magruder Hall Reference Dwg: 3 of 5
 Location: Floor 1 - Equine Exam Area 153
 X Coordinate: N/A Y Coordinate: N/A
 Barrier Area: Laboratory Facilities
 Barrier Type: Eye Wash - Bubbler Height
 Code: 2010 ADAS 602.4
 References:

Barrier Description: Eye wash bubbler height not max. 36"

Notes: Sink is used by staff but the emergency eye wash can be used by anyone in the area and should be accessible

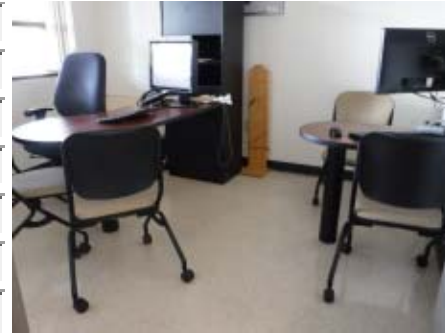
Field Date: 8/24/2017 Report Date: 8/24/2017 Barrier #: 50E
 Bldg Name: Magruder Hall Reference Dwg: 4 of 5
 Location: Floor 1 - Consultation Room 159A
 X Coordinate: N/A Y Coordinate: N/A
 Barrier Area: Clear Floor Space
 Barrier Type: Clear Floor Space - Wheelchair Use
 Code: 2010 ADAS 305
 References:

Barrier Description: Clear floor space of min. 30" by 48" not provided

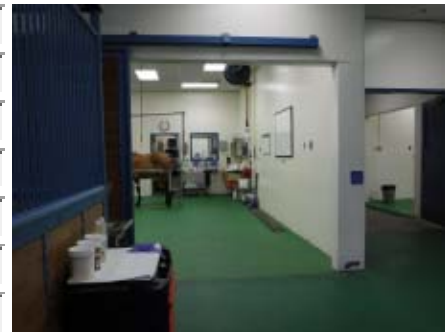
Field Date: 8/24/2017 Report Date: 8/24/2017 Barrier #: 51A
 Bldg Name: Magruder Hall Reference Dwg: 4 of 5
 Location: Floor 1 - Exam Room 151
 X Coordinate: N/A Y Coordinate: N/A
 Barrier Area: Signage
 Barrier Type: Permanent Room/Space - Tactile Characters
 Code: 2010 ADAS 216.2
 References:

Barrier Description: No tactile characters at sign identifying permanent rooms and spaces with visual signs

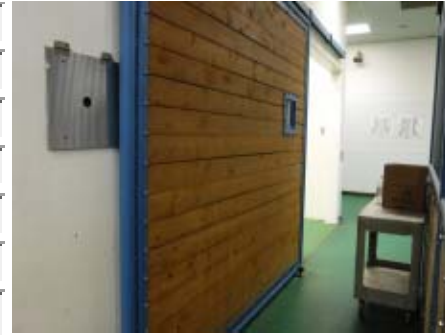
Field Date: 8/24/2017 Report Date: 8/24/2017 Barrier #: 51B
 Bldg Name: Magruder Hall Reference Dwg: 4 of 5
 Location: Floor 1 - Exam Room 151
 X Coordinate: N/A Y Coordinate: N/A
 Barrier Area: Doors or Gates
 Barrier Type: Vision Lights - New Construction
 Code: 2010 ADAS 404.2.11
 References:

Barrier Description: View panels in or adjacent to doors or gates not max. 43" above floor or ground

Barrier Severity: 2 Recommended Cost Est: \$2,250.00 Facility Function: Public Status: Open

Rec. Solution: Replace door/gate or vision panel

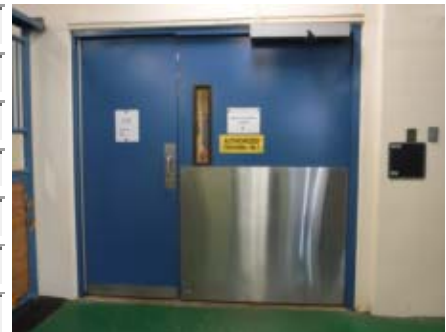
Field Date: 8/24/2017 Report Date: 8/24/2017 Barrier #: 52A
 Bldg Name: Magruder Hall Reference Dwg: 4 of 5
 Location: Floor 1 - ICU H113
 X Coordinate: N/A Y Coordinate: N/A
 Barrier Area: Signage
 Barrier Type: Braille - Multi-lined Braille
 Code: 2010 ADAS .2.3.2
 References:

Barrier Description: Braille not placed below all multi-lined tactile characters in one line together

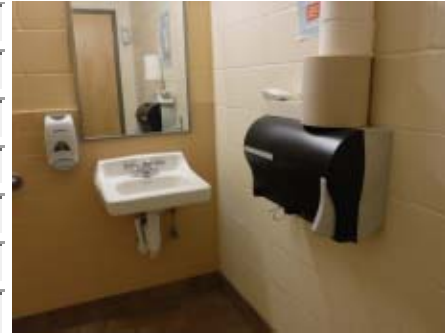
Field Date: 8/24/2017 Report Date: 8/24/2017 Barrier #: 60G
 Bldg Name: Magruder Hall Reference Dwg: 4 of 5
 Location: Floor 1 - Radiology Unisex Accessible Toilet Room 184
 X Coordinate: N/A Y Coordinate: N/A
 Barrier Area: Restrooms
 Barrier Type: Lavatory - Rim Height
 Code: 2010 ADAS 606.3
 References:

Barrier Description: Lavatory rim or counter edge is higher than 34" AFF

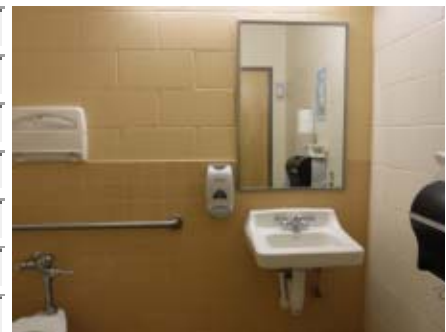
Field Date: 8/24/2017 Report Date: 8/24/2017 Barrier #: 60H
 Bldg Name: Magruder Hall Reference Dwg: 4 of 5
 Location: Floor 1 - Radiology Unisex Accessible Toilet Room 184
 X Coordinate: N/A Y Coordinate: N/A
 Barrier Area: Restrooms
 Barrier Type: Mirror
 Code: 2010 ADAS 603.3
 References:

Barrier Description: Mirror at lavatory/countertop not max. 40" AFF at edge of reflecting surface

Rec. Solution: Replace or remount mirror

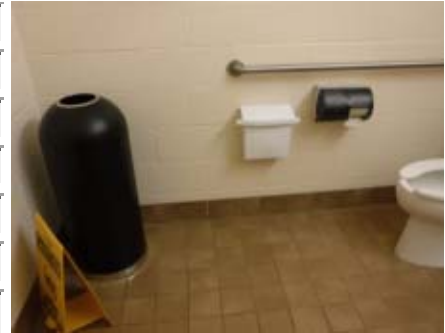
Field Date: 8/24/2017 Report Date: 8/24/2017 Barrier #: 60I
 Bldg Name: Magruder Hall Reference Dwg: 4 of 5
 Location: Floor 1 - Radiology Unisex Accessible Toilet Room 184
 X Coordinate: N/A Y Coordinate: N/A
 Barrier Area: Restrooms
 Barrier Type: Toilet Paper Dispenser
 Code: 2010 ADAS 604.7
 References:

Performance Standard: No Quantity: EACH As-built : 1
 Barrier Description: Toilet tissue dispenser not within 7" to 9" from front edge of toilet

Findings: 15" from rim

Rec. Solution: Reposition or replace toilet paper dispenser
