OREGON STATE UNIVERSITY (OSU)

MAGRUDER HALL

ADA ASSESSMENT & SURVEY

Re: ADA Accessibility Survey and Assessment – Magruder Hall

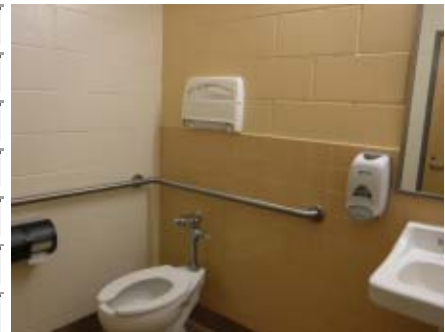
Field Date: 8/24/2017 Report Date: 8/24/2017 Barrier #: 60J
 Bldg Name: Magruder Hall Reference Dwg: 4 of 5
 Location: Floor 1 - Radiology Unisex Accessible Toilet Room 184
 X Coordinate: N/A Y Coordinate: N/A
 Barrier Area: Restrooms
 Barrier Type: Toilet Centerline
 Code: 2010 ADAS 604.2
 References:

Performance Standard: No Quantity: JOB As-built : 1
 Barrier Description: Water closet centerline not between 16" and 18" O. C.

Findings: 18-1/4" on center

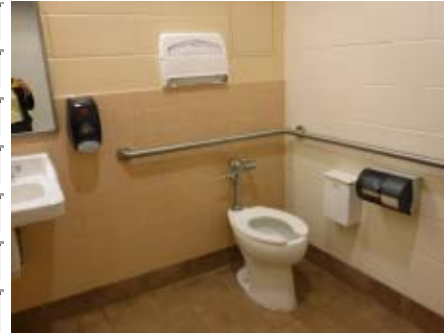
Field Date: 8/24/2017 Report Date: 8/24/2017 Barrier #: 61I
 Bldg Name: Magruder Hall Reference Dwg: 4 of 5
 Location: Floor 1 - Radiology Unisex Accessible Toilet Room 186
 X Coordinate: N/A Y Coordinate: N/A
 Barrier Area: Restrooms
 Barrier Type: Toilet Transfer - Wall-mounted
 Code: 2010 ADAS 604.8.1.1
 References:

Barrier Description: Min. 60" wide x 56" deep clear floor space not provided at wall-mounted fixture

Barrier Severity: 2 Recommended Cost Est: \$12,000.00 Facility Function: Public Status: Open

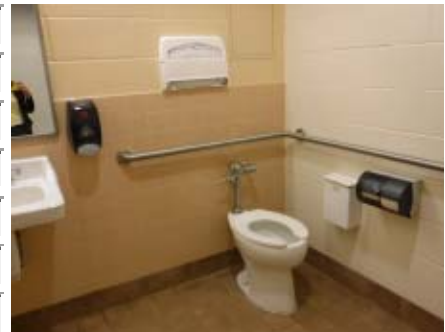
Field Date: 8/24/2017 Report Date: 8/24/2017 Barrier #: 61J
 Bldg Name: Magruder Hall Reference Dwg: 4 of 5
 Location: Floor 1 - Radiology Unisex Accessible Toilet Room 186
 X Coordinate: N/A Y Coordinate: N/A
 Barrier Area: Restrooms
 Barrier Type: Toilet Paper Dispenser
 Code: 2010 ADAS 604.7
 References:

Barrier Description: Toilet tissue dispenser not within 7" to 9" from front edge of toilet

Rec. Solution: Reposition or replace toilet paper dispenser

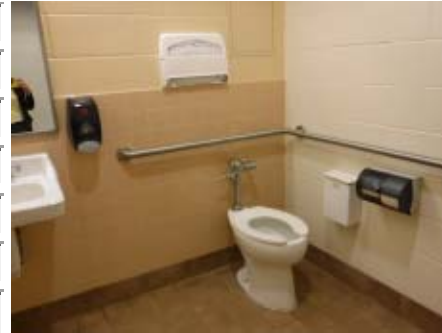
Field Date: 8/24/2017 Report Date: 8/24/2017 Barrier #: 61M
 Bldg Name: Magruder Hall Reference Dwg: 4 of 5
 Location: Floor 1 - Radiology Unisex Accessible Toilet Room 186
 X Coordinate: N/A Y Coordinate: N/A
 Barrier Area: Restrooms
 Barrier Type: Dispensers - Height
 Code: 2010 ADAS 307.2
 References:

Barrier Description: Dispenser control point or operating mechanism not max. 48" AFF

Barrier Severity: 2 Recommended Cost Est \$0.00 Facility Function: Public Status: Open

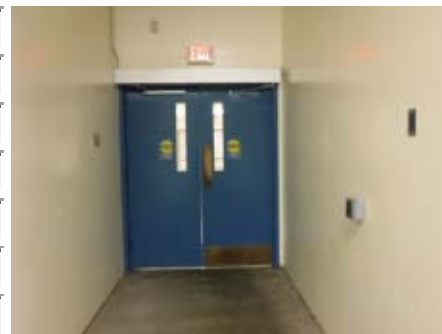
Field Date: 8/24/2017 Report Date: 8/24/2017 Barrier #: 62A
 Bldg Name: Magruder Hall Reference Dwg: 4 of 5
 Location: Floor 1 - Radiology Hall 102
 X Coordinate: N/A Y Coordinate: N/A
 Barrier Area: Doors or Gates
 Barrier Type: Vision Lights - New Construction
 Code: 2010 ADAS 404.2.11
 References:

Barrier Description: View panels in or adjacent to doors or gates not max. 43" above floor or ground

Barrier Severity: 2 Recommended Cost Est \$4,500.00 Facility Function: Public Status: Open

Rec. Solution: Replace door/gate or vision panel

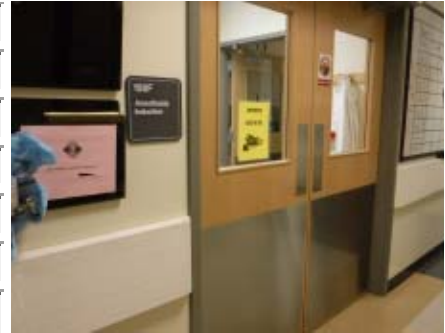
Field Date: 8/24/2017 Report Date: 8/24/2017 Barrier #: 63A
 Bldg Name: Magruder Hall Reference Dwg: 4 of 5
 Location: Floor 1 - Anesthesia Induction Room 108F
 X Coordinate: N/A Y Coordinate: N/A
 Barrier Area: Doors or Gates
 Barrier Type: Vision Lights - New Construction
 Code: 2010 ADAS 404.2.11
 References:

Barrier Description: View panels in or adjacent to doors or gates not max. 43" above floor or ground

Barrier Severity: 2 Recommended Cost Est: \$2,250.00 Facility Function: Public Status: Open

Rec. Solution: Replace door/gate or vision panel

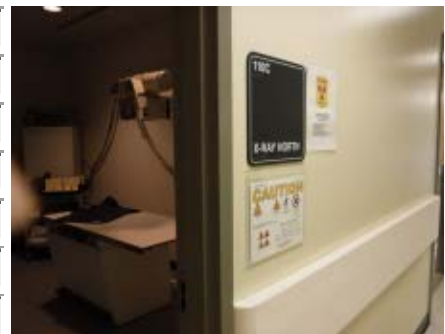
Field Date: 8/24/2017 Report Date: 8/24/2017 Barrier #: 63B
 Bldg Name: Magruder Hall Reference Dwg: 4 of 5
 Location: Floor 1 - Anesthesia Induction Room 108F
 X Coordinate: N/A Y Coordinate: N/A
 Barrier Area: Signage
 Barrier Type: Braille - Multi-lined Braille
 Code: 2010 ADAS .2.3.2
 References:

Barrier Description: Braille not placed below all multi-lined tactile characters in one line together

Notes: Offices 110A, 110C, 110D.

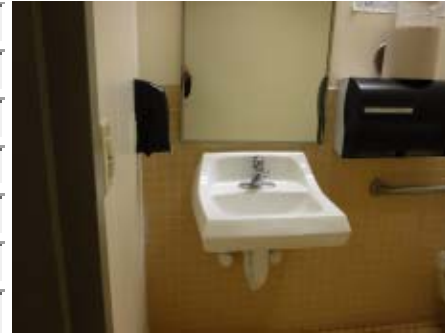
Field Date: 8/24/2017 Report Date: 8/24/2017 Barrier #: 65G
 Bldg Name: Magruder Hall Reference Dwg: 4 of 5
 Location: Floor 1 - Unisex Toilet Room 0173C
 X Coordinate: N/A Y Coordinate: N/A
 Barrier Area: Restrooms
 Barrier Type: Mirror
 Code: 2010 ADAS 603.3
 References:

Barrier Description: Mirror at lavatory/countertop not max. 40" AFF at edge of reflecting surface

Rec. Solution: Replace or remount mirror

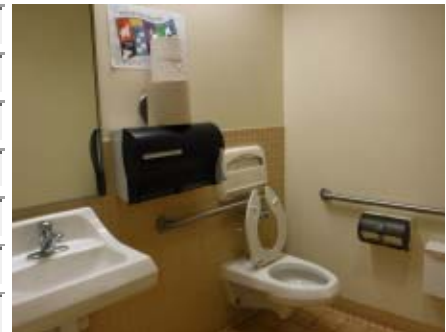
Field Date: 8/24/2017 Report Date: 8/24/2017 Barrier #: 65H
 Bldg Name: Magruder Hall Reference Dwg: 4 of 5
 Location: Floor 1 - Unisex Toilet Room 0173C
 X Coordinate: N/A Y Coordinate: N/A
 Barrier Area: Restrooms
 Barrier Type: Toilet Transfer - Wall-mounted
 Code: 2010 ADAS 604.8.1.1
 References:

Barrier Description: Min. 60" wide x 56" deep clear floor space not provided at wall-mounted fixture

Barrier Severity: 2 Recommended Cost Est: \$12,000.00 Facility Function: Public Status: Open

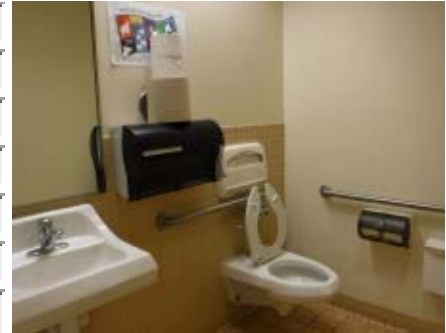
Field Date: 8/24/2017 Report Date: 8/24/2017 Barrier #: 65I
 Bldg Name: Magruder Hall Reference Dwg: 4 of 5
 Location: Floor 1 - Unisex Toilet Room 0173C
 X Coordinate: N/A Y Coordinate: N/A
 Barrier Area: Restrooms
 Barrier Type: Toilet Transfer - Wall-mounted
 Code: 2010 ADAS 604.8.1.1
 References:

Barrier Description: Min. 60" wide x 56" deep clear floor space not provided at wall-mounted fixture

Barrier Severity: 2 Recommended Cost Est: \$150.00 Facility Function: Public Status: Open

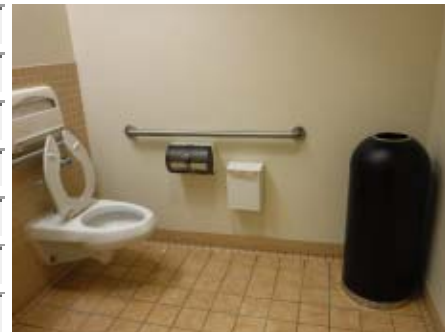
Field Date: 8/24/2017 Report Date: 8/24/2017 Barrier #: 65J
 Bldg Name: Magruder Hall Reference Dwg: 4 of 5
 Location: Floor 1 - Unisex Toilet Room 0173C
 X Coordinate: N/A Y Coordinate: N/A
 Barrier Area: Restrooms
 Barrier Type: Toilet Centerline
 Code: 2010 ADAS 604.2
 References:

Barrier Description: Water closet centerline not between 16" and 18" O. C.

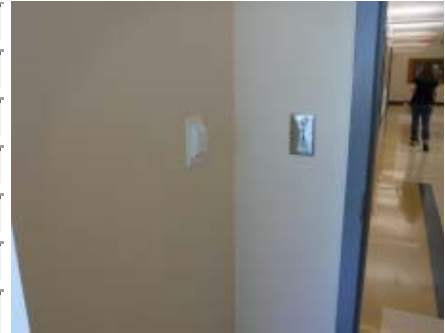
Field Date: 8/24/2017 Report Date: 8/24/2017 Barrier #: 66C
 Bldg Name: Magruder Hall Reference Dwg: 5 of 5
 Location: Floor 2 - Conference Room 262
 X Coordinate: N/A Y Coordinate: N/A
 Barrier Area: Controls and Mechanisms
 Barrier Type: Electrical Switches - Height
 Code: 2010 ADAS 308.2
 References:

Barrier Description: Light switch control box top edge not at max. 48" high

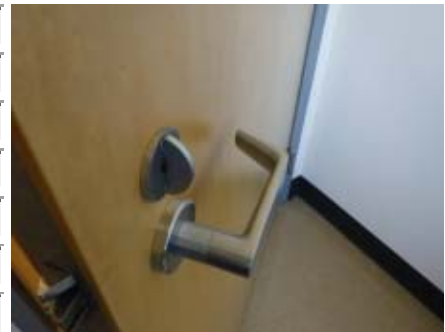
Field Date: 8/24/2017 Report Date: 8/24/2017 Barrier #: 66D
 Bldg Name: Magruder Hall Reference Dwg: 5 of 5
 Location: Floor 2 - Conference Room 262
 X Coordinate: N/A Y Coordinate: N/A
 Barrier Area: Controls and Mechanisms
 Barrier Type: Actuator/Control - Fist Operable
 Code: 2010 ADAS 305.3
 References:

Barrier Description: Control or mechanism not usable with a closed fist

Rec. Solution: Replace operating control

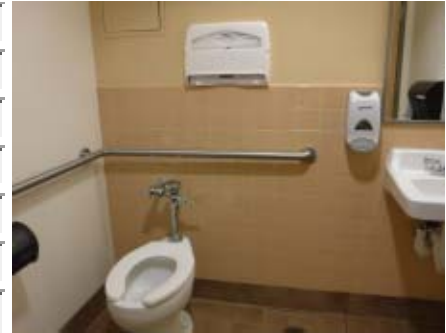
Field Date: 8/24/2017 Report Date: 8/24/2017 Barrier #: 68I
 Bldg Name: Magruder Hall Reference Dwg: 5 of 5
 Location: Floor 2 - Unisex Accessible Toilet Room 260A
 X Coordinate: N/A Y Coordinate: N/A
 Barrier Area: Restrooms
 Barrier Type: Toilet Transfer - Wall-mounted
 Code: 2010 ADAS 604.8.1.1
 References:

Barrier Description: Min. 60" wide x 56" deep clear floor space not provided at wall-mounted fixture

Barrier Severity: 2 Recommended Cost Est: \$12,000.00 Facility Function: Public Status: Open

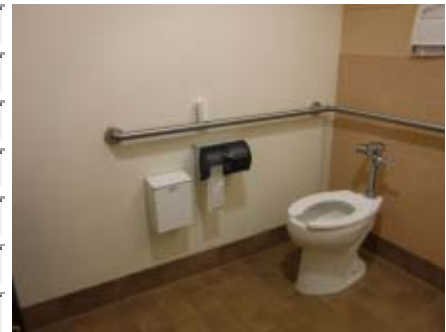
Field Date: 8/24/2017 Report Date: 8/24/2017 Barrier #: 68J
 Bldg Name: Magruder Hall Reference Dwg: 5 of 5
 Location: Floor 2 - Unisex Accessible Toilet Room 260A
 X Coordinate: N/A Y Coordinate: N/A
 Barrier Area: Restrooms
 Barrier Type: Toilet Paper Dispenser
 Code: 2010 ADAS 604.7
 References:

Barrier Description: Toilet tissue dispenser not within 7" to 9" from front edge of toilet

Rec. Solution: Reposition or replace toilet paper dispenser

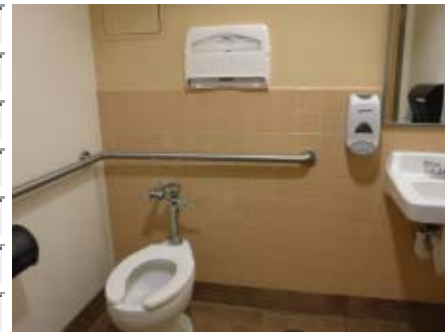
Field Date: 8/24/2017 Report Date: 8/24/2017 Barrier #: 68L
 Bldg Name: Magruder Hall Reference Dwg: 5 of 5
 Location: Floor 2 - Unisex Accessible Toilet Room 260A
 X Coordinate: N/A Y Coordinate: N/A
 Barrier Area: Restrooms
 Barrier Type: Seat Cover Dispenser
 Code: 2010 ADAS 307.2
 References:

Barrier Description: Seat cover dispenser not located on an accessible route. Blocked by water closet

Barrier Severity: 2 Recommended Cost Est: \$125.00 Facility Function: Public Status: Open

Rec. Solution: Replace or remount dispenser on an accessible route with clear floor space

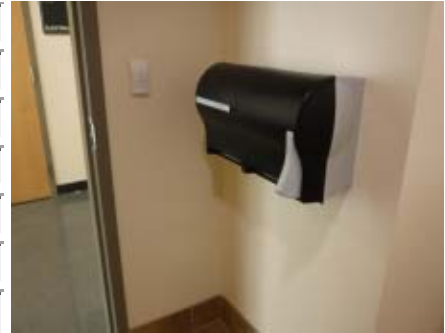
Field Date: 8/24/2017 Report Date: 8/24/2017 Barrier #: 69F
 Bldg Name: Magruder Hall Reference Dwg: 5 of 5
 Location: Floor 2 - Unisex Accessible Toilet Room 260B
 X Coordinate: N/A Y Coordinate: N/A
 Barrier Area: Doors or Gates
 Barrier Type: Front App/pull 18" SEC - Relocate Door
 Code: 2010 ADAS Figure 404.2.4.1
 References:

Barrier Description: Door/Gate at pull side with min. 60" lacks min. 18" strike edge clearance at pull side

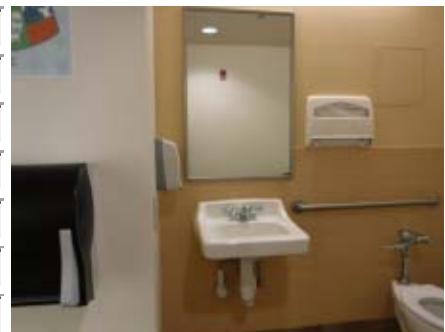
Field Date: 8/24/2017 Report Date: 8/24/2017 Barrier #: 69G
 Bldg Name: Magruder Hall Reference Dwg: 5 of 5
 Location: Floor 2 - Unisex Accessible Toilet Room 260B
 X Coordinate: N/A Y Coordinate: N/A
 Barrier Area: Restrooms
 Barrier Type: Lavatory - Centerline
 Code: 2010 ADAS 606
 References:

Barrier Description: Lavatory adjacent to wall not min. 15" to the centerline of fixture

Barrier Severity: 2 Recommended Cost Est \$450.00 Facility Function: Public Status: Open

Rec. Solution: Relocate or replace lavatory

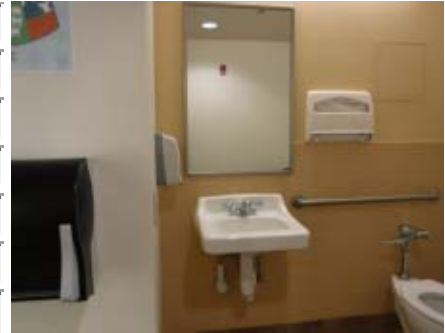
Field Date: 8/24/2017 Report Date: 8/24/2017 Barrier #: 69H
 Bldg Name: Magruder Hall Reference Dwg: 5 of 5
 Location: Floor 2 - Unisex Accessible Toilet Room 260B
 X Coordinate: N/A Y Coordinate: N/A
 Barrier Area: Restrooms
 Barrier Type: Mirror
 Code: 2010 ADAS 603.3
 References:

Barrier Description: Mirror at lavatory/countertop not max. 40" AFF at edge of reflecting surface

Rec. Solution: Replace or remount mirror

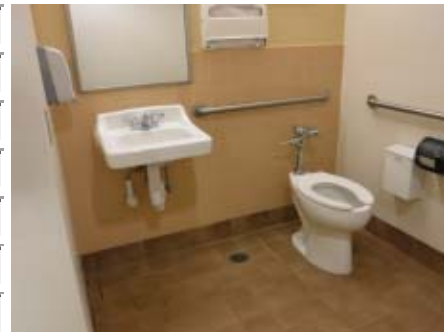
Field Date: 8/24/2017 Report Date: 8/24/2017 Barrier #: 69I
 Bldg Name: Magruder Hall Reference Dwg: 5 of 5
 Location: Floor 2 - Unisex Accessible Toilet Room 260B
 X Coordinate: N/A Y Coordinate: N/A
 Barrier Area: Restrooms
 Barrier Type: Toilet Transfer - Wall-mounted
 Code: 2010 ADAS 604.8.1.1
 References:

Barrier Description: Min. 60" wide x 56" deep clear floor space not provided at wall-mounted fixture

Findings: 45-1/2" from wall to lavatory

Barrier Severity: 2 Recommended Cost Est: \$12,000.00 Facility Function: Public Status: Open

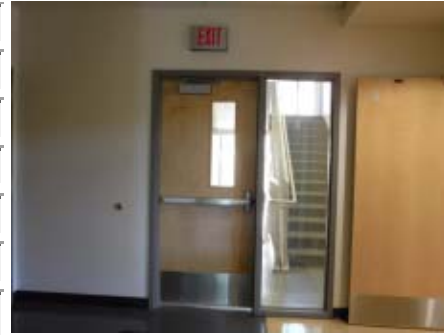
Field Date: 8/24/2017 Report Date: 8/24/2017 Barrier #: 72C
 Bldg Name: Magruder Hall Reference Dwg: 5 of 5
 Location: Floor 2 - Exit Stairway 274
 X Coordinate: N/A Y Coordinate: N/A
 Barrier Area: Stairways
 Barrier Type: Door Closer - Interior Sweep ADA
 Code: 2010 ADAS 404.2.8.1
 References:

Barrier Description: Door closer lacks min. 5 second sweep period

Barrier Severity: 2 Recommended Cost Est: \$0.00 Facility Function: Public Status: Open

Rec. Solution: Replace or adjust existing closer

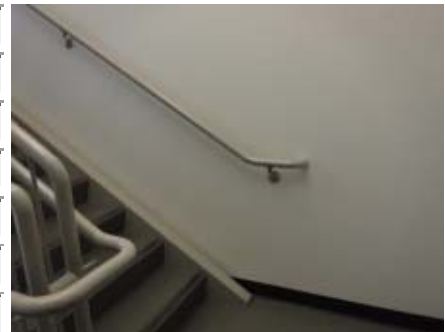
Field Date: 8/24/2017 Report Date: 8/24/2017 Barrier #: 72D
 Bldg Name: Magruder Hall Reference Dwg: 5 of 5
 Location: Floor 2 - Exit Stairway 274
 X Coordinate: N/A Y Coordinate: N/A
 Barrier Area: Stairways
 Barrier Type: Sign - Enclosed Exit Stairway Level
 Code: ICC A117.1
 References:

Barrier Description: Tactile stairway signage not provided to indicate floor level

Barrier Severity: 2 Recommended Cost Est: \$250.00 Facility Function: Public Status: Open

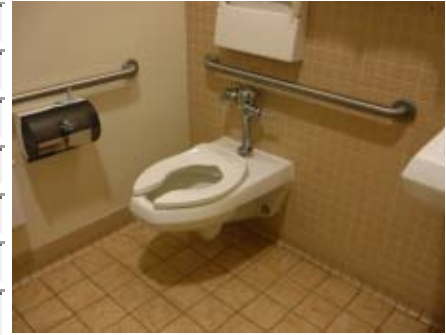
Field Date: 8/24/2017 Report Date: 8/24/2017 Barrier #: 73H
 Bldg Name: Magruder Hall Reference Dwg: 5 of 5
 Location: Floor 2 - Unisex Accessible Restroom 297
 X Coordinate: N/A Y Coordinate: N/A
 Barrier Area: Restrooms
 Barrier Type: Toilet Transfer - Wall-mounted (per-ADA)
 Code: 2010 ADAS 604.8.1.1
 References:

Barrier Description: Min. 60" wide x 56" deep clear floor space not provided at wall-mounted fixture

Barrier Severity: 2 Recommended Cost Est: \$12,000.00 Facility Function: Public Status: Open

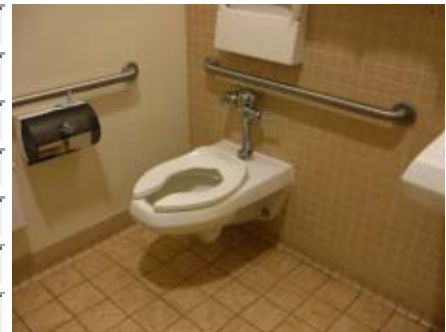
Field Date: 8/24/2017 Report Date: 8/24/2017 Barrier #: 73I
 Bldg Name: Magruder Hall Reference Dwg: 5 of 5
 Location: Floor 2 - Unisex Accessible Restroom 297
 X Coordinate: N/A Y Coordinate: N/A
 Barrier Area: Restrooms
 Barrier Type: Toilet - Rear Grab Bar
 Code: 2010 ADAS 609.4
 References:

Barrier Description: Rear grab bar not mounted between 33" and 36" above floor

Rec. Solution: Replace grab bars with reinforcement

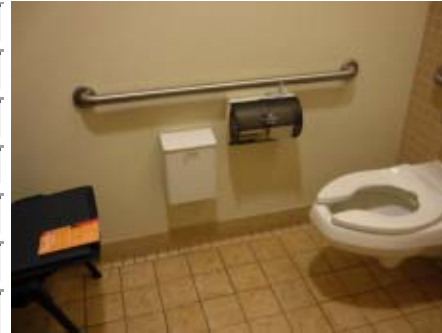
Field Date: 8/24/2017 Report Date: 8/24/2017 Barrier #: 73L
 Bldg Name: Magruder Hall Reference Dwg: 5 of 5
 Location: Floor 2 - Unisex Accessible Restroom 297
 X Coordinate: N/A Y Coordinate: N/A
 Barrier Area: Restrooms
 Barrier Type: Toilet Transfer - Wall-mounted
 Code: 2010 ADAS 604.8.1.1
 References:

Barrier Description: Min. 60" wide x 56" deep clear floor space not provided at wall-mounted fixture

Barrier Severity: 2 Recommended Cost Est: \$150.00 Facility Function: Public Status: Open

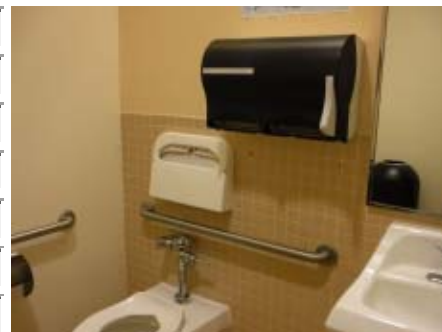
Field Date: 8/24/2017 Report Date: 8/24/2017 Barrier #: 73M
 Bldg Name: Magruder Hall Reference Dwg: 5 of 5
 Location: Floor 2 - Unisex Accessible Restroom 297
 X Coordinate: N/A Y Coordinate: N/A
 Barrier Area: Restrooms
 Barrier Type: Seat Cover Dispenser
 Code: 2010 ADAS 307.2
 References:

Barrier Description: Seat cover dispenser not located on an accessible route. Blocked by water closet

Barrier Severity: 2 Recommended Cost Est: \$125.00 Facility Function: Public Status: Open

Rec. Solution: Replace or remount dispenser on an accessible route with clear floor space

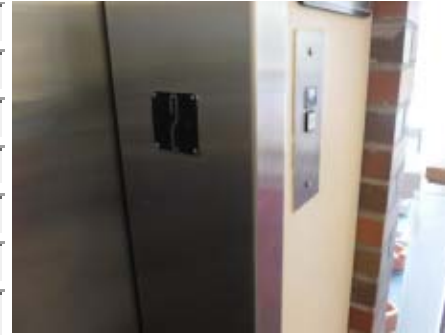
Field Date: 8/24/2017 Report Date: 8/24/2017 Barrier #: 74C
 Bldg Name: Magruder Hall Reference Dwg: 5 of 5
 Location: Floor 2 - Elevator 1
 X Coordinate: N/A Y Coordinate: N/A
 Barrier Area: Elevators
 Barrier Type: Doorjamb marking - Braille
 Code: 2010 ADAS 407.2.3.1
 References:

Barrier Description: Braille not placed below the corresponding raised characters on both door jambs

Rec. Solution: Replace door jamb signage

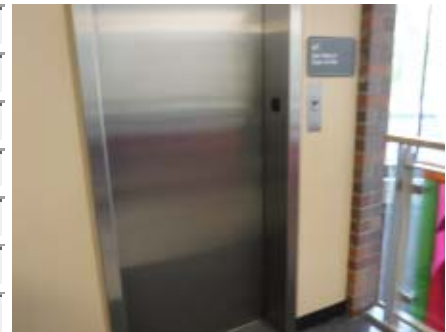
Field Date: 8/24/2017 Report Date: 8/24/2017 Barrier #: 74D
 Bldg Name: Magruder Hall Reference Dwg: 5 of 5
 Location: Floor 2 - Elevator 1
 X Coordinate: N/A Y Coordinate: N/A
 Barrier Area: Elevators
 Barrier Type: Evacuation Sign
 Code: Performance Standard & 2010 ADAS 703.1
 References:

Barrier Description: Sign stating "IN FIRE EMERGENCY, DO NOT USE ELEVATOR. USE EXIT STAIRS" not provided with tactile information

Rec. Solution: Replace sign

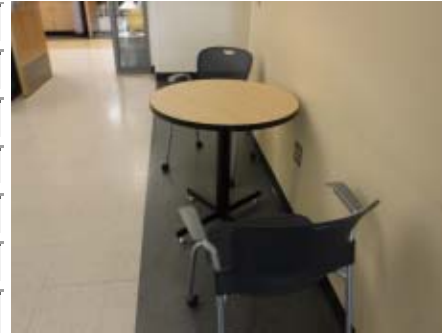
Field Date: 8/24/2017 Report Date: 8/24/2017 Barrier #: 75B
 Bldg Name: Magruder Hall Reference Dwg: 5 of 5
 Location: Floor 2 - Lobby H201
 X Coordinate: N/A Y Coordinate: N/A
 Barrier Area: Counters and Tables
 Barrier Type: Table - Pedestal Base
 Code: 2010 ADAS 306.2.2 & 306.2.3
 References:

Barrier Description: Knee clearance not min. 27" high, 19" deep or 30" wide

Barrier Severity: 2 Recommended Cost Est: \$1,800.00 Facility Function: Public Status: Open

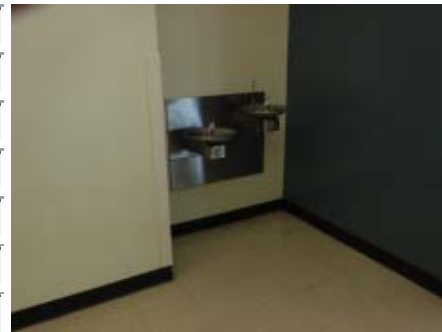
Field Date: 8/24/2017 Report Date: 8/24/2017 Barrier #: 75C
 Bldg Name: Magruder Hall Reference Dwg: 5 of 5
 Location: Floor 2 - Lobby H201
 X Coordinate: N/A Y Coordinate: N/A
 Barrier Area: Drinking Fountains
 Barrier Type: Knee Clearance
 Code: 2010 ADAS 306.3
 References:

Barrier Description: Knee clearance under fountain not min. 27" high

Rec. Solution: Replace drinking fountain with accessible unit or remount existing

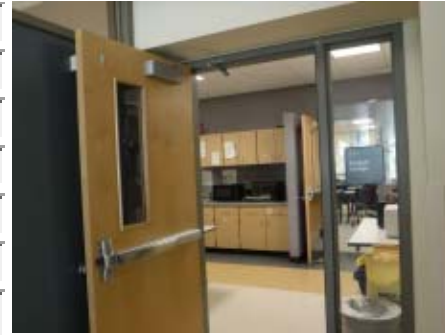
Field Date: 8/24/2017 Report Date: 8/24/2017 Barrier #: 76B
 Bldg Name: Magruder Hall Reference Dwg: 5 of 5
 Location: Floor 2 - Student Lounge 294
 X Coordinate: N/A Y Coordinate: N/A
 Barrier Area: Doors or Gates
 Barrier Type: Door Closer - Interior Sweep Period
 Code: 2010 ADAS 404.2.8.1
 References:

Barrier Description: Door closer lacks min. 5 second sweep period or does not stop 5" from door frame

Notes: Fire rated doors such as these generally cannot operate at max. 5 lbf without a compensating devices like an automatic door opening device.

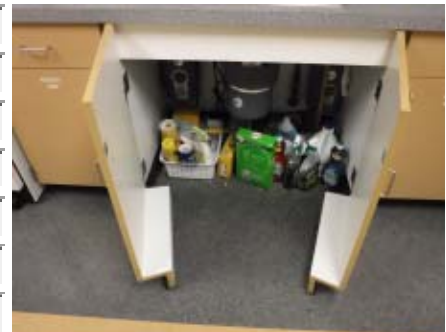
Field Date: 8/24/2017 Report Date: 8/24/2017 Barrier #: 76C
 Bldg Name: Magruder Hall Reference Dwg: 5 of 5
 Location: Floor 2 - Student Lounge 294
 X Coordinate: N/A Y Coordinate: N/A
 Barrier Area: Kitchens
 Barrier Type: Sink - Knee Clearance
 Code: 2010 ADAS 804.4 & 606.2
 References:

Barrier Description: Knee clearance not min. 27" high, 19" deep or 30" wide

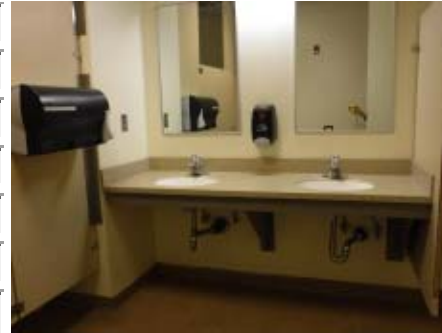
Field Date: 8/24/2017 Report Date: 8/24/2017 Barrier #: 81L
 Bldg Name: Magruder Hall Reference Dwg: 5 of 5
 Location: Floor 2 - Multi-accommodation Men's Restroom 206
 X Coordinate: N/A Y Coordinate: N/A
 Barrier Area: Controls and Mechanisms
 Barrier Type: Electrical Outlets - Hi/Low Reach
 Code: 2010 ADAS 308.2.2
 References:

Performance Standard: No Quantity: EACH As-built : 1

Barrier Description: Use of outlet involves low reach of less than 15" above floor or more than 48" high

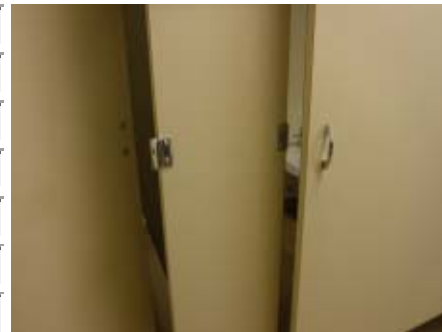
Field Date: 8/24/2017 Report Date: 8/24/2017 Barrier #: 81M
 Bldg Name: Magruder Hall Reference Dwg: 5 of 5
 Location: Floor 2 - Multi-accommodation Men's Restroom 206
 X Coordinate: N/A Y Coordinate: N/A
 Barrier Area: Restrooms
 Barrier Type: Stall Door Closer
 Code: 2010 ADAS 604.8.1.2
 References:

Performance Standard: No Quantity: JOB As-built : 1

Barrier Description: Stall door not equipped with an automatic closing device

Rec. Solution: Replace compartment hinge with adjustable mechanism

Barrier Severity: 2 Recommended Cost Est: \$1,650.00 Facility Function: Public Status: Open

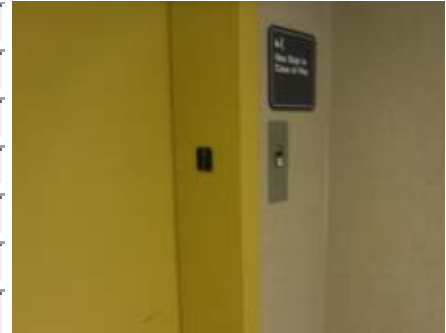
Field Date: 8/24/2017 Report Date: 8/24/2017 Barrier #: 84A
 Bldg Name: Magruder Hall Reference Dwg: 5 of 5
 Location: Floor 2 - Elevator 2
 X Coordinate: N/A Y Coordinate: N/A
 Barrier Area: Elevators
 Barrier Type: Doorjamb marking - Height
 Code: 2010 ADAS 407.2.3.1
 References:

Barrier Description: Elevator landing door jamb signage not located 60" on center on both jamb panels

Rec. Solution: Replace door jamb signage

Barrier Severity: 2 Recommended Cost Est: \$250.00 Facility Function: Public Status: Open

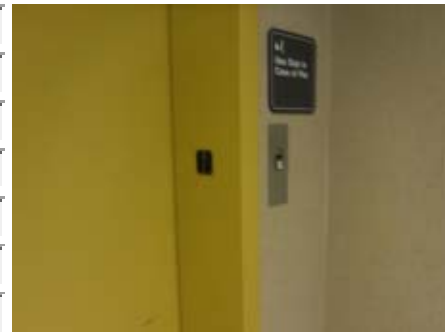
Field Date: 8/24/2017 Report Date: 8/24/2017 Barrier #: 84B
 Bldg Name: Magruder Hall Reference Dwg: 5 of 5
 Location: Floor 2 - Elevator 2
 X Coordinate: N/A Y Coordinate: N/A
 Barrier Area: Elevators
 Barrier Type: Doorjamb marking - Braille
 Code: 2010 ADAS 407.2.3.1
 References:

Barrier Description: Braille not placed below the corresponding raised characters on both door jambs

Rec. Solution: Replace door jamb signage

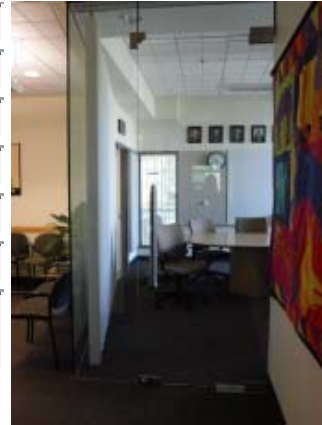
Field Date: 8/24/2017 Report Date: 8/24/2017 Barrier #: 87A
 Bldg Name: Magruder Hall Reference Dwg: 5 of 5
 Location: Floor 2 - Conference Room 200A
 X Coordinate: N/A Y Coordinate: N/A
 Barrier Area: Signage
 Barrier Type: Location - Raised Characters
 Code: 2010 ADAS703.3
 References:

Barrier Description: No Braille/tactile information on sign at latch side of door

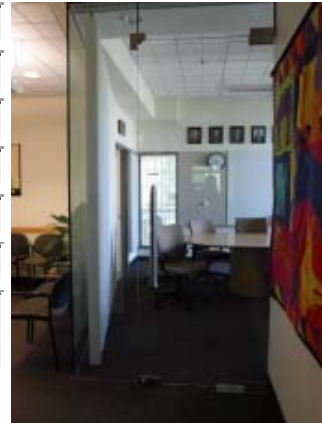
Field Date: 8/24/2017 Report Date: 8/24/2017 Barrier #: 87B
 Bldg Name: Magruder Hall Reference Dwg: 5 of 5
 Location: Floor 2 - Conference Room 200A
 X Coordinate: N/A Y Coordinate: N/A
 Barrier Area: Doors or Gates
 Barrier Type: Door Closer - Interior Adjustment
 Code: 2010 ADAS 404.2.9
 References:

Barrier Description: Door opening force exceeds 5 lbf

Rec. Solution: Replace or adjust existing closer

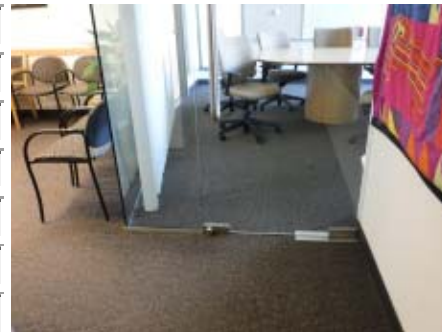
Field Date: 8/24/2017 Report Date: 8/24/2017 Barrier #: 87D
 Bldg Name: Magruder Hall Reference Dwg: 5 of 5
 Location: Floor 2 - Conference Room 200A
 X Coordinate: N/A Y Coordinate: N/A
 Barrier Area: Doors or Gates
 Barrier Type: Door 10" Bottom Surface - Kickplate
 Code: 2010 ADAS 404.2.10
 References:

Barrier Description: Door/Gate lacks min. 10" smooth uninterrupted bottom surface
