OREGON STATE UNIVERSITY (OSU)

CHILD CARE CENTER

ADA ASSESSMENT & SURVEY

Re: ADA Accessibility Survey and Assessment – Child Care Center

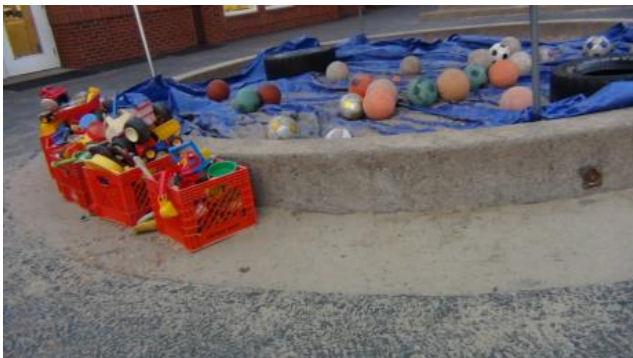
EXTERIOR PLAY AREAS

The play areas were provided in three locations and used according to classroom and age groups. The exit doors to the play areas were identified with un-secured door mats and some were also identified with trip hazards at the transition from concrete door landing to asphalt surface. Play components were located in grass areas or in areas with wood chips as a play surface, which does not provide attenuation to protect children who fall when playing, or a firm

and stable pedestrian surfaces to enable travel for mobility assist devices. In another area, a sand box with a curb is accessible as the curb acts as a transfer platform for children using wheelchairs from which they can transfer from their chair and into the sandbox (see photo above).

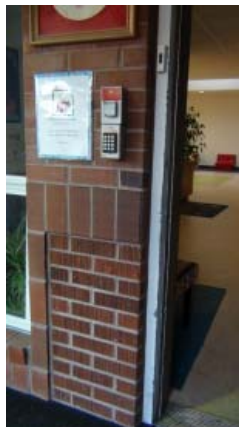
Field Date: 11/9/2015 Report Date: 12/1/2015 Barrier #: 1E
 Bldg Name: Child Care Center Reference Dwg: 2 of 3
 Location: Floor 1 - Main Entrance
 X Coordinate: N/A Y Coordinate: N/A
 Barrier Area: Doors or Gates
 Barrier Type: Hardware - Location
 Code: 2010 ADAS 404.2.7
 References:

Barrier Description: Hardware not located between 34" and 48" above ground/floor

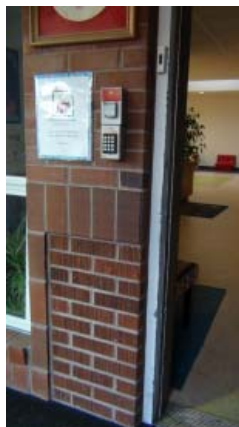
Field Date: 11/9/2015 Report Date: 12/1/2015 Barrier #: 1F
 Bldg Name: Child Care Center Reference Dwg: 2 of 3
 Location: Floor 1 - Main Entrance
 X Coordinate: N/A Y Coordinate: N/A
 Barrier Area: Clear Floor Space
 Barrier Type: Clear Floor Space - Wheelchair Use
 Code: 2010 ADAS 305
 References:

Barrier Description: Clear floor space of min. 30" by 48" not provided

Barrier Severity: 2 Recommended Cost Est: \$350.00 Facility Function: Public Status: Open

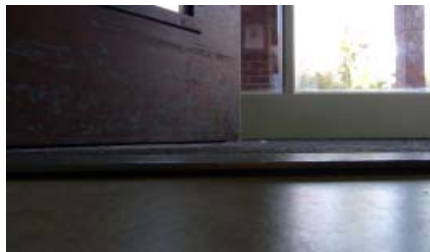
Code: 2010 ADAS 404.2.5

Barrier Description: Door/Gate threshold exceeds 1/4" in height without a bevel

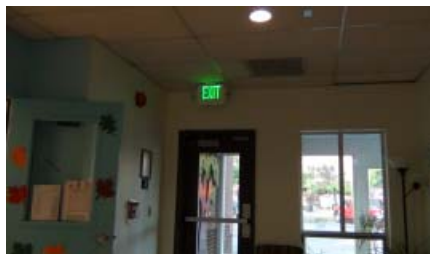
Barrier Description: Exit door leading directly to an exit to the exterior lacks tactile exit sign

Barrier Severity: 2 Recommended Cost Est: \$250.00 Facility Function: Public Status: Open

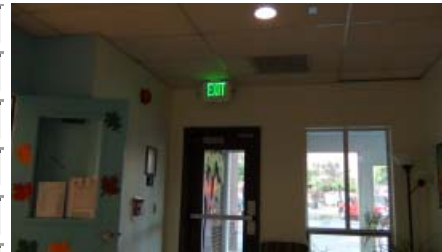
Field Date: 11/9/2015 Report Date: 12/1/2015 Barrier #: 2C
 Bldg Name: Child Care Center Reference Dwg: 2 of 3
 Location: Floor 1 - Entry Lobby
 X Coordinate: N/A Y Coordinate: N/A
 Barrier Area: Alarms
 Barrier Type: Horn - No Strobe
 Code: 2010 ADAS 702
 References:

Barrier Description: Horn provided in location where no strobe is provided

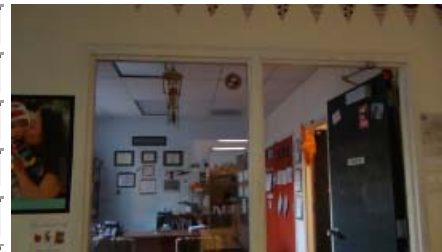
Field Date: 11/9/2015 Report Date: 12/1/2015 Barrier #: 3A
 Bldg Name: Child Care Center Reference Dwg: 2 of 3
 Location: Floor 1 - Director's Office
 X Coordinate: N/A Y Coordinate: N/A
 Barrier Area: Signage
 Barrier Type: Permanent Room/Space - Tactile Characters
 Code: 2010 ADAS 216.2
 References:

Barrier Description: No tactile characters at sign identifying permanent rooms and spaces with visual signs

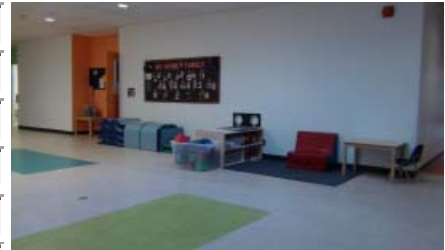
Field Date: 11/9/2015 Report Date: 12/1/2015 Barrier #: 4C
 Bldg Name: Child Care Center Reference Dwg: 2 of 3
 Location: Floor 1 - Central Common Area
 X Coordinate: N/A Y Coordinate: N/A
 Barrier Area: Alarms
 Barrier Type: Horn - No Strobe
 Code: 2010 ADAS 702
 References:

Barrier Description: Horn provided in location where no strobe is provided

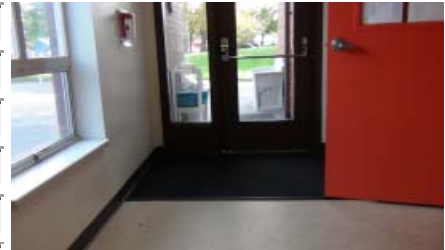
Field Date: 11/9/2015 Report Date: 12/1/2015 Barrier #: 5F
 Bldg Name: Child Care Center Reference Dwg: 2 of 3
 Location: Floor 1 - West Corridor
 X Coordinate: N/A Y Coordinate: N/A
 Barrier Area: Signage
 Barrier Type: Tactile Exit Signs - Door
 Code: 2010 ADAS 216.4.1
 References:

Barrier Description: Ground floor doors that exit to exterior lacks tactile exit sign

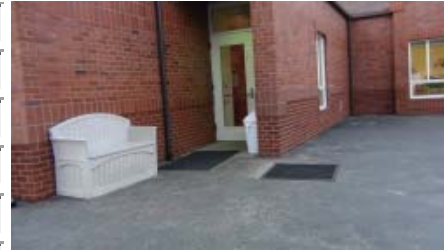
Field Date: 11/9/2015 Report Date: 12/1/2015 Barrier #: 5G
 Bldg Name: Child Care Center Reference Dwg: 2 of 3
 Location: Floor 1 - West Corridor
 X Coordinate: N/A Y Coordinate: N/A
 Barrier Area: Doors or Gates
 Barrier Type: Landing - Existing (3.1% to 4.0%)
 Code: 2010 ADAS 404.2.4.4
 References:

Barrier Description: Door or gate lacks landing on both sides of door

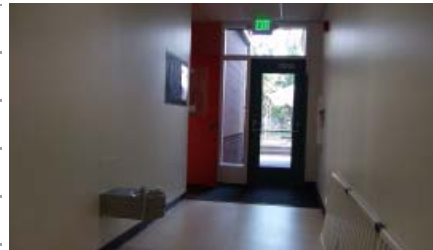
Field Date: 11/9/2015 Report Date: 12/1/2015 Barrier #: 7A
 Bldg Name: Child Care Center Reference Dwg: 2 of 3
 Location: Floor 1 - East Corridor
 X Coordinate: N/A Y Coordinate: N/A
 Barrier Area: Drinking Fountains
 Barrier Type: Alcove - Existing (pre-1992)
 Code: 2010 ADAS 307.2
 References:

Barrier Description: Fountain with a leading edge between 27" and 80" high protrudes more than 4" into the circulation path.

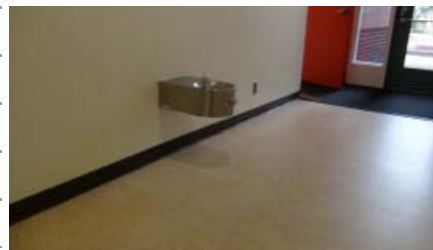
Field Date: 11/9/2015 Report Date: 12/1/2015 Barrier #: 7B
 Bldg Name: Child Care Center Reference Dwg: 2 of 3
 Location: Floor 1 - East Corridor
 X Coordinate: N/A Y Coordinate: N/A
 Barrier Area: Corridors
 Barrier Type: Electrical Outlets - Hi/Low Reach
 Code: 2010 ADAS 205.1 & 309.3
 References:

Barrier Description: Use of outlet involves low reach of less than 15" above floor or more than 48" high

Barrier Severity: 2 Recommended Cost Est: \$225.00 Facility Function: Public Status: Open

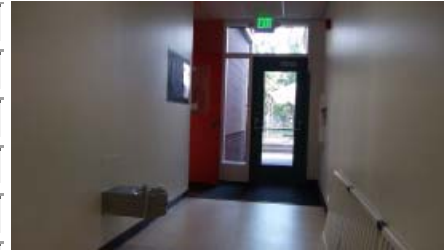
Field Date: 11/9/2015 Report Date: 12/1/2015 Barrier #: 7C
 Bldg Name: Child Care Center Reference Dwg: 2 of 3
 Location: Floor 1 - East Corridor
 X Coordinate: N/A Y Coordinate: N/A
 Barrier Area: Alarms
 Barrier Type: Horn - No Strobe
 Code: 2010 ADAS 702
 References:

Barrier Description: Horn provided in location where no strobe is provided

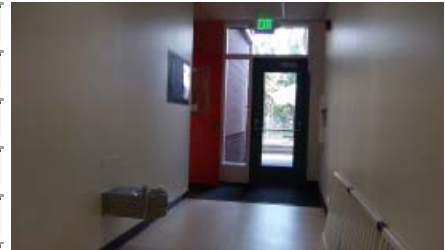
Field Date: 11/9/2015 Report Date: 12/1/2015 Barrier #: 7D
 Bldg Name: Child Care Center Reference Dwg: 2 of 3
 Location: Floor 1 - East Corridor
 X Coordinate: N/A Y Coordinate: N/A
 Barrier Area: Doors or Gates
 Barrier Type: Door Closer - Exterior Automatic Door
 Code: Performance Standard
 References:

Barrier Description: Door opening force exceeds 8.5 lbf

Barrier Severity: 2 Recommended Cost Est: \$250.00 Facility Function: Public Status: Open

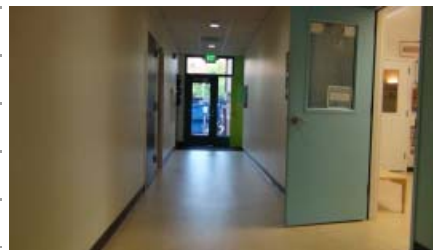
Field Date: 11/9/2015 Report Date: 12/1/2015 Barrier #: 7F
 Bldg Name: Child Care Center Reference Dwg: 2 of 3
 Location: Floor 1 - East Corridor
 X Coordinate: N/A Y Coordinate: N/A
 Barrier Area: Corridors
 Barrier Type: Door Mat
 Code: 2010 ADAS 302.2 & Advisory 302.2
 References:

Barrier Description: Recessed doormat not anchored to floor

Rec. Solution: Replace door mat

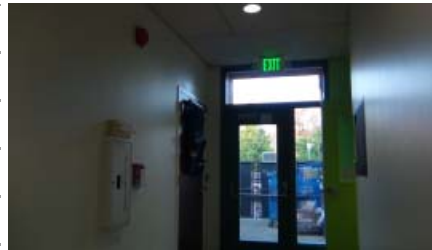
Field Date: 11/9/2015 Report Date: 12/1/2015 Barrier #: 7K
 Bldg Name: Child Care Center Reference Dwg: 2 of 3
 Location: Floor 1 - East Corridor
 X Coordinate: N/A Y Coordinate: N/A
 Barrier Area: Alarms
 Barrier Type: Horn - No Strobe
 Code: 2010 ADAS 702
 References:

Barrier Description: Horn provided in location where no strobe is provided

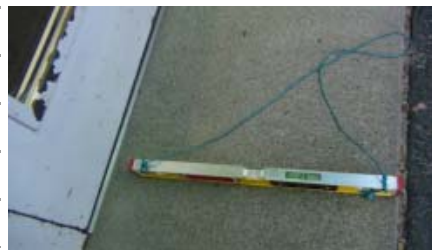
Barrier Description: Door or gate lacks landing on both sides of door

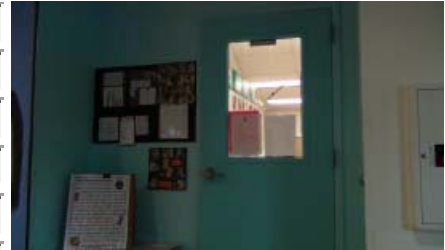
Field Date: 11/9/2015 Report Date: 12/1/2015 Barrier #: 8B
 Bldg Name: Child Care Center Reference Dwg: 2 of 3
 Location: Floor 1 - Preschool Room 107
 X Coordinate: N/A Y Coordinate: N/A
 Barrier Area: Doors or Gates
 Barrier Type: Vision Lights - Existing
 Code: 2010 ADAS 404.2.11
 References:

Barrier Description: View panels in or adjacent to doors or gates not max. 43" above floor or ground

Rec. Solution: Replace door/gate or vision panel

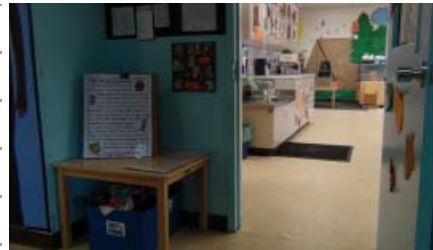
Field Date: 11/9/2015 Report Date: 12/1/2015 Barrier #: 8D
 Bldg Name: Child Care Center Reference Dwg: 2 of 3
 Location: Floor 1 - Preschool Room 107
 X Coordinate: N/A Y Coordinate: N/A
 Barrier Area: Classrooms
 Barrier Type: Clear Floor Space - Stored Elements
 Code: 2010 ADAS 305.3
 References:

Barrier Description: Clear floor space for wheelchair not provided at control or mechanism

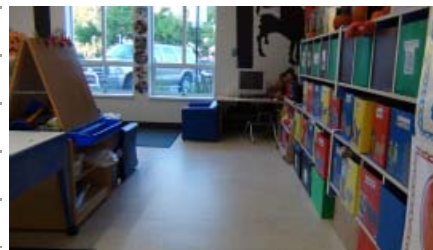
Barrier Description: Control or mechanism not at min. 15" or max. 48" high

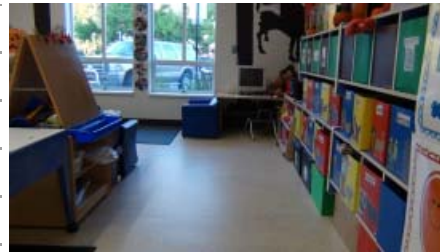
Field Date: 11/9/2015 Report Date: 12/1/2015 Barrier #: 8F
 Bldg Name: Child Care Center Reference Dwg: 2 of 3
 Location: Floor 1 - Preschool Room 107
 X Coordinate: N/A Y Coordinate: N/A
 Barrier Area: Counters and Tables
 Barrier Type: Table - Knee Clearance
 Code: 2010 ADAS 305.3
 References:

Barrier Description: Knee clearance not min. 27" high, 19" deep or 30" wide

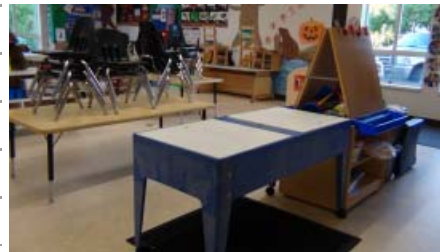
Field Date: 11/9/2015 Report Date: 12/1/2015 Barrier #: 8I
 Bldg Name: Child Care Center Reference Dwg: 2 of 3
 Location: Floor 1 - Preschool Room 107
 X Coordinate: N/A Y Coordinate: N/A
 Barrier Area: Counters and Tables
 Barrier Type: Table - Knee Clearance
 Code: 2010 ADAS 305.3
 References:

Barrier Description: Knee clearance not min. 27" high, 19" deep or 30" wide

Notes: Central rectangular tables X 3 with 19" kn cl in classroom area, but they may be adjustable.

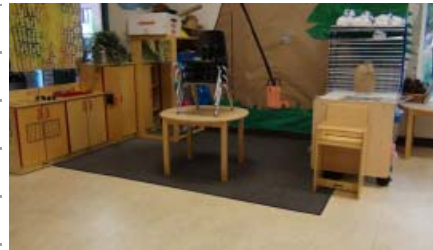
Field Date: 11/9/2015 Report Date: 12/1/2015 Barrier #: 8J
 Bldg Name: Child Care Center Reference Dwg: 2 of 3
 Location: Floor 1 - Preschool Room 107
 X Coordinate: N/A Y Coordinate: N/A
 Barrier Area: Counters and Tables
 Barrier Type: Table - Knee Clearance
 Code: 2010 ADAS 305.3
 References:

Barrier Description: Knee clearance not min. 27" high, 19" deep or 30" wide

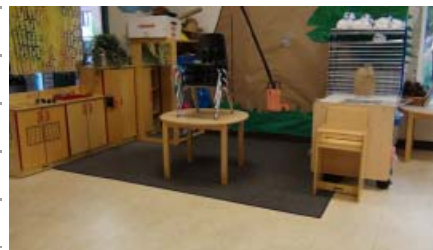
Field Date: 11/9/2015 Report Date: 12/1/2015 Barrier #: 8K
 Bldg Name: Child Care Center Reference Dwg: 2 of 3
 Location: Floor 1 - Preschool Room 107
 X Coordinate: N/A Y Coordinate: N/A
 Barrier Area: Classrooms
 Barrier Type: Desk - Knee Clearance
 Code: 2010 ADAS 902
 References:

Barrier Description: Knee clearance of at least 27" high, 30" wide and 8" deep not provided underneath desk

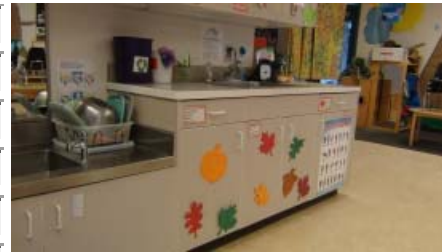
Field Date: 11/9/2015 Report Date: 12/1/2015 Barrier #: 8R
 Bldg Name: Child Care Center Reference Dwg: 2 of 3
 Location: Floor 1 - Preschool Room 107
 X Coordinate: N/A Y Coordinate: N/A
 Barrier Area: Classrooms
 Barrier Type: Counter - Surface
 Code: 2010 ADAS 902
 References:

Barrier Description: Counter surface height exceeds 34" high

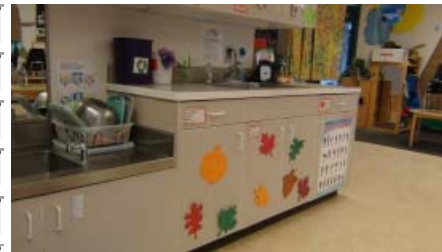
Field Date: 11/9/2015 Report Date: 12/1/2015 Barrier #: 8S
 Bldg Name: Child Care Center Reference Dwg: 2 of 3
 Location: Floor 1 - Preschool Room 107
 X Coordinate: N/A Y Coordinate: N/A
 Barrier Area: Classrooms
 Barrier Type: Counter - Knee Clearance
 Code: 2010 ADAS 305.3
 References:

Barrier Description: Knee clearance not min. 27" high, 19" deep or 30" wide

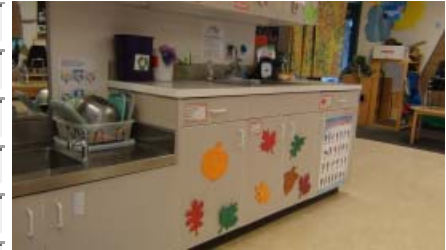
Field Date: 11/9/2015 Report Date: 12/1/2015 Barrier #: 8T
 Bldg Name: Child Care Center Reference Dwg: 2 of 3
 Location: Floor 1 - Preschool Room 107
 X Coordinate: N/A Y Coordinate: N/A
 Barrier Area: Classrooms
 Barrier Type: Sink - Rim or Countertop
 Code: 2010 ADAS 606.3
 References:

Barrier Description: No accessible section of counter at max 34" high provided

Rec. Solution: Replace cabinet and remount sink

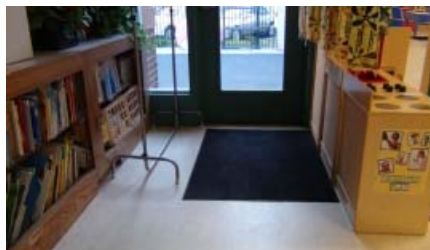
Field Date: 11/9/2015 Report Date: 12/1/2015 Barrier #: 8Y
 Bldg Name: Child Care Center Reference Dwg: 2 of 3
 Location: Floor 1 - Preschool Room 107
 X Coordinate: N/A Y Coordinate: N/A
 Barrier Area: Doors or Gates
 Barrier Type: Doormat
 Code: 2010 ADAS 302.2 & Advisory 302.2
 References:

Barrier Description: Doormat not anchored to floor

Rec. Solution: Secure exiting doormat or replace

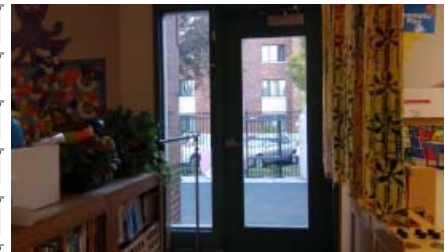
Barrier Description: Door opening force exceeds 5 lbf

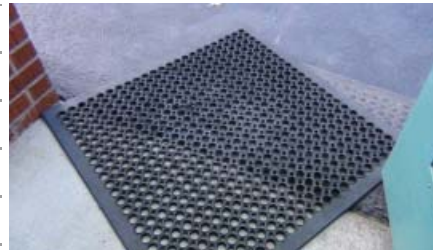
Field Date: 11/9/2015 Report Date 12/1/2015 Barrier #: 8AD
 Bldg Name: Child Care Center Reference Dwg: 2 of 3
 Location: Floor 1 - Preschool Room 107
 X Coordinate: N/A Y Coordinate: N/A
 Barrier Area: Doors or Gates
 Barrier Type: Doormat
 Code: 2010 ADAS 302.2 & Advisory 302.2
 References:

Barrier Description: Doormat not anchored to floor

Rec. Solution: Secure exiting doormat or replace

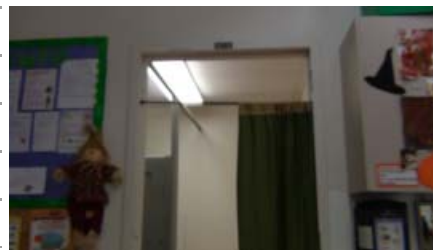
Barrier Description: No tactile characters at sign identifying permanent rooms and spaces with visual signs

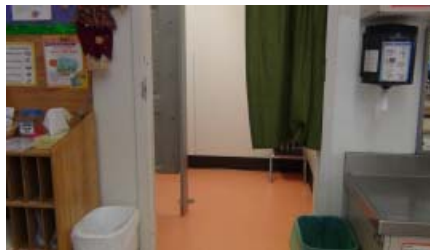
Field Date: 11/9/2015 Report Date: 12/1/2015 Barrier #: 9B
 Bldg Name: Child Care Center Reference Dwg: 2 of 3
 Location: Floor 1 - Restroom Room 107
 X Coordinate: N/A Y Coordinate: N/A
 Barrier Area: Restrooms
 Barrier Type: Door Clear Width
 Code: 2010 ADAS 404.2.3
 References:

Barrier Description: Door clear width is not min. 32"

Rec. Solution: Replace door/gate and frame

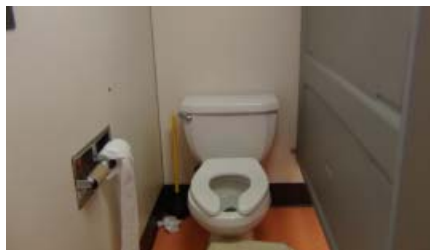
Field Date: 11/9/2015 Report Date: 12/1/2015 Barrier #: 9C
 Bldg Name: Child Care Center Reference Dwg: 2 of 3
 Location: Floor 1 - Restroom Room 107
 X Coordinate: N/A Y Coordinate: N/A
 Barrier Area: Restrooms
 Barrier Type: Toilet Paper Dispenser
 Code: 2010 ADAS 604.7
 References:

Barrier Description: Toilet tissue dispenser not within 7" to 9" from front edge of toilet

Rec. Solution: Reposition or replace toilet paper dispenser

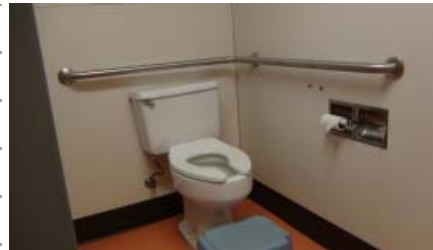
Field Date: 11/9/2015 Report Date: 12/1/2015 Barrier #: 9F
 Bldg Name: Child Care Center Reference Dwg: 2 of 3
 Location: Floor 1 - Restroom Room 107
 X Coordinate: N/A Y Coordinate: N/A
 Barrier Area: Restrooms
 Barrier Type: Toilet Paper Dispenser
 Code: 2010 ADAS 604.7
 References:

Barrier Description: Toilet tissue dispenser not within 7" to 9" from front edge of toilet

Rec. Solution: Reposition or replace toilet paper dispenser

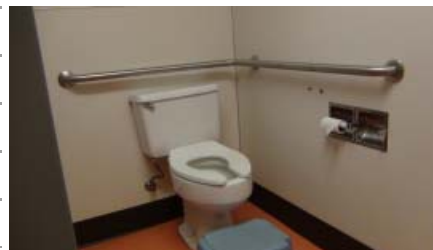
Field Date: 11/9/2015 Report Date: 12/1/2015 Barrier #: 9G
 Bldg Name: Child Care Center Reference Dwg: 2 of 3
 Location: Floor 1 - Restroom Room 107
 X Coordinate: N/A Y Coordinate: N/A
 Barrier Area: Restrooms
 Barrier Type: Toilet - Side Grab Bar
 Code: 2010 ADAS 604.5.1
 References:

Barrier Description: Side grab bar does not extend min. 54" from rear wall

Rec. Solution: Replace grab bars with reinforcement

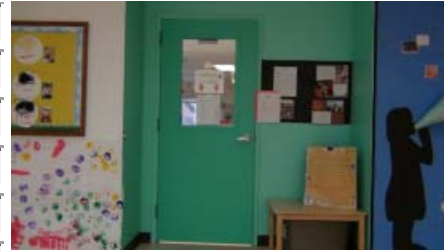
Barrier Description: No tactile characters at sign identifying permanent rooms and spaces with visual signs

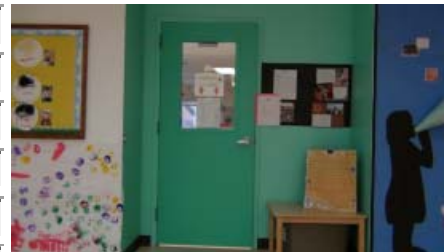
Field Date: 11/10/2015 Report Date: 12/1/2015 Barrier #: 10B
 Bldg Name: Child Care Center Reference Dwg: 2 of 3
 Location: Floor 1 - Preschool Room 117
 X Coordinate: N/A Y Coordinate: N/A
 Barrier Area: Doors or Gates
 Barrier Type: Vision Lights - Existing
 Code: 2010 ADAS 404.2.11
 References:

Barrier Description: View panels in or adjacent to doors or gates not max. 43" above floor or ground

Rec. Solution: Replace door/gate or vision panel

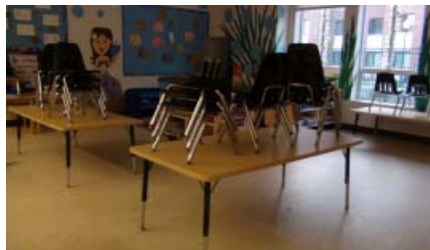
Field Date: 11/10/2015 Report Date: 12/1/2015 Barrier #: 10G
 Bldg Name: Child Care Center Reference Dwg: 2 of 3
 Location: Floor 1 - Preschool Room 117
 X Coordinate: N/A Y Coordinate: N/A
 Barrier Area: Counters and Tables
 Barrier Type: Table - Knee Clearance
 Code: 2010 ADAS 305.3
 References:

Barrier Description: Knee clearance not min. 27" high, 19" deep or 30" wide

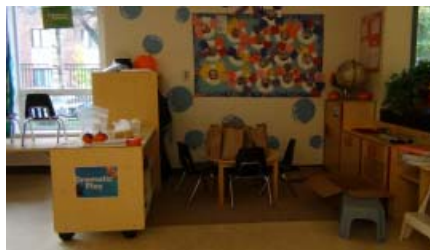
Field Date: 11/10/2015 Report Date: 12/1/2015 Barrier #: 10H
 Bldg Name: Child Care Center Reference Dwg: 2 of 3
 Location: Floor 1 - Preschool Room 117
 X Coordinate: N/A Y Coordinate: N/A
 Barrier Area: Counters and Tables
 Barrier Type: Table - Knee Clearance
 Code: 2010 ADAS 305.3
 References:

Barrier Description: Knee clearance not min. 27" high, 19" deep or 30" wide

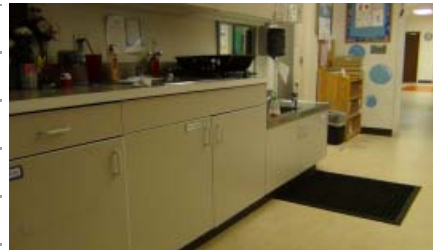
Field Date: 11/10/2015 Report Date: 12/1/2015 Barrier #: 101
 Bldg Name: Child Care Center Reference Dwg: 2 of 3
 Location: Floor 1 - Preschool Room 117
 X Coordinate: N/A Y Coordinate: N/A
 Barrier Area: Classrooms
 Barrier Type: Sink - 30" x 48" Clearance
 Code: 2010 ADAS 305
 References:

Barrier Description: Sink lacks 30" x 48" clear floor space

Rec. Solution: Replace sink and remodel area

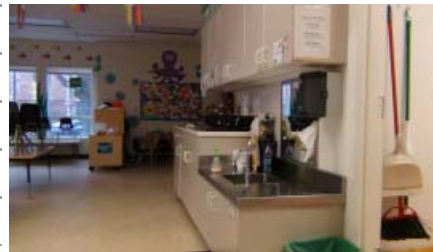
Field Date: 11/10/2015 Report Date: 12/1/2015 Barrier #: 10J
 Bldg Name: Child Care Center Reference Dwg: 2 of 3
 Location: Floor 1 - Preschool Room 117
 X Coordinate: N/A Y Coordinate: N/A
 Barrier Area: Classrooms
 Barrier Type: Sink - Rim or Countertop
 Code: 2010 ADAS 606.3
 References:

Barrier Description: No accessible section of counter at max 34" high provided

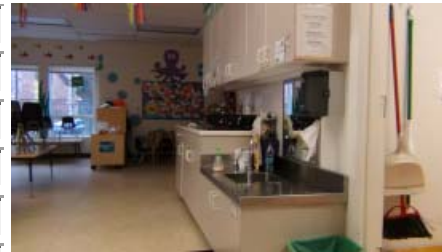
Field Date: 11/10/2015 Report Date: 12/1/2015 Barrier #: 10K
 Bldg Name: Child Care Center Reference Dwg: 2 of 3
 Location: Floor 1 - Preschool Room 117
 X Coordinate: N/A Y Coordinate: N/A
 Barrier Area: Drinking Fountains
 Barrier Type: Knee Clearance
 Code: 2010 ADAS 306.3
 References:

Barrier Description: Knee clearance under fountain not min. 27" high

Rec. Solution: Replace drinking fountain with accessible unit or remount existing

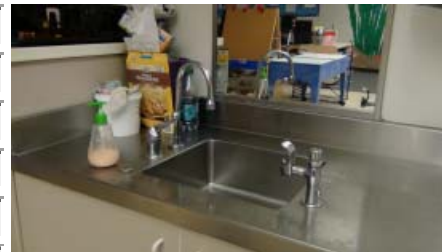
Field Date: 11/10/2015 Report Date: 12/1/2015 Barrier #: 10L
 Bldg Name: Child Care Center Reference Dwg: 2 of 3
 Location: Floor 1 - Preschool Room 117
 X Coordinate: N/A Y Coordinate: N/A
 Barrier Area: Drinking Fountains
 Barrier Type: High Bubbler
 Code: 2010 ADAS 211.2 & 602.7
 References:

Barrier Description: Fountain high bubbler located below 42" above ground or floor

Rec. Solution: Replace fountain with accessible unit

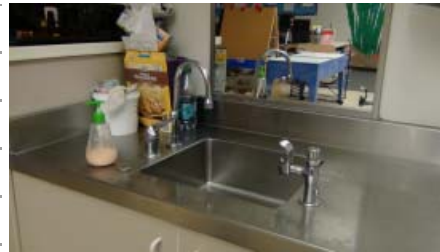
Field Date: 11/10/2015 Report Date: 12/1/2015 Barrier #: 10M
 Bldg Name: Child Care Center Reference Dwg: 2 of 3
 Location: Floor 1 - Preschool Room 117
 X Coordinate: N/A Y Coordinate: N/A
 Barrier Area: Drinking Fountains
 Barrier Type: Operation - Manual (Fist)
 Code: 2010 ADAS 602.3
 References:

Barrier Description: Operating mechanism at fountain is not operable with a fist

Rec. Solution: Replace fountain with accessible unit

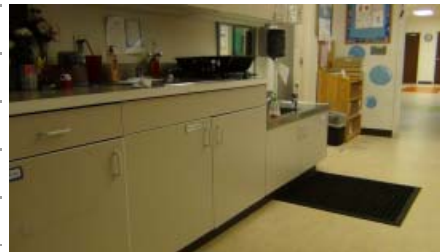
Field Date: 11/10/2015 Report Date: 12/1/2015 Barrier #: 10N
 Bldg Name: Child Care Center Reference Dwg: 2 of 3
 Location: Floor 1 - Preschool Room 117
 X Coordinate: N/A Y Coordinate: N/A
 Barrier Area: Classrooms
 Barrier Type: Counter - Surface
 Code: 2010 ADAS 902
 References:

Barrier Description: Counter surface height exceeds 34" high

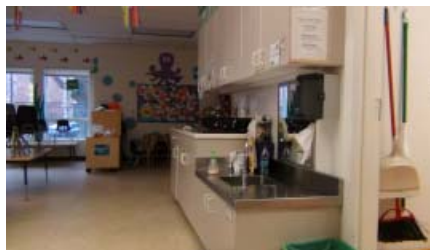
Field Date: 11/10/2015 Report Date: 12/1/2015 Barrier #: 10R
 Bldg Name: Child Care Center Reference Dwg: 2 of 3
 Location: Floor 1 - Preschool Room 117
 X Coordinate: N/A Y Coordinate: N/A
 Barrier Area: Classrooms
 Barrier Type: Shelves or Cabinets
 Code: 2010 ADAS 603.4
 References:

Barrier Description: Shelf or cabinet not mounted between 40" and 48" above floor or ground

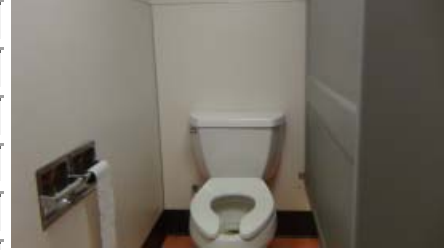
Field Date: 11/10/2015 Report Date: 12/1/2015 Barrier #: 11G
 Bldg Name: Child Care Center Reference Dwg: 2 of 3
 Location: Floor 1 - Restroom Room 117
 X Coordinate: N/A Y Coordinate: N/A
 Barrier Area: Restrooms
 Barrier Type: Toilet - Seat Height
 Code: 2010 ADAS 604.4
 References:

Barrier Description: Water closet seat not between 17" to 19" high

Rec. Solution: Replace water closet

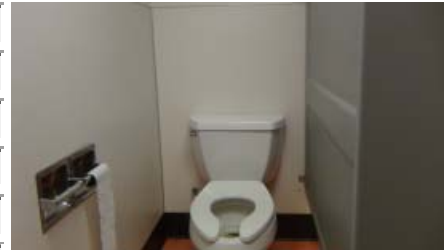
Field Date: 11/10/2015 Report Date: 12/1/2015 Barrier #: 11H
 Bldg Name: Child Care Center Reference Dwg: 2 of 3
 Location: Floor 1 - Restroom Room 117
 X Coordinate: N/A Y Coordinate: N/A
 Barrier Area: Restrooms
 Barrier Type: Toilet - Grab Bars
 Code: 2010 ADAS 604.5
 References:

Barrier Description: No grab bars provided at water closet

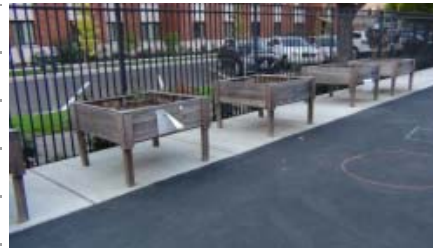
Field Date: 11/10/2015 Report Date: 12/1/2015 Barrier #: 12B
 Bldg Name: Child Care Center Reference Dwg: 1 of 3
 Location: Exterior - Shared Play Area for Classrooms 107-137
 X Coordinate: N/A Y Coordinate: N/A
 Barrier Area: Classrooms
 Barrier Type: Desk - Knee Clearance
 Code: 2010 ADAS 902
 References:

Barrier Description: Knee clearance of at least 27" high, 30" wide and 8" deep not provided underneath desk

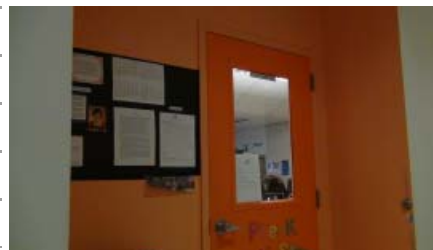
Field Date: 11/10/2015 Report Date: 12/1/2015 Barrier #: 13A
 Bldg Name: Child Care Center Reference Dwg: 2 of 3
 Location: Floor 1 - Pre-Kindergarten Room 127
 X Coordinate: N/A Y Coordinate: N/A
 Barrier Area: Signage
 Barrier Type: Permanent Room/Space - Tactile Characters
 Code: 2010 ADAS 216.2
 References:

Barrier Description: No tactile characters at sign identifying permanent rooms and spaces with visual signs

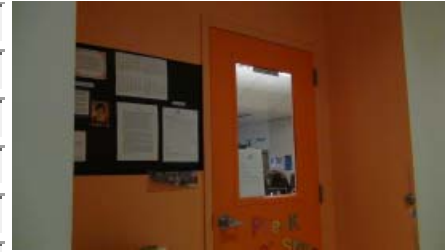
Field Date: 11/10/2015 Report Date: 12/1/2015 Barrier #: 13B
 Bldg Name: Child Care Center Reference Dwg: 2 of 3
 Location: Floor 1 - Pre-Kindergarten Room 127
 X Coordinate: N/A Y Coordinate: N/A
 Barrier Area: Doors or Gates
 Barrier Type: Vision Lights - Existing
 Code: 2010 ADAS 404.2.11
 References:

Barrier Description: View panels in or adjacent to doors or gates not max. 43" above floor or ground

Rec. Solution: Replace door/gate or vision panel

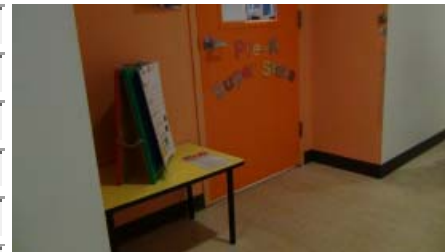
Field Date: 11/10/2015 Report Date: 12/1/2015 Barrier #: 13C
 Bldg Name: Child Care Center Reference Dwg: 2 of 3
 Location: Floor 1 - Pre-Kindergarten Room 127
 X Coordinate: N/A Y Coordinate: N/A
 Barrier Area: Doors or Gates
 Barrier Type: Front App/pull 18" SEC - Blocked
 Code: 2010 ADAS Figure 404.2.4.1
 References:

Barrier Description: Door/Gate at pull side with min. 60" lacks min. 18" strike edge clearance at pull side

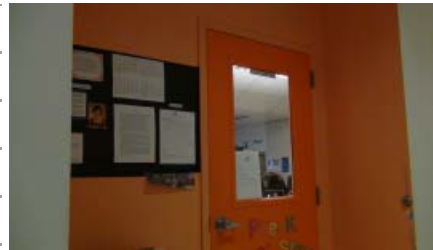
Field Date: 11/10/2015 Report Date: 12/1/2015 Barrier #: 13D
 Bldg Name: Child Care Center Reference Dwg: 2 of 3
 Location: Floor 1 - Pre-Kindergarten Room 127
 X Coordinate: N/A Y Coordinate: N/A
 Barrier Area: Classrooms
 Barrier Type: Clear Floor Space - Stored Elements
 Code: 2010 ADAS 305.3
 References:

Barrier Description: Clear floor space for wheelchair not provided at control or mechanism

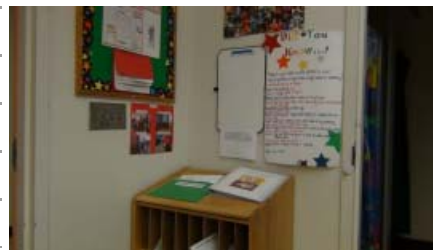
Field Date: 11/10/2015 Report Date: 12/1/2015 Barrier #: 13E
 Bldg Name: Child Care Center Reference Dwg: 2 of 3
 Location: Floor 1 - Pre-Kindergarten Room 127
 X Coordinate: N/A Y Coordinate: N/A
 Barrier Area: Classrooms
 Barrier Type: Clear Floor Space - Stored Elements
 Code: 2010 ADAS 305.3
 References:

Barrier Description: Clear floor space for wheelchair not provided at control or mechanism

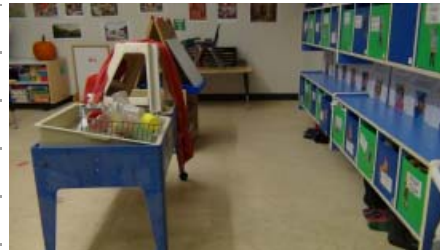
Field Date: 11/10/2015 Report Date: 12/1/2015 Barrier #: 13F
 Bldg Name: Child Care Center Reference Dwg: 2 of 3
 Location: Floor 1 - Pre-Kindergarten Room 127
 X Coordinate: N/A Y Coordinate: N/A
 Barrier Area: Classrooms
 Barrier Type: Actuator/Control - Side Reach High Unobstructed
 Code: 2010 ADAS 305.3
 References:

Barrier Description: Control or mechanism not at min. 15" or max. 48" high

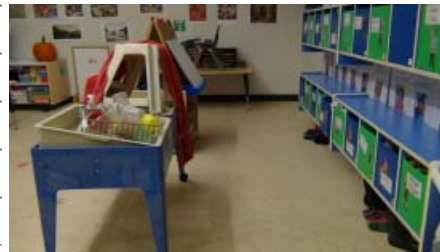
Field Date: 11/10/2015 Report Date: 12/1/2015 Barrier #: 13G
 Bldg Name: Child Care Center Reference Dwg: 2 of 3
 Location: Floor 1 - Pre-Kindergarten Room 127
 X Coordinate: N/A Y Coordinate: N/A
 Barrier Area: Counters and Tables
 Barrier Type: Table - Knee Clearance
 Code: 2010 ADAS 305.3
 References:

Barrier Description: Knee clearance not min. 27" high, 19" deep or 30" wide

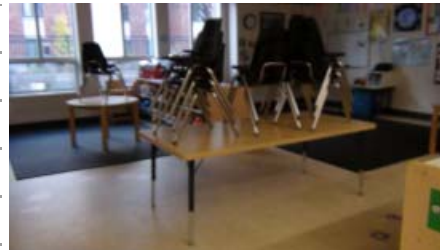
Field Date: 11/10/2015 Report Date: 12/1/2015 Barrier #: 13H
 Bldg Name: Child Care Center Reference Dwg: 2 of 3
 Location: Floor 1 - Pre-Kindergarten Room 127
 X Coordinate: N/A Y Coordinate: N/A
 Barrier Area: Classrooms
 Barrier Type: Door Mat - Recessed
 Code: 2010 ADAS 302.2 & Advisory 302.2
 References:

Barrier Description: Recessed doormat not anchored to floor

Rec. Solution: Replace doormat or anchor existing

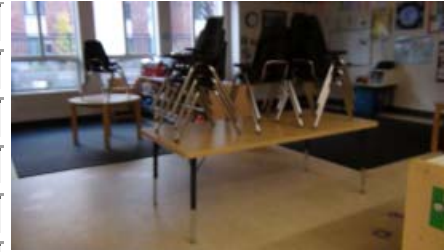
Field Date: 11/10/2015 Report Date: 12/1/2015 Barrier #: 13J
 Bldg Name: Child Care Center Reference Dwg: 2 of 3
 Location: Floor 1 - Pre-Kindergarten Room 127
 X Coordinate: N/A Y Coordinate: N/A
 Barrier Area: Counters and Tables
 Barrier Type: Table - Knee Clearance
 Code: 2010 ADAS 305.3
 References:

Barrier Description: Knee clearance not min. 27" high, 19" deep or 30" wide

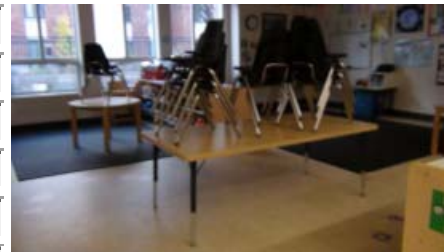
Field Date: 11/10/2015 Report Date: 12/1/2015 Barrier #: 13K
 Bldg Name: Child Care Center Reference Dwg: 2 of 3
 Location: Floor 1 - Pre-Kindergarten Room 127
 X Coordinate: N/A Y Coordinate: N/A
 Barrier Area: Counters and Tables
 Barrier Type: Table - Knee Clearance
 Code: 2010 ADAS 305.3
 References:

Barrier Description: Knee clearance not min. 27" high, 19" deep or 30" wide

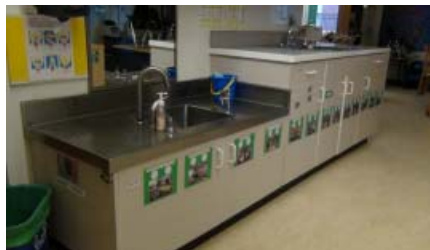
Field Date: 11/10/2015 Report Date: 12/1/2015 Barrier #: 13L
 Bldg Name: Child Care Center Reference Dwg: 2 of 3
 Location: Floor 1 - Pre-Kindergarten Room 127
 X Coordinate: N/A Y Coordinate: N/A
 Barrier Area: Classrooms
 Barrier Type: Sink - Rim or Countertop
 Code: 2010 ADAS 606.3
 References:

Barrier Description: No accessible section of counter at max 34" high provided

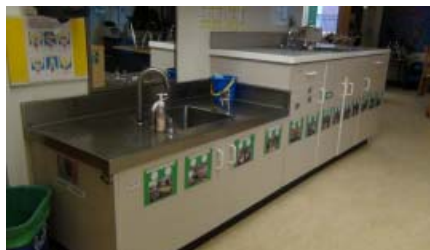
Field Date: 11/10/2015 Report Date: 12/1/2015 Barrier #: 13M
 Bldg Name: Child Care Center Reference Dwg: 2 of 3
 Location: Floor 1 - Pre-Kindergarten Room 127
 X Coordinate: N/A Y Coordinate: N/A
 Barrier Area: Classrooms
 Barrier Type: Sink - Knee Clearance
 Code: 2010 ADAS 606.2 & 306
 References:

Barrier Description: Knee clearance of at least 30" wide and 8" deep at 27" high with 11" depth at 9" high

Rec. Solution: Replace cabinet and remount sink

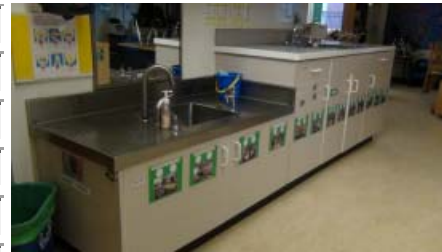
Field Date: 11/10/2015 Report Date: 12/1/2015 Barrier #: 13N
 Bldg Name: Child Care Center Reference Dwg: 2 of 3
 Location: Floor 1 - Pre-Kindergarten Room 127
 X Coordinate: N/A Y Coordinate: N/A
 Barrier Area: Drinking Fountains
 Barrier Type: Knee Clearance
 Code: 2010 ADAS 306.3
 References:

Barrier Description: Knee clearance under fountain not min. 27" high

Rec. Solution: Replace drinking fountain with accessible unit or remount existing

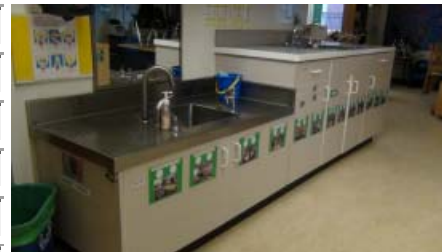
Field Date: 11/10/2015 Report Date: 12/1/2015 Barrier #: 130
 Bldg Name: Child Care Center Reference Dwg: 2 of 3
 Location: Floor 1 - Pre-Kindergarten Room 127
 X Coordinate: N/A Y Coordinate: N/A
 Barrier Area: Drinking Fountains
 Barrier Type: High Bubbler
 Code: 2010 ADAS 211.2 & 602.7
 References:

Barrier Description: Fountain high bubbler located below 42" above ground or floor

Rec. Solution: Replace fountain with accessible unit

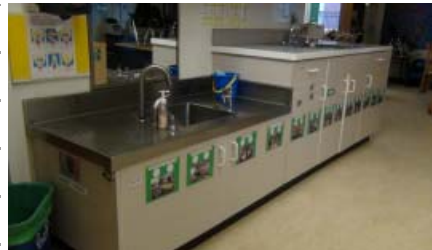
Field Date: 11/10/2015 Report Date: 12/1/2015 Barrier #: 13T
 Bldg Name: Child Care Center Reference Dwg: 2 of 3
 Location: Floor 1 - Pre-Kindergarten Room 127
 X Coordinate: N/A Y Coordinate: N/A
 Barrier Area: Classrooms
 Barrier Type: Sink - Knee Clearance
 Code: 2010 ADAS 606.2 & 306
 References:

Barrier Description: Knee clearance of at least 30" wide and 8" deep at 27" high with 11" depth at 9" high

Rec. Solution: Replace cabinet and remount sink

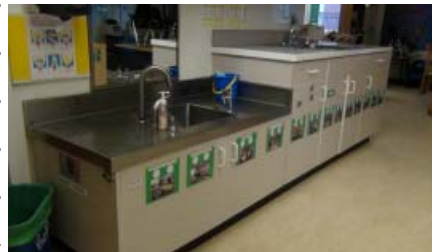
Field Date: 11/10/2015 Report Date: 12/1/2015 Barrier #: 13U
 Bldg Name: Child Care Center Reference Dwg: 2 of 3
 Location: Floor 1 - Pre-Kindergarten Room 127
 X Coordinate: N/A Y Coordinate: N/A
 Barrier Area: Classrooms
 Barrier Type: Counter - Surface
 Code: 2010 ADAS 902
 References:

Barrier Description: Counter surface height exceeds 34" high

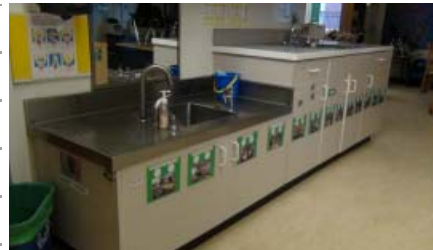
Field Date: 11/10/2015 Report Date: 12/1/2015 Barrier #: 13V
 Bldg Name: Child Care Center Reference Dwg: 2 of 3
 Location: Floor 1 - Pre-Kindergarten Room 127
 X Coordinate: N/A Y Coordinate: N/A
 Barrier Area: Classrooms
 Barrier Type: Counter - Knee Clearance
 Code: 2010 ADAS 305.3
 References:

Barrier Description: Knee clearance not min. 27" high, 19" deep or 30" wide

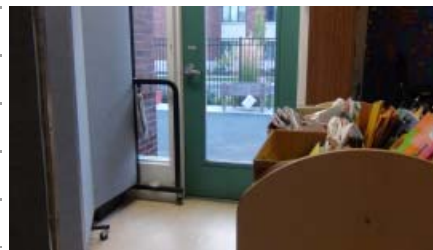
Field Date: 11/10/2015 Report Date: 12/1/2015 Barrier #: 13W
 Bldg Name: Child Care Center Reference Dwg: 2 of 3
 Location: Floor 1 - Pre-Kindergarten Room 127
 X Coordinate: N/A Y Coordinate: N/A
 Barrier Area: Doors or Gates
 Barrier Type: Doormat
 Code: 2010 ADAS 302.2 & Advisory 302.2
 References:

Barrier Description: Doormat not anchored to floor

Rec. Solution: Secure exiting doormat or replace

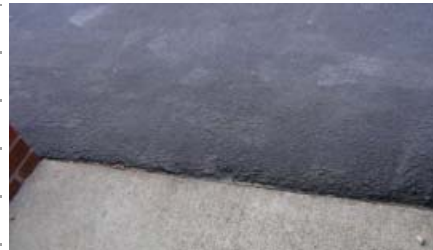
Field Date: 11/10/2015 Report Date: 12/1/2015 Barrier #: 13AB
 Bldg Name: Child Care Center Reference Dwg: 2 of 3
 Location: Floor 1 - Pre-Kindergarten Room 127
 X Coordinate: N/A Y Coordinate: N/A
 Barrier Area: Clear Floor Space
 Barrier Type: Abrupt Change in Level
 Code: 2010 ADAS 303.3
 References:

Barrier Description: Change in level greater than 1/2" in clear floor space

Rec. Solution: Repair trip hazard. Remodel where needed

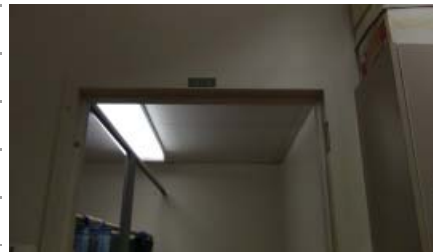
Field Date: 11/10/2015 Report Date: 12/1/2015 Barrier #: 14A
 Bldg Name: Child Care Center Reference Dwg: 2 of 3
 Location: Floor 1 - Restroom 127A
 X Coordinate: N/A Y Coordinate: N/A
 Barrier Area: Signage
 Barrier Type: Permanent Room/Space - Tactile Characters
 Code: 2010 ADAS 216.2
 References:

Barrier Description: No tactile characters at sign identifying permanent rooms and spaces with visual signs

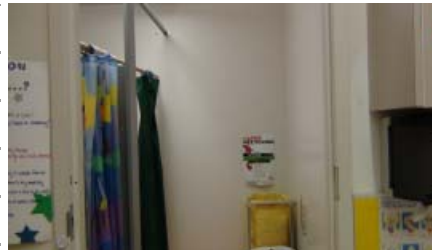
Field Date: 11/10/2015 Report Date: 12/1/2015 Barrier #: 14B
 Bldg Name: Child Care Center Reference Dwg: 2 of 3
 Location: Floor 1 - Restroom 127A
 X Coordinate: N/A Y Coordinate: N/A
 Barrier Area: Restrooms
 Barrier Type: Door Clear Width
 Code: 2010 ADAS 404.2.3
 References:

Barrier Description: Door clear width is not min. 32"

Rec. Solution: Replace door/gate and frame

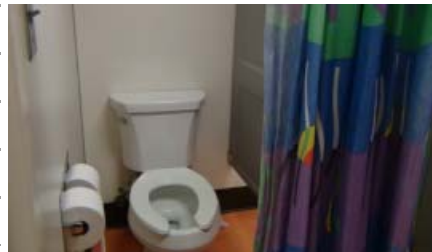
Field Date: 11/10/2015 Report Date: 12/1/2015 Barrier #: 14C
 Bldg Name: Child Care Center Reference Dwg: 2 of 3
 Location: Floor 1 - Restroom 127A
 X Coordinate: N/A Y Coordinate: N/A
 Barrier Area: Restrooms
 Barrier Type: Toilet Paper Dispenser
 Code: 2010 ADAS 604.7
 References:

Barrier Description: Toilet tissue dispenser not within 7" to 9" from front edge of toilet

Rec. Solution: Reposition or replace toilet paper dispenser

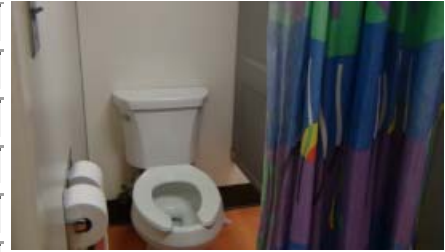
Field Date: 11/10/2015 Report Date: 12/1/2015 Barrier #: 14D
 Bldg Name: Child Care Center Reference Dwg: 2 of 3
 Location: Floor 1 - Restroom 127A
 X Coordinate: N/A Y Coordinate: N/A
 Barrier Area: Restrooms
 Barrier Type: Toilet - Seat Height
 Code: 2010 ADAS 604.4
 References:

Barrier Description: Water closet seat not between 17" to 19" high

Barrier Severity: 2 Recommended Cost Est: \$850.00 Facility Function: Public Status: Open

Rec. Solution: Replace water closet

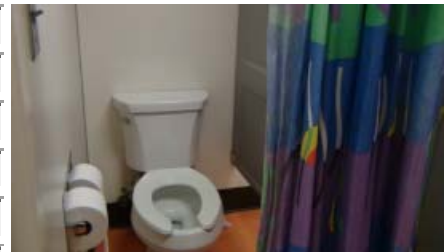
Field Date: 11/10/2015 Report Date: 12/1/2015 Barrier #: 14E
 Bldg Name: Child Care Center Reference Dwg: 2 of 3
 Location: Floor 1 - Restroom 127A
 X Coordinate: N/A Y Coordinate: N/A
 Barrier Area: Restrooms
 Barrier Type: Toilet Transfer - Wall-mounted
 Code: 2010 ADAS 604.8.1.1
 References:

Barrier Description: Min. 60" wide x 56" deep clear floor space not provided at wall-mounted fixture

Barrier Severity: 2 Recommended Cost Est: \$150.00 Facility Function: Public Status: Open

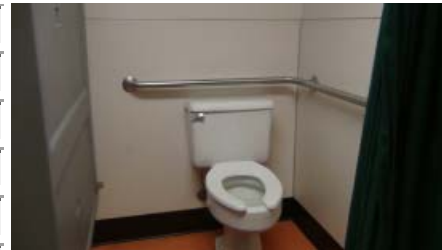
Field Date: 11/10/2015 Report Date: 12/1/2015 Barrier #: 14F
 Bldg Name: Child Care Center Reference Dwg: 2 of 3
 Location: Floor 1 - Restroom 127A
 X Coordinate: N/A Y Coordinate: N/A
 Barrier Area: Restrooms
 Barrier Type: Toilet Paper Dispenser
 Code: 2010 ADAS 604.7
 References:

Barrier Description: Toilet tissue dispenser not within 7" to 9" from front edge of toilet

Rec. Solution: Reposition or replace toilet paper dispenser

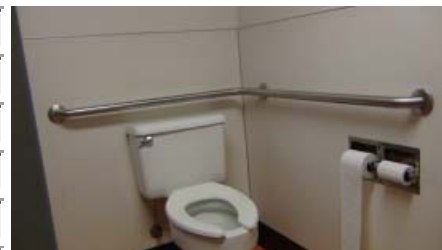
Field Date: 11/10/2015 Report Date: 12/1/2015 Barrier #: 14G
 Bldg Name: Child Care Center Reference Dwg: 2 of 3
 Location: Floor 1 - Restroom 127A
 X Coordinate: N/A Y Coordinate: N/A
 Barrier Area: Restrooms
 Barrier Type: Toilet - Side Grab Bar
 Code: 2010 ADAS 604.5.1
 References:

Barrier Description: Side grab bar does not extend min. 54" from rear wall

Rec. Solution: Replace grab bars with reinforcement

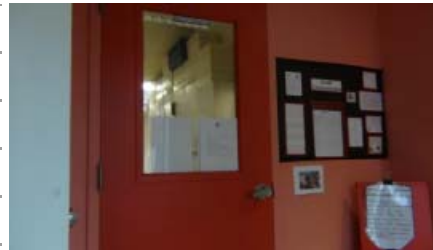
Field Date: 11/10/2015 Report Date: 12/1/2015 Barrier #: 15A
 Bldg Name: Child Care Center Reference Dwg: 2 of 3
 Location: Floor 1 - Pre-Kindergarten Room 137
 X Coordinate: N/A Y Coordinate: N/A
 Barrier Area: Signage
 Barrier Type: Permanent Room/Space - Tactile Characters
 Code: 2010 ADAS 216.2
 References:

Barrier Description: No tactile characters at sign identifying permanent rooms and spaces with visual signs

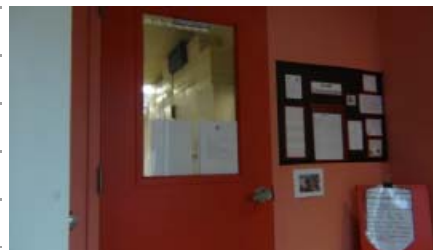
Field Date: 11/10/2015 Report Date: 12/1/2015 Barrier #: 15B
 Bldg Name: Child Care Center Reference Dwg: 2 of 3
 Location: Floor 1 - Pre-Kindergarten Room 137
 X Coordinate: N/A Y Coordinate: N/A
 Barrier Area: Doors or Gates
 Barrier Type: Vision Lights - Existing
 Code: 2010 ADAS 404.2.11
 References:

Barrier Description: View panels in or adjacent to doors or gates not max. 43" above floor or ground

Rec. Solution: Replace door/gate or vision panel

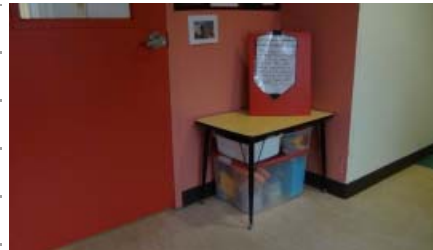
Field Date: 11/10/2015 Report Date: 12/1/2015 Barrier #: 15C
 Bldg Name: Child Care Center Reference Dwg: 2 of 3
 Location: Floor 1 - Pre-Kindergarten Room 137
 X Coordinate: N/A Y Coordinate: N/A
 Barrier Area: Doors or Gates
 Barrier Type: Front App/pull 18" SEC - Blocked
 Code: 2010 ADAS Figure 404.2.4.1
 References:

Barrier Description: Door/Gate at pull side with min. 60" lacks min. 18" strike edge clearance at pull side

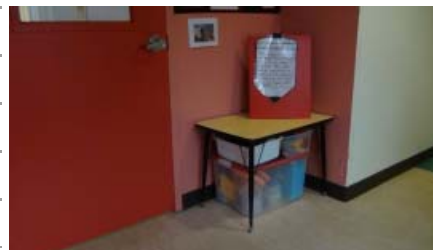
Field Date: 11/10/2015 Report Date: 12/1/2015 Barrier #: 15D
 Bldg Name: Child Care Center Reference Dwg: 2 of 3
 Location: Floor 1 - Pre-Kindergarten Room 137
 X Coordinate: N/A Y Coordinate: N/A
 Barrier Area: Classrooms
 Barrier Type: Clear Floor Space - Stored Elements
 Code: 2010 ADAS 305.3
 References:

Barrier Description: Clear floor space for wheelchair not provided at control or mechanism

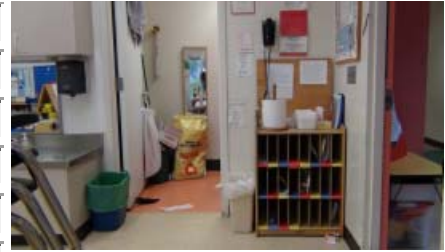
Field Date: 11/10/2015 Report Date: 12/1/2015 Barrier #: 15E
 Bldg Name: Child Care Center Reference Dwg: 2 of 3
 Location: Floor 1 - Pre-Kindergarten Room 137
 X Coordinate: N/A Y Coordinate: N/A
 Barrier Area: Classrooms
 Barrier Type: Clear Floor Space - Stored Elements
 Code: 2010 ADAS 305.3
 References:

Barrier Description: Clear floor space for wheelchair not provided at control or mechanism

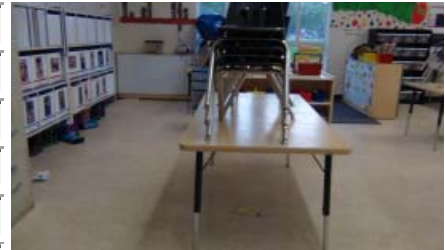
Field Date: 11/10/2015 Report Date: 12/1/2015 Barrier #: 15F
 Bldg Name: Child Care Center Reference Dwg: 2 of 3
 Location: Floor 1 - Pre-Kindergarten Room 137
 X Coordinate: N/A Y Coordinate: N/A
 Barrier Area: Classrooms
 Barrier Type: Actuator/Control - Side Reach High Unobstructed
 Code: 2010 ADAS 305.3
 References:

Barrier Description: Control or mechanism not at min. 15" or max. 48" high

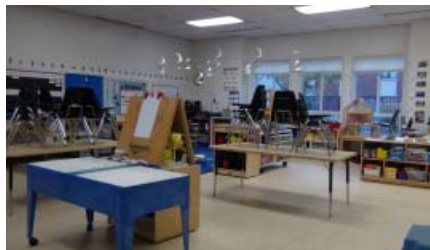
Code: 2010 ADAS 902

Barrier Description: Knee clearance of at least 27" high, 30" wide and 8" deep not provided

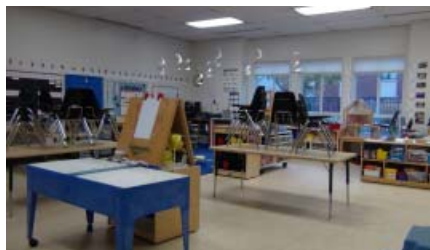
Code: 2010 ADAS 305.3

Barrier Description: Knee clearance not min. 27" high, 19" deep or 30" wide

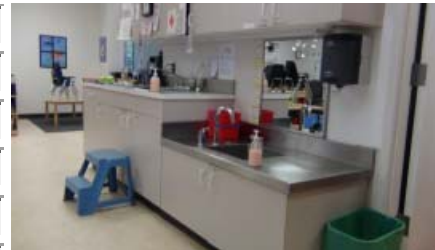
Field Date: 11/10/2015 Report Date: 12/1/2015 Barrier #: 15M
 Bldg Name: Child Care Center Reference Dwg: 2 of 3
 Location: Floor 1 - Pre-Kindergarten Room 137
 X Coordinate: N/A Y Coordinate: N/A
 Barrier Area: Classrooms
 Barrier Type: Sink - Knee Clearance
 Code: 2010 ADAS 606.2 & 306
 References:

Barrier Description: Knee clearance of at least 30" wide and 8" deep at 27" high with 11" depth at 9" high

Rec. Solution: Replace cabinet and remount sink

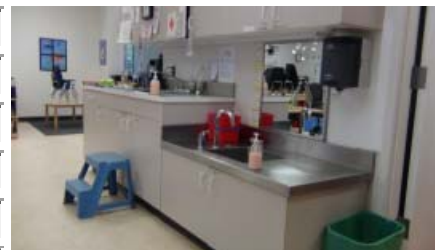
Field Date: 11/10/2015 Report Date: 12/1/2015 Barrier #: 15N
 Bldg Name: Child Care Center Reference Dwg: 2 of 3
 Location: Floor 1 - Pre-Kindergarten Room 137
 X Coordinate: N/A Y Coordinate: N/A
 Barrier Area: Drinking Fountains
 Barrier Type: Knee Clearance
 Code: 2010 ADAS 306.3
 References:

Barrier Description: Knee clearance under fountain not min. 27" high

Rec. Solution: Replace drinking fountain with accessible unit or remount existing

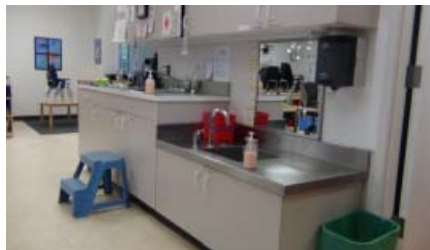
Field Date: 11/10/2015 Report Date: 12/1/2015 Barrier #: 150
 Bldg Name: Child Care Center Reference Dwg: 2 of 3
 Location: Floor 1 - Pre-Kindergarten Room 137
 X Coordinate: N/A Y Coordinate: N/A
 Barrier Area: Drinking Fountains
 Barrier Type: High Bubblers
 Code: 2010 ADAS 211.2 & 602.7
 References:

Barrier Description: Fountain high bubbler located below 42" above ground or floor

Rec. Solution: Replace fountain with accessible unit

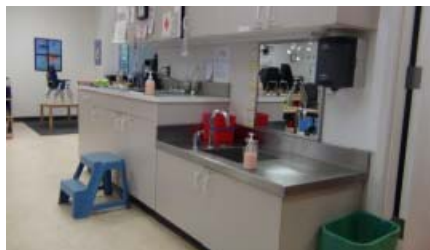
Field Date: 11/10/2015 Report Date: 12/1/2015 Barrier #: 15P
 Bldg Name: Child Care Center Reference Dwg: 2 of 3
 Location: Floor 1 - Pre-Kindergarten Room 137
 X Coordinate: N/A Y Coordinate: N/A
 Barrier Area: Drinking Fountains
 Barrier Type: Operation - Manual (Fist)
 Code: 2010 ADAS 602.3
 References:

Barrier Description: Operating mechanism at fountain is not operable with a fist

Barrier Severity: 2 Recommended Cost Est: \$750.00 Facility Function: Public Status: Open

Rec. Solution: Replace fountain with accessible unit

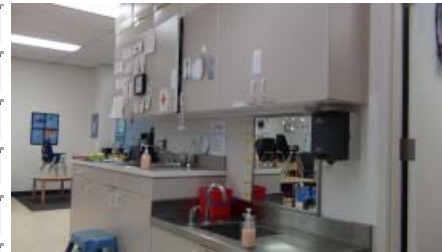
Field Date: 11/10/2015 Report Date 12/1/2015 Barrier #: 15Q
 Bldg Name: Child Care Center Reference Dwg: 2 of 3
 Location: Floor 1 - Pre-Kindergarten Room 137
 X Coordinate: N/A Y Coordinate: N/A
 Barrier Area: Classrooms
 Barrier Type: Counter - Surface
 Code 2010 ADAS 902
 References:

Barrier Description: Counter surface height exceeds 34" high

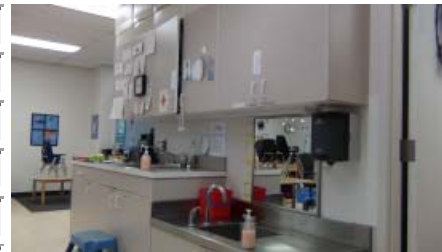
Field Date: 11/10/2015 Report Date 12/1/2015 Barrier #: 15R
 Bldg Name: Child Care Center Reference Dwg: 2 of 3
 Location: Floor 1 - Pre-Kindergarten Room 137
 X Coordinate: N/A Y Coordinate: N/A
 Barrier Area: Classrooms
 Barrier Type: Counter - Knee Clearance
 Code 2010 ADAS 305.3
 References:

Barrier Description: Knee clearance not min. 27" high, 19" deep or 30" wide

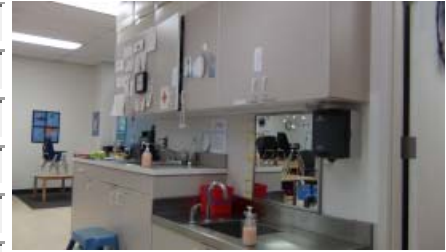
Field Date: 11/10/2015 Report Date 12/1/2015 Barrier #: 15S
 Bldg Name: Child Care Center Reference Dwg: 2 of 3
 Location: Floor 1 - Pre-Kindergarten Room 137
 X Coordinate: N/A Y Coordinate: N/A
 Barrier Area: Classrooms
 Barrier Type: Sink - Rim or Countertop
 Code 2010 ADAS 606.3
 References:

Barrier Description: No accessible section of counter at max 34" high provided

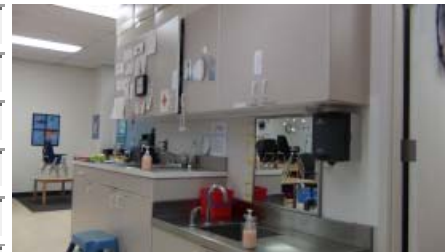
Field Date: 11/10/2015 Report Date 12/1/2015 Barrier #: 15T
 Bldg Name: Child Care Center Reference Dwg: 2 of 3
 Location: Floor 1 - Pre-Kindergarten Room 137
 X Coordinate: N/A Y Coordinate: N/A
 Barrier Area: Classrooms
 Barrier Type: Sink - Knee Clearance
 Code 2010 ADAS 606.2 & 306
 References:

Barrier Description: Knee clearance of at least 30" wide and 8" deep at 27" high with 11" depth at 9" high

Rec. Solution: Replace cabinet and remount sink

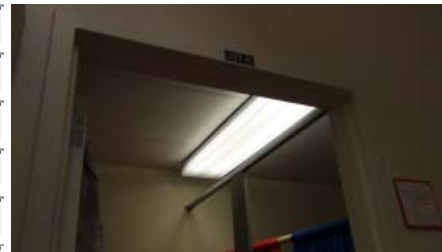
Field Date: 11/10/2015 Report Date: 12/1/2015 Barrier #: 16A
 Bldg Name: Child Care Center Reference Dwg: 2 of 3
 Location: Floor 1 - Restroom 137
 X Coordinate: N/A Y Coordinate: N/A
 Barrier Area: Signage
 Barrier Type: Permanent Room/Space - Tactile Characters
 Code: 2010 ADAS 216.2
 References:

Barrier Description: No tactile characters at sign identifying permanent rooms and spaces with visual signs

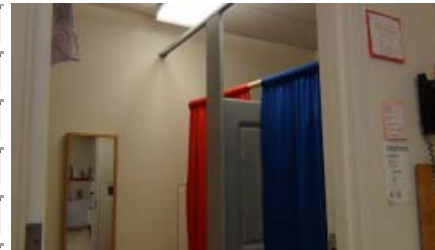
Field Date: 11/10/2015 Report Date: 12/1/2015 Barrier #: 16B
 Bldg Name: Child Care Center Reference Dwg: 2 of 3
 Location: Floor 1 - Restroom 137
 X Coordinate: N/A Y Coordinate: N/A
 Barrier Area: Restrooms
 Barrier Type: Door Clear Width
 Code: 2010 ADAS 404.2.3
 References:

Barrier Description: Door clear width is not min. 32"

Rec. Solution: Replace door/gate and frame

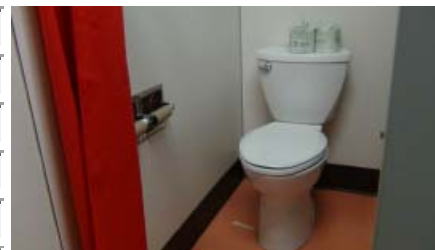
Field Date: 11/10/2015 Report Date: 12/1/2015 Barrier #: 16C
 Bldg Name: Child Care Center Reference Dwg: 2 of 3
 Location: Floor 1 - Restroom 137
 X Coordinate: N/A Y Coordinate: N/A
 Barrier Area: Restrooms
 Barrier Type: Toilet Paper Dispenser
 Code: 2010 ADAS 604.7
 References:

Barrier Description: Toilet tissue dispenser not within 7" to 9" from front edge of toilet

Rec. Solution: Reposition or replace toilet paper dispenser

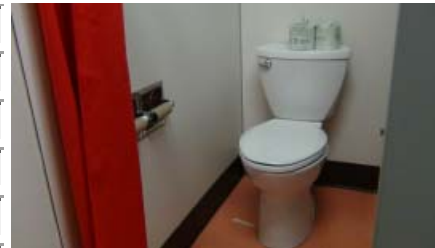
Field Date: 11/10/2015 Report Date: 12/1/2015 Barrier #: 16D
 Bldg Name: Child Care Center Reference Dwg: 2 of 3
 Location: Floor 1 - Restroom 137
 X Coordinate: N/A Y Coordinate: N/A
 Barrier Area: Restrooms
 Barrier Type: Toilet - Seat Height
 Code: 2010 ADAS 604.4
 References:

Barrier Description: Water closet seat not between 17" to 19" high

Rec. Solution: Replace water closet

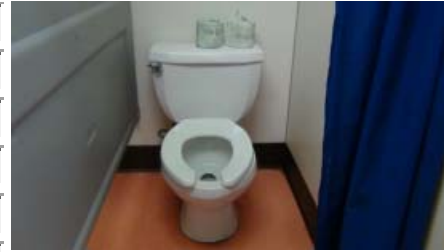
Field Date: 11/10/2015 Report Date: 12/1/2015 Barrier #: 16F
 Bldg Name: Child Care Center Reference Dwg: 2 of 3
 Location: Floor 1 - Restroom 137
 X Coordinate: N/A Y Coordinate: N/A
 Barrier Area: Restrooms
 Barrier Type: Toilet Paper Dispenser
 Code: 2010 ADAS 604.7
 References:

Barrier Description: Toilet tissue dispenser not within 7" to 9" from front edge of toilet

Rec. Solution: Reposition or replace toilet paper dispenser

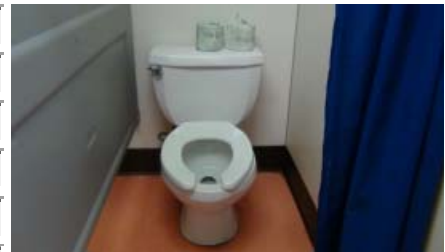
Field Date: 11/10/2015 Report Date: 12/1/2015 Barrier #: 16G
 Bldg Name: Child Care Center Reference Dwg: 2 of 3
 Location: Floor 1 - Restroom 137
 X Coordinate: N/A Y Coordinate: N/A
 Barrier Area: Restrooms
 Barrier Type: Toilet - Side Grab Bar
 Code: 2010 ADAS 604.5.1
 References:

Barrier Description: Side grab bar does not extend min. 54" from rear wall

Rec. Solution: Replace grab bars with reinforcement

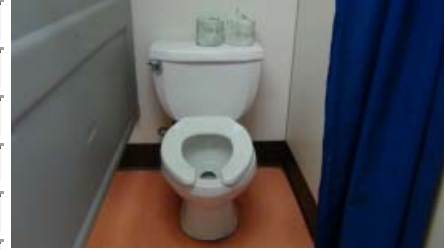
Field Date: 11/10/2015 Report Date: 12/1/2015 Barrier #: 16H
 Bldg Name: Child Care Center Reference Dwg: 2 of 3
 Location: Floor 1 - Restroom 137
 X Coordinate: N/A Y Coordinate: N/A
 Barrier Area: Restrooms
 Barrier Type: Toilet - Seat Height
 Code: 2010 ADAS 604.4
 References:

Barrier Description: Water closet seat not between 17" to 19" high

Rec. Solution: Replace water closet

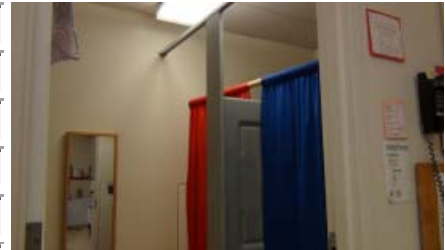
Field Date: 11/10/2015 Report Date: 12/1/2015 Barrier #: 16I
 Bldg Name: Child Care Center Reference Dwg: 2 of 3
 Location: Floor 1 - Restroom 137
 X Coordinate: N/A Y Coordinate: N/A
 Barrier Area: Alarms
 Barrier Type: Horn/Strobe - Common Use Area
 Code: 2010 ADAS 702.1
 References:

Barrier Description: No horn/strobes in common use areas

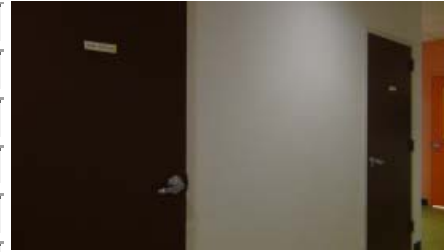
Field Date: 11/11/2015 Report Date: 12/1/2015 Barrier #: 17A
 Bldg Name: Child Care Center Reference Dwg: 2 of 3
 Location: Floor 1 - Unisex Restroom West
 X Coordinate: N/A Y Coordinate: N/A
 Barrier Area: Restrooms
 Barrier Type: Sign - ISA at Accessible Restroom
 Code: 2010 ADAS 216.8
 References:

Barrier Description: No ISA symbol on wall sign posted at accessible toilet room

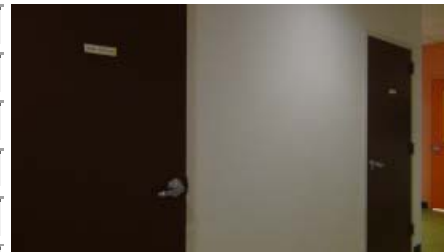
Field Date: 11/11/2015 Report Date: 12/1/2015 Barrier #: 17B
 Bldg Name: Child Care Center Reference Dwg: 2 of 3
 Location: Floor 1 - Unisex Restroom West
 X Coordinate: N/A Y Coordinate: N/A
 Barrier Area: Signage
 Barrier Type: Permanent Room/Space - Tactile Characters
 Code: 2010 ADAS 216.2
 References:

Barrier Description: No tactile characters at sign identifying permanent rooms and spaces with visual signs
