OREGON STATE UNIVERSITY (OSU)

CHILD CARE CENTER

ADA ASSESSMENT & SURVEY

Re: ADA Accessibility Survey and Assessment – Child Care Center

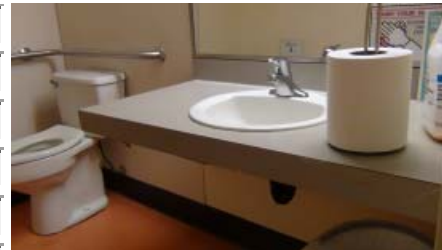
Code: 2010 ADAS 606.2 & 306

Barrier Description: Lavatory bottom apron/edge not at least 27" high

Rec. Solution: Replace lavatory counter

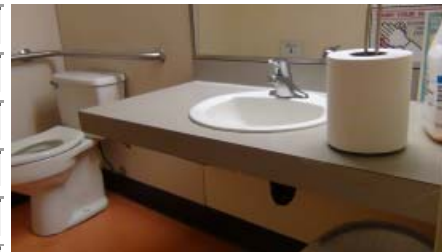
Code: 2010 ADAS 604.3.1 & 604.8.1.1

Barrier Description: Water closet clear space not min. 60" measured wall-to-wall

Rec. Solution: Replace counter to provide minimum clear width

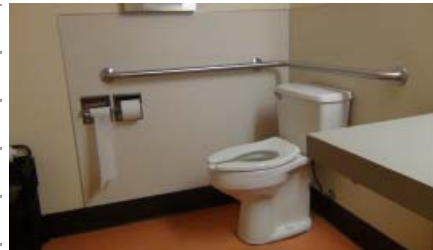
Field Date: 11/11/2015 Report Date: 12/1/2015 Barrier #: 17E
 Bldg Name: Child Care Center Reference Dwg: 2 of 3
 Location: Floor 1 - Unisex Restroom West
 X Coordinate: N/A Y Coordinate: N/A
 Barrier Area: Restrooms
 Barrier Type: Toilet - Flush Handle
 Code: 2010 ADAS 604.6
 References:

Performance Standard: No Quantity: JOB As-built : 1
 Barrier Description: Handle does not point to wide side of stall or compartment

Findings: Handle pointing towards small side of stall/room

Rec. Solution: Replace water closet

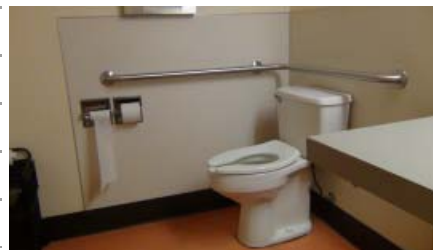
Field Date: 11/11/2015 Report Date: 12/1/2015 Barrier #: 17F
 Bldg Name: Child Care Center Reference Dwg: 2 of 3
 Location: Floor 1 - Unisex Restroom West
 X Coordinate: N/A Y Coordinate: N/A
 Barrier Area: Restrooms
 Barrier Type: Toilet Paper Dispenser
 Code: 2010 ADAS 604.7
 References:

Performance Standard: No Quantity: EACH As-built : 1
 Barrier Description: Toilet tissue dispenser not within 7" to 9" from front edge of toilet

Findings: 17" from rim

Rec. Solution: Reposition or replace toilet paper dispenser

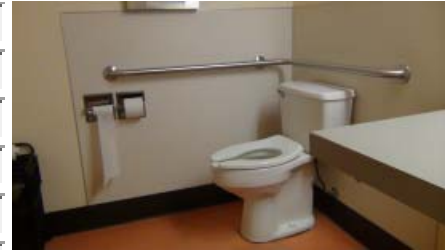
Field Date: 11/11/2015 Report Date: 12/1/2015 Barrier #: 17G
 Bldg Name: Child Care Center Reference Dwg: 2 of 3
 Location: Floor 1 - Unisex Restroom West
 X Coordinate: N/A Y Coordinate: N/A
 Barrier Area: Restrooms
 Barrier Type: Dispensers - Height
 Code: 2010 ADAS 307.2
 References:

Barrier Description: Dispenser control point or operating mechanism not max. 48" AFF

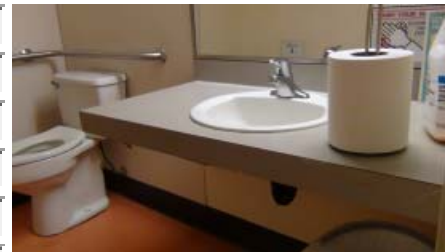
Field Date: 11/11/2015 Report Date: 12/1/2015 Barrier #: 17H
 Bldg Name: Child Care Center Reference Dwg: 2 of 3
 Location: Floor 1 - Unisex Restroom West
 X Coordinate: N/A Y Coordinate: N/A
 Barrier Area: Restrooms
 Barrier Type: Alarm - Horn/Strobe
 Code: 2010 ADAS 702.1
 References:

Barrier Description: Where a fire alarm is installed, no horn/strobe provided

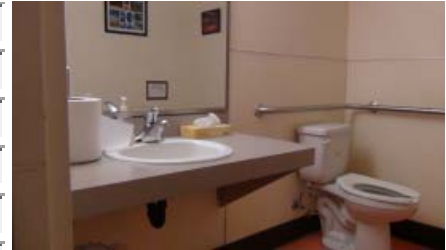
Field Date: 11/11/2015 Report Date: 12/1/2015 Barrier #: 18C
 Bldg Name: Child Care Center Reference Dwg: 2 of 3
 Location: Floor 1 - Unisex Restroom East
 X Coordinate: N/A Y Coordinate: N/A
 Barrier Area: Restrooms
 Barrier Type: Lavatory - Knee Clearance
 Code: 2010 ADAS 606.2 & 306
 References:

Barrier Description: Lavatory bottom apron/edge not at least 27" high

Rec. Solution: Replace lavatory counter

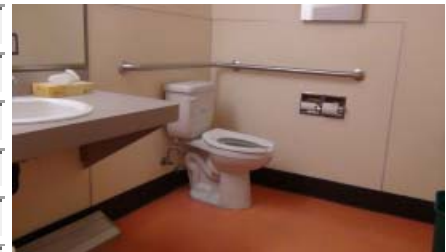
Field Date: 11/11/2015 Report Date: 12/1/2015 Barrier #: 18D
 Bldg Name: Child Care Center Reference Dwg: 2 of 3
 Location: Floor 1 - Unisex Restroom East
 X Coordinate: N/A Y Coordinate: N/A
 Barrier Area: Restrooms
 Barrier Type: Toilet - Clear Space (post-ADA)
 Code: 2010 ADAS 604.3.1 & 604.8.1.1
 References:

Barrier Description: Water closet clear space not min. 60" measured wall-to-wall

Rec. Solution: Replace counter to provide accessible clear width

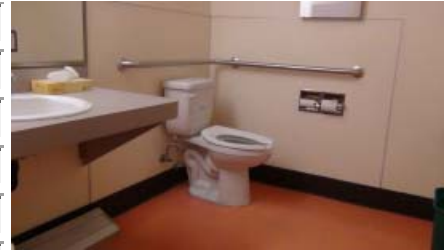
Field Date: 11/11/2015 Report Date: 12/1/2015 Barrier #: 18E
 Bldg Name: Child Care Center Reference Dwg: 2 of 3
 Location: Floor 1 - Unisex Restroom East
 X Coordinate: N/A Y Coordinate: N/A
 Barrier Area: Restrooms
 Barrier Type: Toilet - Flush Handle
 Code: 2010 ADAS 604.6
 References:

Performance Standard: No Quantity: JOB As-built : 1
 Barrier Description: Handle does not point to wide side of stall or compartment

Findings: Handle pointing towards small side of stall/room

Rec. Solution: Replace water closet

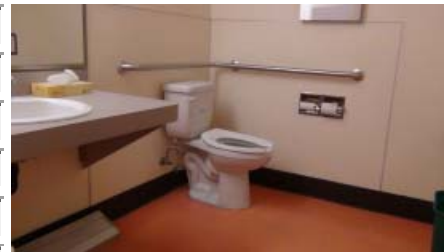
Field Date: 11/11/2015 Report Date: 12/1/2015 Barrier #: 18F
 Bldg Name: Child Care Center Reference Dwg: 2 of 3
 Location: Floor 1 - Unisex Restroom East
 X Coordinate: N/A Y Coordinate: N/A
 Barrier Area: Restrooms
 Barrier Type: Toilet Paper Dispenser
 Code: 2010 ADAS 604.7
 References:

Performance Standard: No Quantity: EACH As-built : 1
 Barrier Description: Toilet tissue dispenser not within 7" to 9" from front edge of toilet

Findings: 12" from rim

Rec. Solution: Reposition or replace toilet paper dispenser

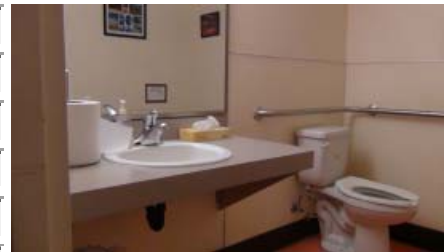
Field Date: 11/11/2015 Report Date: 12/1/2015 Barrier #: 18H
 Bldg Name: Child Care Center Reference Dwg: 2 of 3
 Location: Floor 1 - Unisex Restroom East
 X Coordinate: N/A Y Coordinate: N/A
 Barrier Area: Restrooms
 Barrier Type: Alarm - Horn/Strobe
 Code: 2010 ADAS 702.1
 References:

Barrier Description: Where a fire alarm is installed, no horn/strobe provided

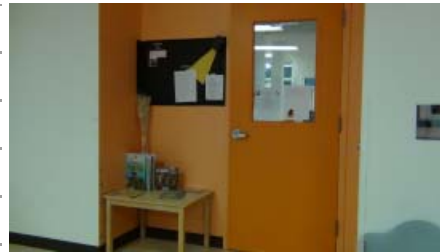
Field Date: 11/11/2015 Report Date: 12/1/2015 Barrier #: 19C
 Bldg Name: Child Care Center Reference Dwg: 2 of 3
 Location: Floor 1 - Pre-Kindergarten Room 147
 X Coordinate: N/A Y Coordinate: N/A
 Barrier Area: Doors or Gates
 Barrier Type: Front App/pull 18" SEC - Blocked
 Code: 2010 ADAS Figure 404.2.4.1
 References:

Barrier Description: Door/Gate at pull side with min. 60" lacks min. 18" strike edge clearance at pull side

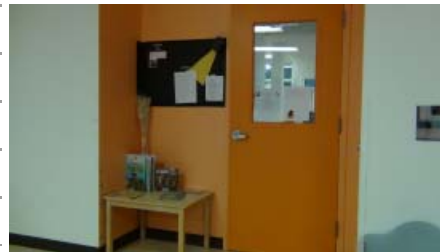
Field Date: 11/11/2015 Report Date: 12/1/2015 Barrier #: 19D
 Bldg Name: Child Care Center Reference Dwg: 2 of 3
 Location: Floor 1 - Pre-Kindergarten Room 147
 X Coordinate: N/A Y Coordinate: N/A
 Barrier Area: Classrooms
 Barrier Type: Clear Floor Space - Stored Elements
 Code: 2010 ADAS 305.3
 References:

Barrier Description: Clear floor space for wheelchair not provided at control or mechanism

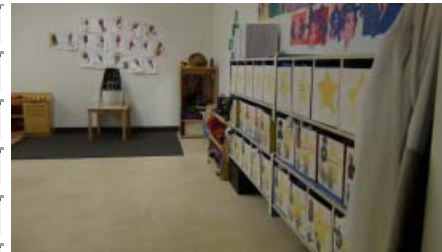
Field Date: 11/11/2015 Report Date: 12/1/2015 Barrier #: 19E
 Bldg Name: Child Care Center Reference Dwg: 2 of 3
 Location: Floor 1 - Pre-Kindergarten Room 147
 X Coordinate: N/A Y Coordinate: N/A
 Barrier Area: Classrooms
 Barrier Type: Actuator/Control - Side Reach High Unobstructed
 Code: 2010 ADAS 305.3
 References:

Barrier Description: Control or mechanism not at min. 15" or max. 48" high

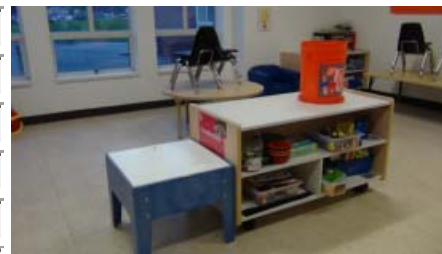
Field Date: 11/11/2015 Report Date: 12/1/2015 Barrier #: 19F
 Bldg Name: Child Care Center Reference Dwg: 2 of 3
 Location: Floor 1 - Pre-Kindergarten Room 147
 X Coordinate: N/A Y Coordinate: N/A
 Barrier Area: Counters and Tables
 Barrier Type: Table - Knee Clearance
 Code: 2010 ADAS 305.3
 References:

Barrier Description: Knee clearance not min. 27" high, 19" deep or 30" wide

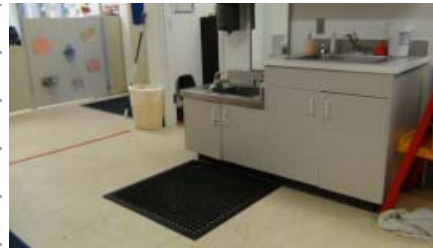
Field Date: 11/11/2015 Report Date: 12/1/2015 Barrier #: 19K
 Bldg Name: Child Care Center Reference Dwg: 2 of 3
 Location: Floor 1 - Pre-Kindergarten Room 147
 X Coordinate: N/A Y Coordinate: N/A
 Barrier Area: Classrooms
 Barrier Type: Sink - Knee Clearance
 Code: 2010 ADAS 606.2 & 306
 References:

Barrier Description: Knee clearance of at least 30" wide and 8" deep at 27" high with 11" depth at 9" high

Rec. Solution: Replace cabinet and remount sink

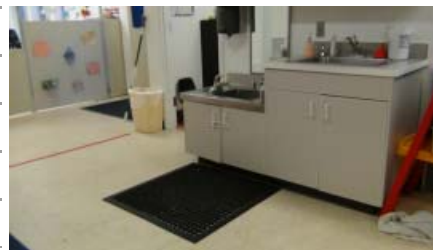
Field Date: 11/11/2015 Report Date: 12/1/2015 Barrier #: 19L
 Bldg Name: Child Care Center Reference Dwg: 2 of 3
 Location: Floor 1 - Pre-Kindergarten Room 147
 X Coordinate: N/A Y Coordinate: N/A
 Barrier Area: Drinking Fountains
 Barrier Type: Knee Clearance
 Code: 2010 ADAS 306.3
 References:

Barrier Description: Knee clearance under fountain not min. 27" high

Rec. Solution: Replace drinking fountain with accessible unit or remount existing

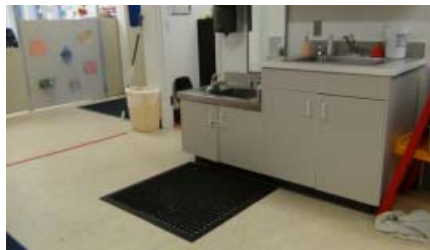
Code: 2010 ADAS 606.3

Barrier Description: No accessible section of counter at max 34" high provided

Rec. Solution: Replace cabinet and remount sink

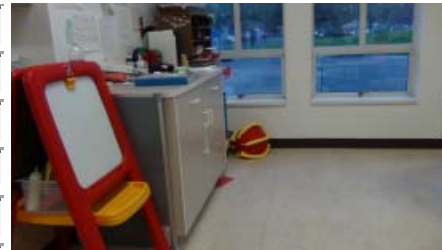
Field Date: 11/11/2015 Report Date: 12/1/2015 Barrier #: 19S
 Bldg Name: Child Care Center Reference Dwg: 2 of 3
 Location: Floor 1 - Pre-Kindergarten Room 147
 X Coordinate: N/A Y Coordinate: N/A
 Barrier Area: Classrooms
 Barrier Type: Counter - Surface
 Code: 2010 ADAS 902
 References:

Barrier Description: Counter surface height exceeds 34" high

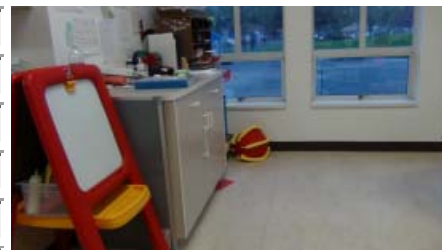
Field Date: 11/11/2015 Report Date: 12/1/2015 Barrier #: 19T
 Bldg Name: Child Care Center Reference Dwg: 2 of 3
 Location: Floor 1 - Pre-Kindergarten Room 147
 X Coordinate: N/A Y Coordinate: N/A
 Barrier Area: Classrooms
 Barrier Type: Counter - Knee Clearance
 Code: 2010 ADAS 305.3
 References:

Barrier Description: Knee clearance not min. 27" high, 19" deep or 30" wide

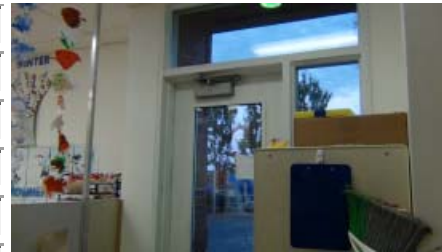
Field Date: 11/11/2015 Report Date: 12/1/2015 Barrier #: 19Y
 Bldg Name: Child Care Center Reference Dwg: 2 of 3
 Location: Floor 1 - Pre-Kindergarten Room 147
 X Coordinate: N/A Y Coordinate: N/A
 Barrier Area: Doors or Gates
 Barrier Type: Door Closer - Exterior Sweep Period
 Code: 2010 ADAS 404.2.8.1
 References:

Barrier Description: Door closer lacks min. 5 second sweep period

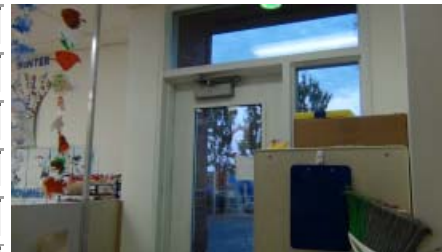
Field Date: 11/11/2015 Report Date: 12/1/2015 Barrier #: 19Z
 Bldg Name: Child Care Center Reference Dwg: 2 of 3
 Location: Floor 1 - Pre-Kindergarten Room 147
 X Coordinate: N/A Y Coordinate: N/A
 Barrier Area: Signage
 Barrier Type: Tactile Exit Signs - Door
 Code: 2010 ADAS 216.4.1
 References:

Barrier Description: Ground floor doors that exit to exterior lacks tactile exit sign

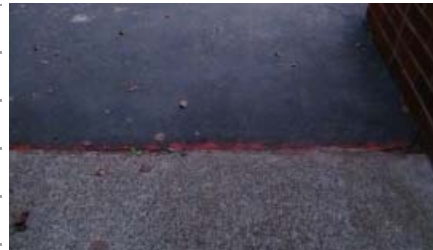
Field Date: 11/11/2015 Report Date: 12/1/2015 Barrier #: 19AA
 Bldg Name: Child Care Center Reference Dwg: 2 of 3
 Location: Floor 1 - Pre-Kindergarten Room 147
 X Coordinate: N/A Y Coordinate: N/A
 Barrier Area: Clear Floor Space
 Barrier Type: Abrupt Change in Level
 Code: 2010 ADAS 303.3
 References:

Barrier Description: Change in level greater than 1/2" in clear floor space

Rec. Solution: Repair trip hazard. Remodel where needed

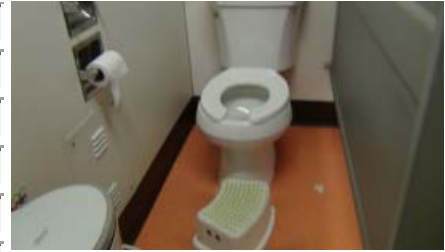
Field Date: 11/11/2015 Report Date: 12/1/2015 Barrier #: 20J
 Bldg Name: Child Care Center Reference Dwg: 2 of 3
 Location: Floor 1 - Pre-Kindergarten Restroom Room 147
 X Coordinate: N/A Y Coordinate: N/A
 Barrier Area: Restrooms
 Barrier Type: Toilet - Grab Bars
 Code: 2010 ADAS 604.5
 References:

Barrier Description: No grab bars provided at water closet

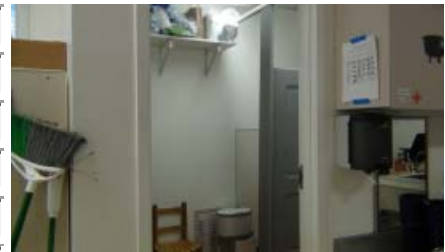
Field Date: 11/11/2015 Report Date: 12/1/2015 Barrier #: 20K
 Bldg Name: Child Care Center Reference Dwg: 2 of 3
 Location: Floor 1 - Pre-Kindergarten Restroom Room 147
 X Coordinate: N/A Y Coordinate: N/A
 Barrier Area: Alarms
 Barrier Type: Horn/Strobe - Common Use Area
 Code: 2010 ADAS 702.1
 References:

Barrier Description: No horn/strobes in common use areas

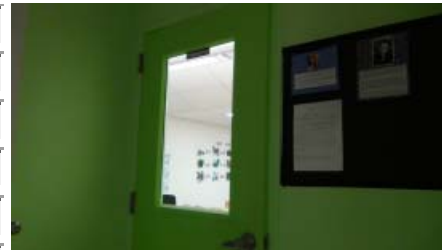
Field Date: 11/11/2015 Report Date: 12/1/2015 Barrier #: 21A
 Bldg Name: Child Care Center Reference Dwg: 3 of 3
 Location: Floor 1 - Toddlers Room 157
 X Coordinate: N/A Y Coordinate: N/A
 Barrier Area: Signage
 Barrier Type: Permanent Room/Space - Tactile Characters
 Code: 2010 ADAS 216.2
 References:

Barrier Description: No tactile characters at sign identifying permanent rooms and spaces with visual signs

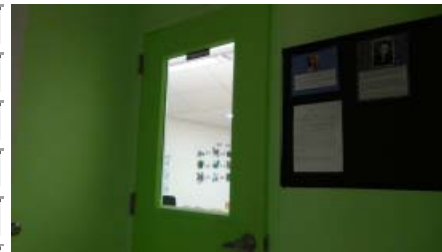
Field Date: 11/11/2015 Report Date: 12/1/2015 Barrier #: 21B
 Bldg Name: Child Care Center Reference Dwg: 3 of 3
 Location: Floor 1 - Toddlers Room 157
 X Coordinate: N/A Y Coordinate: N/A
 Barrier Area: Doors or Gates
 Barrier Type: Vision Lights - Existing
 Code: 2010 ADAS 404.2.11
 References:

Barrier Description: View panels in or adjacent to doors or gates not max. 43" above floor or ground

Rec. Solution: Replace door/gate or vision panel

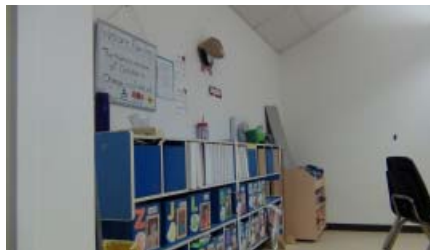
Code: 2010 ADAS 305.3

Barrier Description: Control or mechanism not at min. 15" or max. 48" high

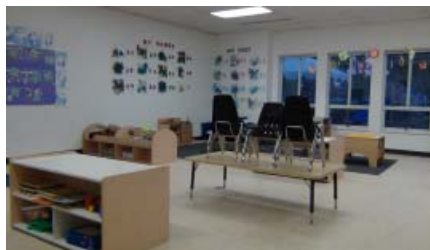
Code: 2010 ADAS 305.3

Barrier Description: Knee clearance not min. 27" high, 19" deep or 30" wide

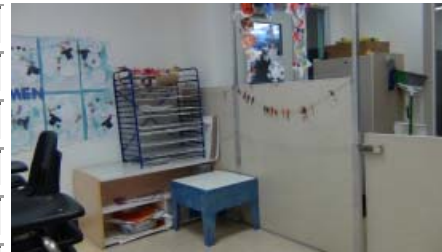
Field Date: 11/11/2015 Report Date: 12/1/2015 Barrier #: 21E
 Bldg Name: Child Care Center Reference Dwg: 3 of 3
 Location: Floor 1 - Toddlers Room 157
 X Coordinate: N/A Y Coordinate: N/A
 Barrier Area: Counters and Tables
 Barrier Type: Table - Knee Clearance
 Code: 2010 ADAS 305.3
 References:

Barrier Description: Knee clearance not min. 27" high, 19" deep or 30" wide

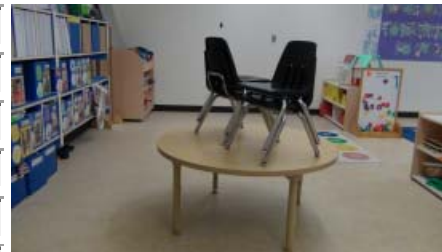
Field Date: 11/11/2015 Report Date: 12/1/2015 Barrier #: 21F
 Bldg Name: Child Care Center Reference Dwg: 3 of 3
 Location: Floor 1 - Toddlers Room 157
 X Coordinate: N/A Y Coordinate: N/A
 Barrier Area: Counters and Tables
 Barrier Type: Table - Knee Clearance
 Code: 2010 ADAS 305.3
 References:

Barrier Description: Knee clearance not min. 27" high, 19" deep or 30" wide

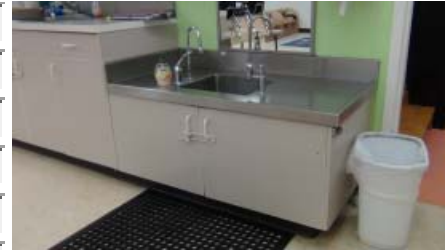
Field Date: 11/11/2015 Report Date: 12/1/2015 Barrier #: 21G
 Bldg Name: Child Care Center Reference Dwg: 3 of 3
 Location: Floor 1 - Toddlers Room 157
 X Coordinate: N/A Y Coordinate: N/A
 Barrier Area: Classrooms
 Barrier Type: Sink - Rim or Countertop
 Code: 2010 ADAS 606.3
 References:

Barrier Description: No accessible section of counter at max 34" high provided

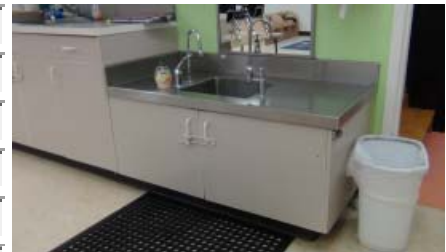
Field Date: 11/11/2015 Report Date: 12/1/2015 Barrier #: 21H
 Bldg Name: Child Care Center Reference Dwg: 3 of 3
 Location: Floor 1 - Toddlers Room 157
 X Coordinate: N/A Y Coordinate: N/A
 Barrier Area: Classrooms
 Barrier Type: Sink - Knee Clearance
 Code: 2010 ADAS 606.2 & 306
 References:

Barrier Description: Knee clearance of at least 30" wide and 8" deep at 27" high with 11" depth at 9" high

Rec. Solution: Replace cabinet and remount sink

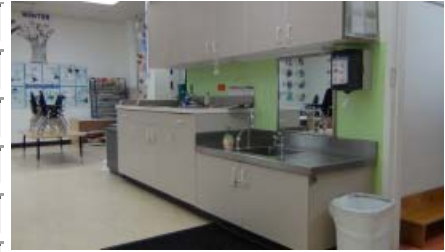
Field Date: 11/11/2015 Report Date: 12/1/2015 Barrier #: 21M
 Bldg Name: Child Care Center Reference Dwg: 3 of 3
 Location: Floor 1 - Toddlers Room 157
 X Coordinate: N/A Y Coordinate: N/A
 Barrier Area: Classrooms
 Barrier Type: Counter - Knee Clearance
 Code: 2010 ADAS 305.3
 References:

Barrier Description: Knee clearance not min. 27" high, 19" deep or 30" wide

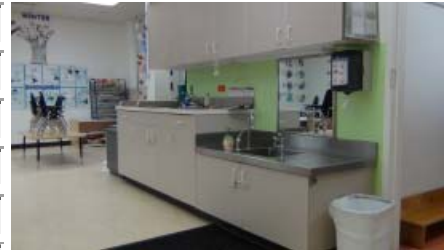
Field Date: 11/11/2015 Report Date: 12/1/2015 Barrier #: 21N
 Bldg Name: Child Care Center Reference Dwg: 3 of 3
 Location: Floor 1 - Toddlers Room 157
 X Coordinate: N/A Y Coordinate: N/A
 Barrier Area: Classrooms
 Barrier Type: Sink - Rim or Countertop
 Code: 2010 ADAS 606.3
 References:

Barrier Description: No accessible section of counter at max 34" high provided

Rec. Solution: Replace cabinet and remount sink

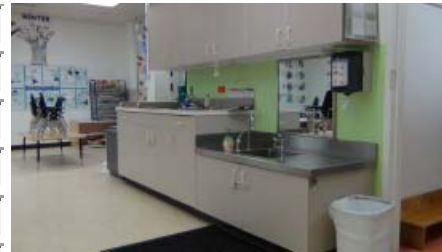
Field Date: 11/11/2015 Report Date: 12/1/2015 Barrier #: 210
 Bldg Name: Child Care Center Reference Dwg: 3 of 3
 Location: Floor 1 - Toddlers Room 157
 X Coordinate: N/A Y Coordinate: N/A
 Barrier Area: Classrooms
 Barrier Type: Sink - Knee Clearance
 Code: 2010 ADAS 606.2 & 306
 References:

Barrier Description: Knee clearance of at least 30" wide and 8" deep at 27" high with 11" depth at 9" high

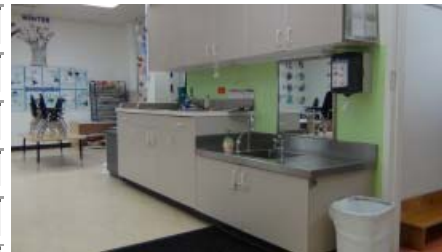
Field Date: 11/11/2015 Report Date: 12/1/2015 Barrier #: 21P
 Bldg Name: Child Care Center Reference Dwg: 3 of 3
 Location: Floor 1 - Toddlers Room 157
 X Coordinate: N/A Y Coordinate: N/A
 Barrier Area: Classrooms
 Barrier Type: Shelves or Cabinets
 Code: 2010 ADAS 603.4
 References:

Barrier Description: Shelf or cabinet not mounted between 40" and 48" above floor or ground

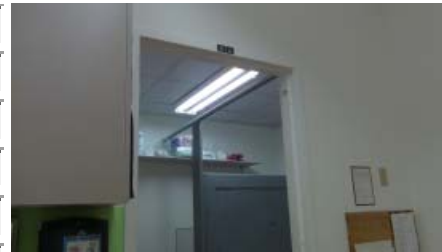
Field Date: 11/11/2015 Report Date: 12/1/2015 Barrier #: 22A
 Bldg Name: Child Care Center Reference Dwg: 3 of 3
 Location: Floor 1 - Toddlers Restroom 157A
 X Coordinate: N/A Y Coordinate: N/A
 Barrier Area: Signage
 Barrier Type: Permanent Room/Space - Tactile Characters
 Code: 2010 ADAS 216.2
 References:

Barrier Description: No tactile characters at sign identifying permanent rooms and spaces with visual signs

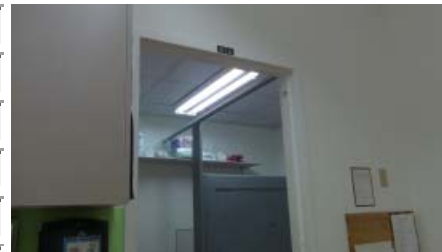
Field Date: 11/11/2015 Report Date: 12/1/2015 Barrier #: 22B
 Bldg Name: Child Care Center Reference Dwg: 3 of 3
 Location: Floor 1 - Toddlers Restroom 157A
 X Coordinate: N/A Y Coordinate: N/A
 Barrier Area: Restrooms
 Barrier Type: Door Clear Width
 Code: 2010 ADAS 404.2.3
 References:

Barrier Description: Door clear width is not min. 32"

Rec. Solution: Replace door/gate and frame

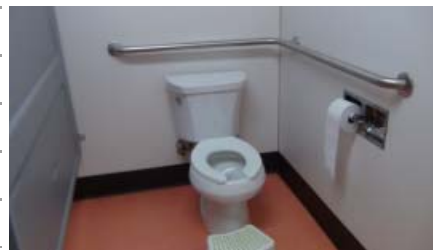
Field Date: 11/11/2015 Report Date: 12/1/2015 Barrier #: 22F
 Bldg Name: Child Care Center Reference Dwg: 3 of 3
 Location: Floor 1 - Toddlers Restroom 157A
 X Coordinate: N/A Y Coordinate: N/A
 Barrier Area: Restrooms
 Barrier Type: Toilet Paper Dispenser
 Code: 2010 ADAS 604.7
 References:

Barrier Description: Toilet tissue dispenser not within 7" to 9" from front edge of toilet

Rec. Solution: Reposition or replace toilet paper dispenser

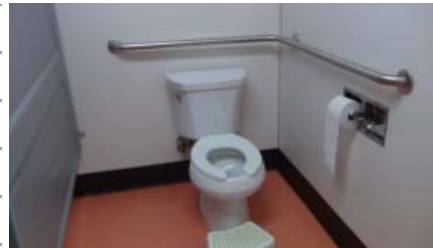
Field Date: 11/11/2015 Report Date 12/1/2015 Barrier #: 22G
 Bldg Name: Child Care Center Reference Dwg: 3 of 3
 Location: Floor 1 - Toddlers Restroom 157A
 X Coordinate: N/A Y Coordinate: N/A
 Barrier Area: Restrooms
 Barrier Type: Toilet - Side Grab Bar
 Code: 2010 ADAS 604.5.1
 References:

Barrier Description: Side grab bar does not extend min. 54" from rear wall

Rec. Solution: Replace grab bars with reinforcement

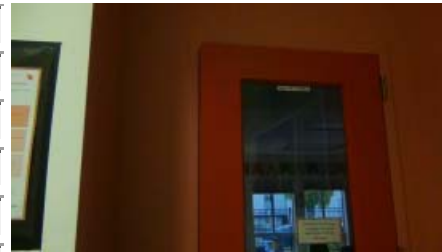
Field Date: 11/11/2015 Report Date: 12/1/2015 Barrier #: 23B
 Bldg Name: Child Care Center Reference Dwg: 3 of 3
 Location: Floor 1 - Toddlers Room 167
 X Coordinate: N/A Y Coordinate: N/A
 Barrier Area: Signage
 Barrier Type: Permanent Room/Space - Tactile Characters
 Code: 2010 ADAS 216.2
 References:

Barrier Description: No tactile characters at sign identifying permanent rooms and spaces with visual signs

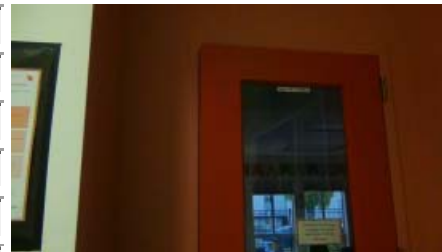
Field Date: 11/11/2015 Report Date: 12/1/2015 Barrier #: 23C
 Bldg Name: Child Care Center Reference Dwg: 3 of 3
 Location: Floor 1 - Toddlers Room 167
 X Coordinate: N/A Y Coordinate: N/A
 Barrier Area: Doors or Gates
 Barrier Type: Vision Lights - Existing
 Code: 2010 ADAS 404.2.11
 References:

Barrier Description: View panels in or adjacent to doors or gates not max. 43" above floor or ground

Rec. Solution: Replace door/gate or vision panel

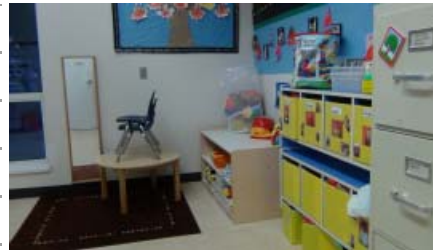
Field Date: 11/11/2015 Report Date: 12/1/2015 Barrier #: 23D
 Bldg Name: Child Care Center Reference Dwg: 3 of 3
 Location: Floor 1 - Toddlers Room 167
 X Coordinate: N/A Y Coordinate: N/A
 Barrier Area: Classrooms
 Barrier Type: Actuator/Control - Side Reach High Unobstructed
 Code: 2010 ADAS 305.3
 References:

Barrier Description: Control or mechanism not at min. 15" or max. 48" high

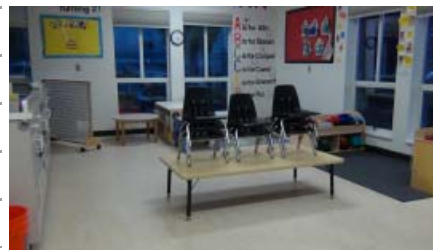
Field Date: 11/11/2015 Report Date: 12/1/2015 Barrier #: 23E
 Bldg Name: Child Care Center Reference Dwg: 3 of 3
 Location: Floor 1 - Toddlers Room 167
 X Coordinate: N/A Y Coordinate: N/A
 Barrier Area: Counters and Tables
 Barrier Type: Table - Knee Clearance
 Code: 2010 ADAS 305.3
 References:

Barrier Description: Knee clearance not min. 27" high, 19" deep or 30" wide

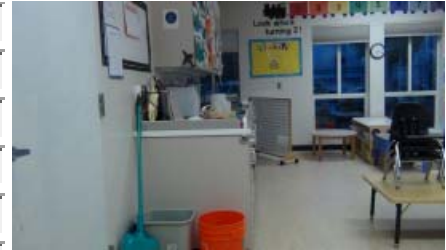
Field Date: 11/11/2015 Report Date: 12/1/2015 Barrier #: 23F
 Bldg Name: Child Care Center Reference Dwg: 3 of 3
 Location: Floor 1 - Toddlers Room 167
 X Coordinate: N/A Y Coordinate: N/A
 Barrier Area: Classrooms
 Barrier Type: Counter - Surface
 Code: 2010 ADAS 902
 References:

Barrier Description: Counter surface height exceeds 34" high

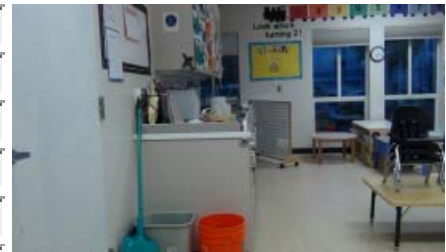
Field Date: 11/11/2015 Report Date: 12/1/2015 Barrier #: 23G
 Bldg Name: Child Care Center Reference Dwg: 3 of 3
 Location: Floor 1 - Toddlers Room 167
 X Coordinate: N/A Y Coordinate: N/A
 Barrier Area: Classrooms
 Barrier Type: Counter - Knee Clearance
 Code: 2010 ADAS 305.3
 References:

Barrier Description: Knee clearance not min. 27" high, 19" deep or 30" wide

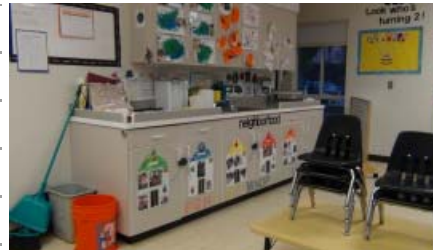
Field Date: 11/11/2015 Report Date: 12/1/2015 Barrier #: 23H
 Bldg Name: Child Care Center Reference Dwg: 3 of 3
 Location: Floor 1 - Toddlers Room 167
 X Coordinate: N/A Y Coordinate: N/A
 Barrier Area: Classrooms
 Barrier Type: Sink - Rim or Countertop
 Code: 2010 ADAS 606.3
 References:

Barrier Description: No accessible section of counter at max 34" high provided

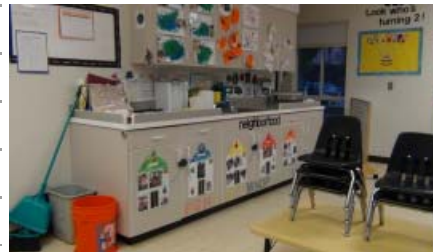
Field Date: 11/11/2015 Report Date: 12/1/2015 Barrier #: 23I
 Bldg Name: Child Care Center Reference Dwg: 3 of 3
 Location: Floor 1 - Toddlers Room 167
 X Coordinate: N/A Y Coordinate: N/A
 Barrier Area: Classrooms
 Barrier Type: Sink - Knee Clearance
 Code: 2010 ADAS 606.2 & 306
 References:

Barrier Description: Knee clearance of at least 30" wide and 8" deep at 27" high with 11" depth at 9" high

Rec. Solution: Replace cabinet and remount sink

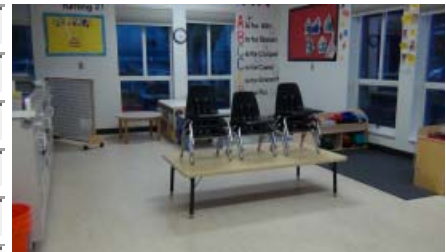
Field Date: 11/11/2015 Report Date: 12/1/2015 Barrier #: 23K
 Bldg Name: Child Care Center Reference Dwg: 3 of 3
 Location: Floor 1 - Toddlers Room 167
 X Coordinate: N/A Y Coordinate: N/A
 Barrier Area: Alarms
 Barrier Type: Horn/Strobe - Common Use Area
 Code: 2010 ADAS 702.1
 References:

Barrier Description: No horn/strobes in common use areas

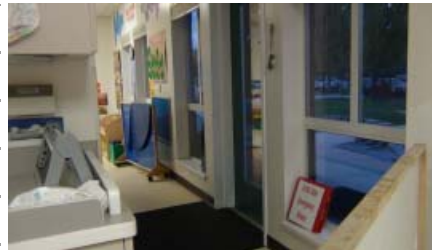
Field Date: 11/11/2015 Report Date: 12/1/2015 Barrier #: 23L
 Bldg Name: Child Care Center Reference Dwg: 3 of 3
 Location: Floor 1 - Toddlers Room 167
 X Coordinate: N/A Y Coordinate: N/A
 Barrier Area: Doors or Gates
 Barrier Type: Doormat
 Code: 2010 ADAS 302.2 & Advisory 302.2
 References:

Barrier Description: Doormat not anchored to floor

Rec. Solution: Secure exiting doormat or replace

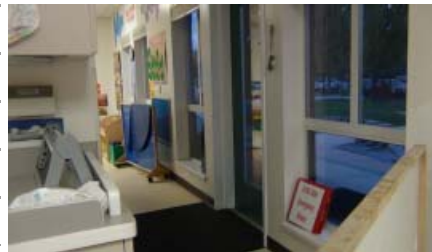
Field Date: 11/11/2015 Report Date: 12/1/2015 Barrier #: 23M
 Bldg Name: Child Care Center Reference Dwg: 3 of 3
 Location: Floor 1 - Toddlers Room 167
 X Coordinate: N/A Y Coordinate: N/A
 Barrier Area: Doors or Gates
 Barrier Type: Door 10" Bottom Surface - Door Stop
 Code: 2010 ADAS 404.2.10
 References:

Barrier Description: Door stop interrupts min.10" smooth bottom surface

Findings: Door stop at bottom of door can create trapping condition

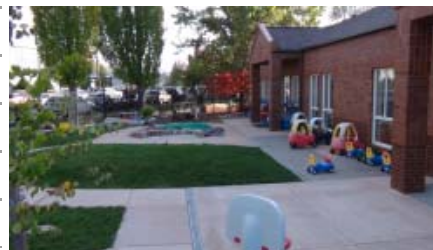
Field Date: 11/11/2015 Report Date: 12/1/2015 Barrier #: 23Q
 Bldg Name: Child Care Center Reference Dwg: 3 of 3
 Location: Floor 1 - Toddlers Room 167
 X Coordinate: N/A Y Coordinate: N/A
 Barrier Area: Doors or Gates
 Barrier Type: Landing - Existing (3.1% to 4.0%)
 Code: 2010 ADAS 404.2.4.4
 References:

Barrier Description: Door or gate lacks landing on both sides of door

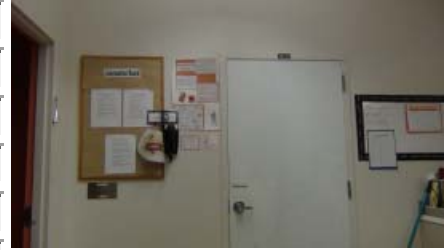
Field Date: 11/11/2015 Report Date: 12/1/2015 Barrier #: 24A
 Bldg Name: Child Care Center Reference Dwg: 3 of 3
 Location: Floor 1 - Shared Restroom 167A
 X Coordinate: N/A Y Coordinate: N/A
 Barrier Area: Signage
 Barrier Type: Permanent Room/Space - Tactile Characters
 Code: 2010 ADAS 216.2
 References:

Barrier Description: No tactile characters at sign identifying permanent rooms and spaces with visual signs

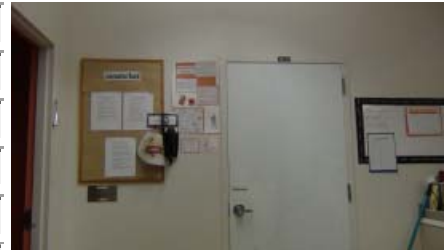
Field Date: 11/11/2015 Report Date: 12/1/2015 Barrier #: 24B
 Bldg Name: Child Care Center Reference Dwg: 3 of 3
 Location: Floor 1 - Shared Restroom 167A
 X Coordinate: N/A Y Coordinate: N/A
 Barrier Area: Doors or Gates
 Barrier Type: Door Closer - Exterior Automatic Door
 Code: Performance Standard
 References:

Barrier Description: Door opening force exceeds 8.5 lbf

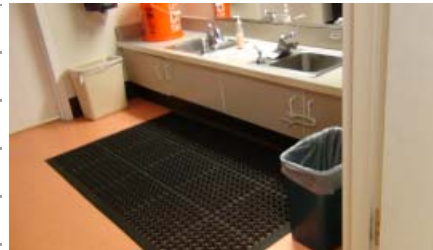
Field Date: 11/11/2015 Report Date: 12/1/2015 Barrier #: 24E
 Bldg Name: Child Care Center Reference Dwg: 3 of 3
 Location: Floor 1 - Shared Restroom 167A
 X Coordinate: N/A Y Coordinate: N/A
 Barrier Area: Restrooms
 Barrier Type: Lavatory - Surfaces
 Code: 2010 ADAS 606.5
 References:

Barrier Description: Lavatory has sharp or abrasive surfaces on edge, rim or apron

Rec. Solution: Replace min. 1 lavatory

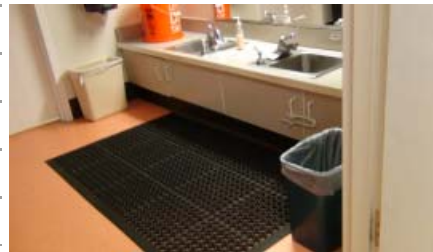
Field Date: 11/11/2015 Report Date: 12/1/2015 Barrier #: 24F
 Bldg Name: Child Care Center Reference Dwg: 3 of 3
 Location: Floor 1 - Shared Restroom 167A
 X Coordinate: N/A Y Coordinate: N/A
 Barrier Area: Restrooms
 Barrier Type: Lavatory - Knee Clearance
 Code: 2010 ADAS 606.2 & 306
 References:

Barrier Description: Lavatory bottom apron/edge not at least 27" high

Rec. Solution: Replace lavatory

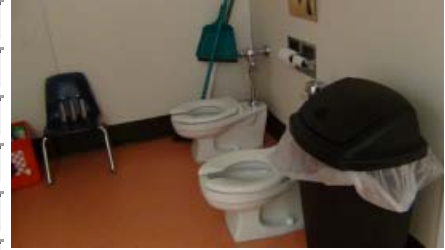
Field Date: 11/11/2015 Report Date: 12/1/2015 Barrier #: 24G
 Bldg Name: Child Care Center Reference Dwg: 3 of 3
 Location: Floor 1 - Shared Restroom 167A
 X Coordinate: N/A Y Coordinate: N/A
 Barrier Area: Restrooms
 Barrier Type: Toilet - Grab Bars
 Code: 2010 ADAS 604.5
 References:

Barrier Description: No grab bars provided at water closet

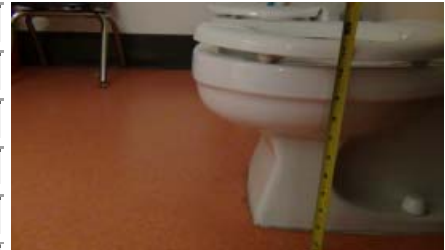
Field Date: 11/11/2015 Report Date: 12/1/2015 Barrier #: 24H
 Bldg Name: Child Care Center Reference Dwg: 3 of 3
 Location: Floor 1 - Shared Restroom 167A
 X Coordinate: N/A Y Coordinate: N/A
 Barrier Area: Restrooms
 Barrier Type: Toilet - Seat Height
 Code: 2010 ADAS 604.4
 References:

Barrier Description: Water closet seat not between 17" to 19" high

Barrier Severity: 2 Recommended Cost Est: \$1,700.00 Facility Function: Public Status: Open

Notes: Wheelchair users cannot transfer from low toilets back to their wheelchair without assistance.

Rec. Solution: Replace water closet

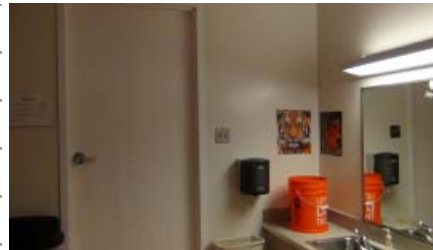
Field Date: 11/11/2015 Report Date: 12/1/2015 Barrier #: 24I
 Bldg Name: Child Care Center Reference Dwg: 3 of 3
 Location: Floor 1 - Shared Restroom 167A
 X Coordinate: N/A Y Coordinate: N/A
 Barrier Area: Alarms
 Barrier Type: Horn/Strobe - Common Use Area
 Code: 2010 ADAS 702.1
 References:

Barrier Description: No horn/strobes in common use areas

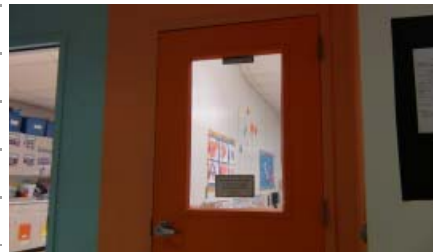
Barrier Description: No tactile characters at sign identifying permanent rooms and spaces with visual signs

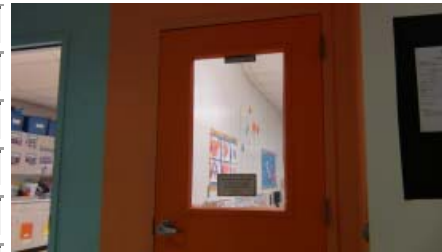
Field Date: 11/11/2015 Report Date: 12/1/2015 Barrier #: 25B
 Bldg Name: Child Care Center Reference Dwg: 3 of 3
 Location: Floor 1 - Toddlers Room 177
 X Coordinate: N/A Y Coordinate: N/A
 Barrier Area: Doors or Gates
 Barrier Type: Vision Lights - Existing
 Code: 2010 ADAS 404.2.11
 References:

Barrier Description: View panels in or adjacent to doors or gates not max. 43" above floor or ground

Rec. Solution: Replace door/gate or vision panel

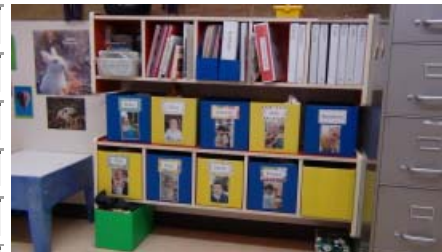
Barrier Description: Control or mechanism not at min. 15" or max. 48" high

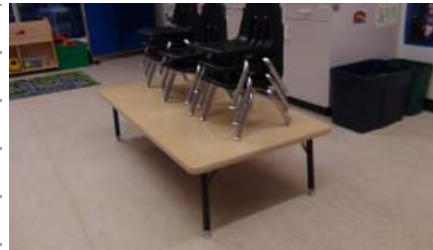
Field Date: 11/11/2015 Report Date: 12/1/2015 Barrier #: 25D
 Bldg Name: Child Care Center Reference Dwg: 3 of 3
 Location: Floor 1 - Toddlers Room 177
 X Coordinate: N/A Y Coordinate: N/A
 Barrier Area: Counters and Tables
 Barrier Type: Table - Knee Clearance
 Code: 2010 ADAS 305.3
 References:

Barrier Description: Knee clearance not min. 27" high, 19" deep or 30" wide

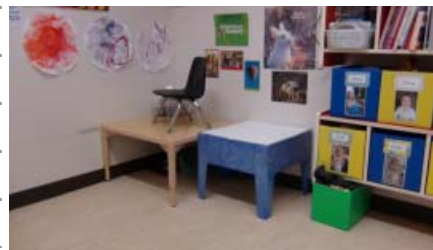
Field Date: 11/11/2015 Report Date: 12/1/2015 Barrier #: 25E
 Bldg Name: Child Care Center Reference Dwg: 3 of 3
 Location: Floor 1 - Toddlers Room 177
 X Coordinate: N/A Y Coordinate: N/A
 Barrier Area: Counters and Tables
 Barrier Type: Table - Knee Clearance
 Code: 2010 ADAS 305.3
 References:

Barrier Description: Knee clearance not min. 27" high, 19" deep or 30" wide

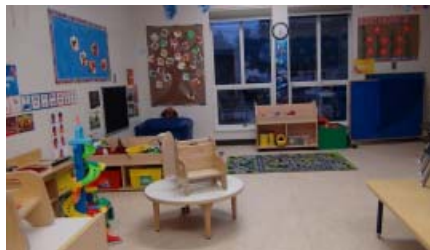
Barrier Description: Knee clearance not min. 27" high, 19" deep or 30" wide

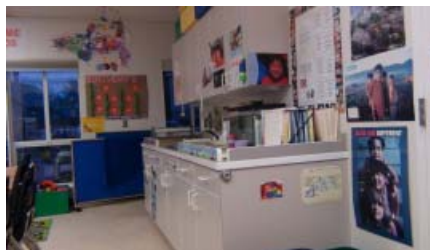
Barrier Description: Counter surface height exceeds 34" high

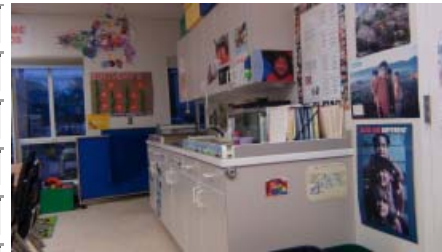
Field Date: 11/11/2015 Report Date: 12/1/2015 Barrier #: 25H
 Bldg Name: Child Care Center Reference Dwg: 3 of 3
 Location: Floor 1 - Toddlers Room 177
 X Coordinate: N/A Y Coordinate: N/A
 Barrier Area: Classrooms
 Barrier Type: Counter - Knee Clearance
 Code: 2010 ADAS 305.3
 References:

Barrier Description: Knee clearance not min. 27" high, 19" deep or 30" wide

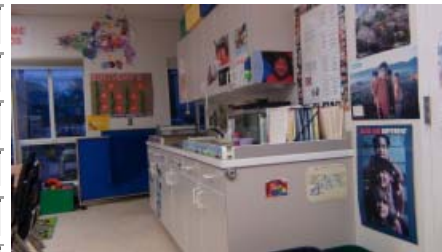
Field Date: 11/11/2015 Report Date: 12/1/2015 Barrier #: 25I
 Bldg Name: Child Care Center Reference Dwg: 3 of 3
 Location: Floor 1 - Toddlers Room 177
 X Coordinate: N/A Y Coordinate: N/A
 Barrier Area: Classrooms
 Barrier Type: Sink - Rim or Countertop
 Code: 2010 ADAS 606.3
 References:

Barrier Description: No accessible section of counter at max 34" high provided

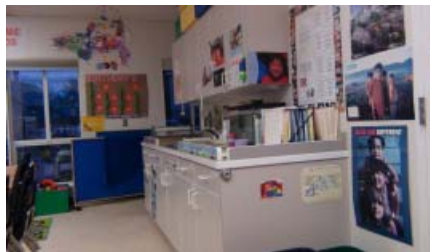
Barrier Description: Knee clearance of at least 30" wide and 8" deep at 27" high with 11" depth at 9" high

Rec. Solution: Replace cabinet and remount sink

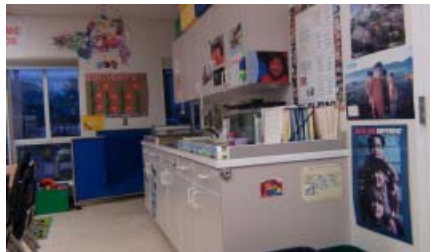
Barrier Description: Shelf or cabinet not mounted between 40" and 48" above floor or ground

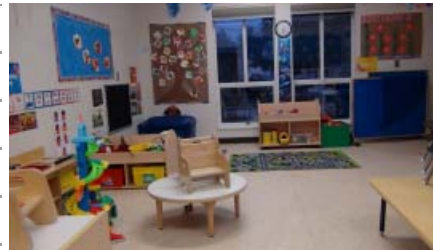
Field Date: 11/11/2015 Report Date: 12/1/2015 Barrier #: 25L
 Bldg Name: Child Care Center Reference Dwg: 3 of 3
 Location: Floor 1 - Toddlers Room 177
 X Coordinate: N/A Y Coordinate: N/A
 Barrier Area: Alarms
 Barrier Type: Horn/Strobe - Common Use Area
 Code: 2010 ADAS 702.1
 References:

Barrier Description: No horn/strobes in common use areas

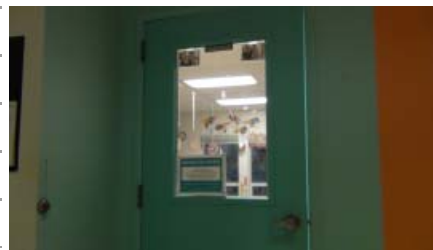
Barrier Description: No tactile characters at sign identifying permanent rooms and spaces with visual signs

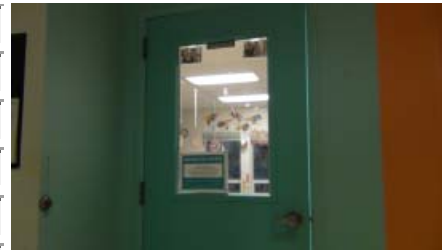
Barrier Description: Door or gate lacks landing on both sides of door

Notes: 2.6%. Door to shared restroom 197A.

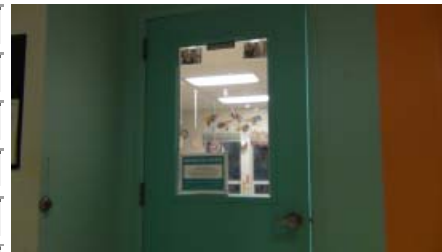
Field Date: 11/11/2015 Report Date: 12/1/2015 Barrier #: 26C
 Bldg Name: Child Care Center Reference Dwg: 3 of 3
 Location: Floor 1 - Infants Room 187
 X Coordinate: N/A Y Coordinate: N/A
 Barrier Area: Doors or Gates
 Barrier Type: Vision Lights - Existing
 Code: 2010 ADAS 404.2.11
 References:

Barrier Description: View panels in or adjacent to doors or gates not max. 43" above floor or ground

Rec. Solution: Replace door/gate or vision panel

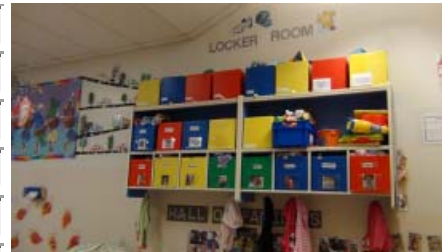
Barrier Description: Control or mechanism not at min. 15" or max. 48" high

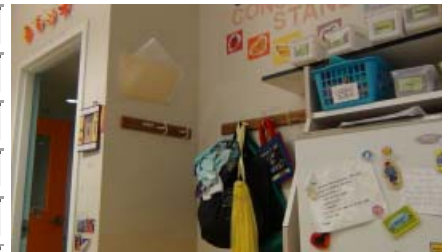
Barrier Description: Clothing hooks not max. 48" high AFF

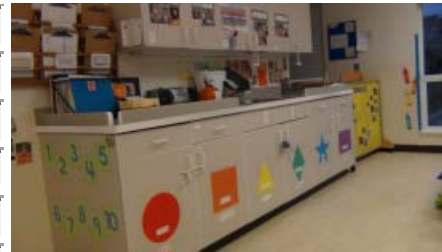
Field Date: 11/11/2015 Report Date: 12/1/2015 Barrier #: 26H
 Bldg Name: Child Care Center Reference Dwg: 3 of 3
 Location: Floor 1 - Infants Room 187
 X Coordinate: N/A Y Coordinate: N/A
 Barrier Area: Classrooms
 Barrier Type: Sink - Rim or Countertop
 Code: 2010 ADAS 606.3
 References:

Barrier Description: No accessible section of counter at max 34" high provided

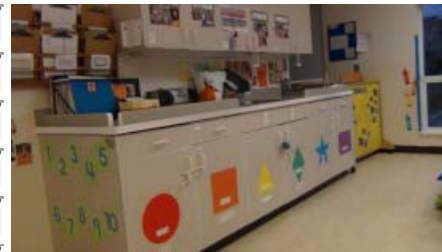
Field Date: 11/11/2015 Report Date: 12/1/2015 Barrier #: 26I
 Bldg Name: Child Care Center Reference Dwg: 3 of 3
 Location: Floor 1 - Infants Room 187
 X Coordinate: N/A Y Coordinate: N/A
 Barrier Area: Classrooms
 Barrier Type: Sink - Knee Clearance
 Code: 2010 ADAS 606.2 & 306
 References:

Barrier Description: Knee clearance of at least 30" wide and 8" deep at 27" high with 11" depth at 9" high

Rec. Solution: Replace cabinet and remount sink

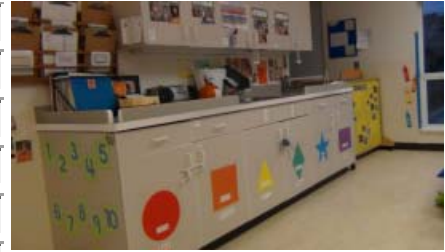
Field Date: 11/11/2015 Report Date: 12/1/2015 Barrier #: 26J
 Bldg Name: Child Care Center Reference Dwg: 3 of 3
 Location: Floor 1 - Infants Room 187
 X Coordinate: N/A Y Coordinate: N/A
 Barrier Area: Classrooms
 Barrier Type: Shelves or Cabinets
 Code: 2010 ADAS 603.4
 References:

Barrier Description: Shelf or cabinet not mounted between 40" and 48" above floor or ground

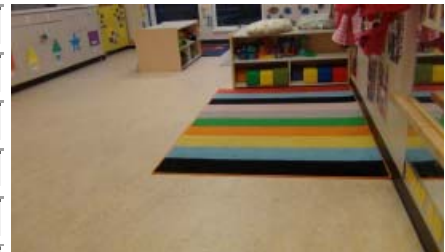
Field Date: 11/11/2015 Report Date: 12/1/2015 Barrier #: 26K
 Bldg Name: Child Care Center Reference Dwg: 3 of 3
 Location: Floor 1 - Infants Room 187
 X Coordinate: N/A Y Coordinate: N/A
 Barrier Area: Alarms
 Barrier Type: Horn/Strobe - Common Use Area
 Code: 2010 ADAS 702.1
 References:

Barrier Description: No horn/strobes in common use areas

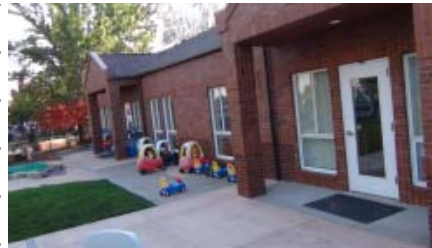
Barrier Description: Door opening force exceeds 8.5 lbf

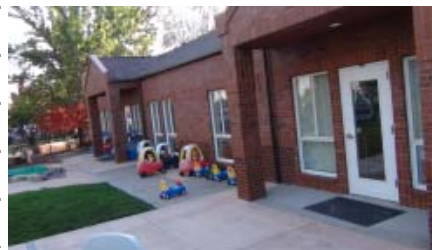
Barrier Description: Door closer lacks min. 5 second sweep period

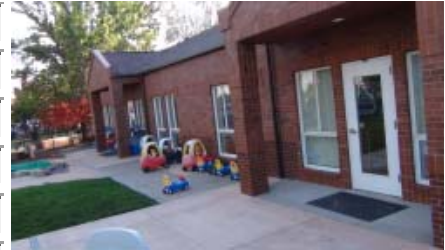
Field Date: 11/11/2015 Report Date: 12/1/2015 Barrier #: 26N
 Bldg Name: Child Care Center Reference Dwg: 3 of 3
 Location: Floor 1 - Infants Room 187
 X Coordinate: N/A Y Coordinate: N/A
 Barrier Area: Signage
 Barrier Type: Tactile Exit Signs - To Exit Door
 Code: Performance Standard
 References:

Barrier Description: Exit door leading directly to an exit to the exterior lacks tactile exit sign

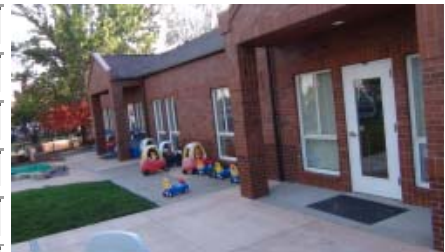
Barrier Description: Door or gate lacks landing on both sides of door

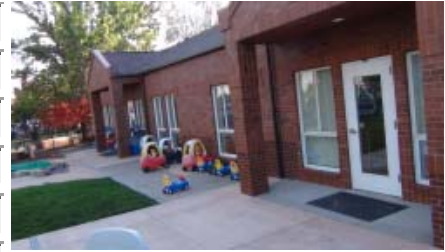
Field Date: 11/11/2015 Report Date: 12/1/2015 Barrier #: 26P
 Bldg Name: Child Care Center Reference Dwg: 3 of 3
 Location: Floor 1 - Infants Room 187
 X Coordinate: N/A Y Coordinate: N/A
 Barrier Area: Doors or Gates
 Barrier Type: Doormat
 Code: 2010 ADAS 302.2 & Advisory 302.2
 References:

Barrier Description: Doormat not anchored to floor

Rec. Solution: Secure exiting doormat or replace

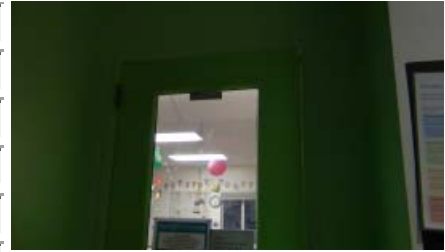
Barrier Description: Door/Gate at pull side with min. 60" lacks min. 18" strike edge clearance at pull side

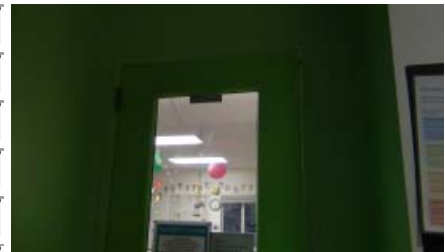
Field Date: 11/11/2015 Report Date: 12/1/2015 Barrier #: 27B
 Bldg Name: Child Care Center Reference Dwg: 3 of 3
 Location: Floor 1 - Infants Room 197
 X Coordinate: N/A Y Coordinate: N/A
 Barrier Area: Doors or Gates
 Barrier Type: Vision Lights - Existing
 Code: 2010 ADAS 404.2.11
 References:

Barrier Description: View panels in or adjacent to doors or gates not max. 43" above floor or ground

Rec. Solution: Replace door/gate or vision panel

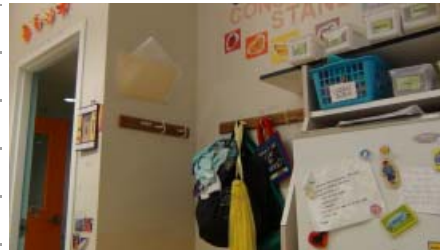
Field Date: 11/11/2015 Report Date: 12/1/2015 Barrier #: 27E
 Bldg Name: Child Care Center Reference Dwg: 3 of 3
 Location: Floor 1 - Infants Room 197
 X Coordinate: N/A Y Coordinate: N/A
 Barrier Area: Classrooms
 Barrier Type: Coat Hook - Height
 Code: 2010 ADAS 603.4
 References:

Barrier Description: Clothing hooks not max. 48" high AFF

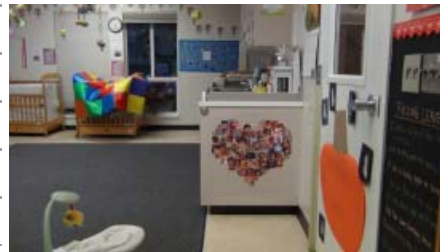
Field Date: 11/11/2015 Report Date: 12/1/2015 Barrier #: 27F
 Bldg Name: Child Care Center Reference Dwg: 3 of 3
 Location: Floor 1 - Infants Room 197
 X Coordinate: N/A Y Coordinate: N/A
 Barrier Area: Classrooms
 Barrier Type: Counter - Surface
 Code: 2010 ADAS 902
 References:

Barrier Description: Counter surface height exceeds 34" high

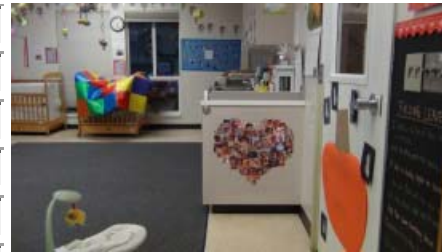
Field Date: 11/11/2015 Report Date: 12/1/2015 Barrier #: 27G
 Bldg Name: Child Care Center Reference Dwg: 3 of 3
 Location: Floor 1 - Infants Room 197
 X Coordinate: N/A Y Coordinate: N/A
 Barrier Area: Classrooms
 Barrier Type: Counter - Knee Clearance
 Code: 2010 ADAS 305.3
 References:

Barrier Description: Knee clearance not min. 27" high, 19" deep or 30" wide

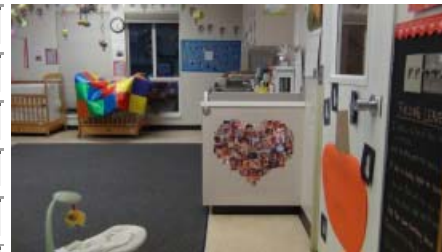
Field Date: 11/11/2015 Report Date: 12/1/2015 Barrier #: 27H
 Bldg Name: Child Care Center Reference Dwg: 3 of 3
 Location: Floor 1 - Infants Room 197
 X Coordinate: N/A Y Coordinate: N/A
 Barrier Area: Classrooms
 Barrier Type: Sink - Rim or Countertop
 Code: 2010 ADAS 606.3
 References:

Barrier Description: No accessible section of counter at max 34" high provided

Rec. Solution: Replace cabinet and remount sink

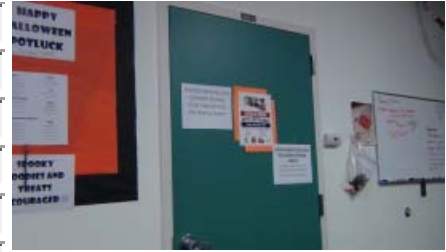
Barrier Description: Door opening force exceeds 5 lbf

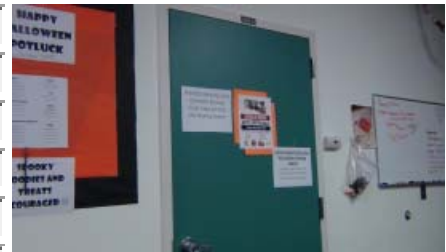
Barrier Description: Door closer lacks min. 5 second sweep period or does not stop 5" from door frame

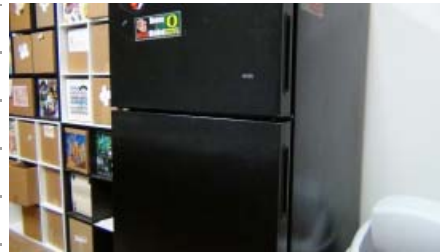
Barrier Description: Control or mechanism not usable with a closed fist

Rec. Solution: Replace refrigerator

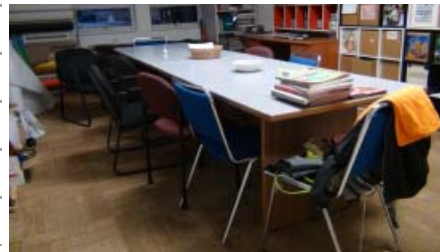
Field Date: 11/12/2015 Report Date: 12/1/2015 Barrier #: 28E
 Bldg Name: Child Care Center Reference Dwg: 3 of 3
 Location: Floor 1 - Break Room 148
 X Coordinate: N/A Y Coordinate: N/A
 Barrier Area: Counters and Tables
 Barrier Type: Table - Knee Clearance
 Code: 2010 ADAS 305.3
 References:

Barrier Description: Knee clearance not min. 27" high, 19" deep or 30" wide

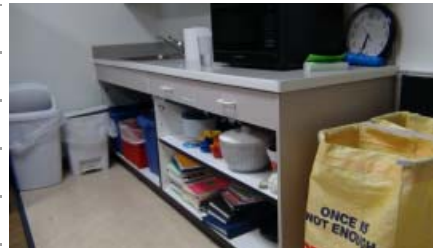
Field Date: 11/12/2015 Report Date: 12/1/2015 Barrier #: 28F
 Bldg Name: Child Care Center Reference Dwg: 3 of 3
 Location: Floor 1 - Break Room 148
 X Coordinate: N/A Y Coordinate: N/A
 Barrier Area: Kitchens
 Barrier Type: Countertop
 Code: 2010 ADAS 804.3
 References:

Barrier Description: No accessible section of counter at max 34" high provided

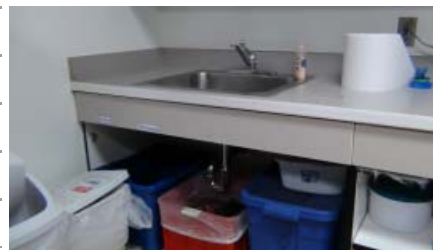
Field Date: 11/12/2015 Report Date: 12/1/2015 Barrier #: 28G
 Bldg Name: Child Care Center Reference Dwg: 3 of 3
 Location: Floor 1 - Break Room 148
 X Coordinate: N/A Y Coordinate: N/A
 Barrier Area: Kitchens
 Barrier Type: Sink - Rim
 Code: 2010 ADAS 606.3
 References:

Barrier Description: Sinks not mounted with the counter or rim no higher than 34" above the finish floor

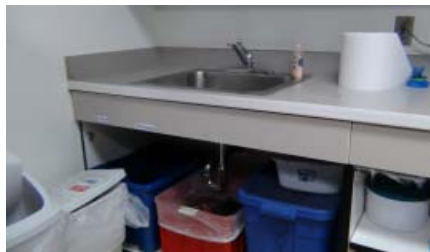
Barrier Description: Knee clearance of at least 27" high, 30" wide and 8" deep not provided

Rec. Solution: Replace cabinet and remount sink if needed

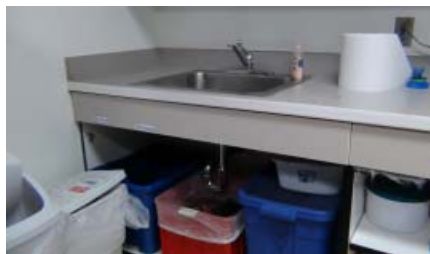
Barrier Description: Outlet located over an 10" to 24" obstruction max. 34" high located above 46"

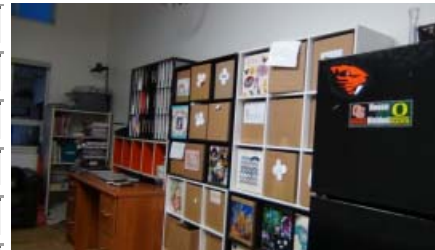
Barrier Description: Use of control involves low reach of less than 15" above floor or more than 48" high

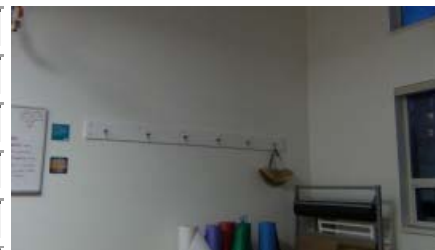
Field Date: 11/12/2015 Report Date 12/1/2015 Barrier #: 28K
 Bldg Name: Child Care Center Reference Dwg: 3 of 3
 Location: Floor 1 - Break Room 148
 X Coordinate: N/A Y Coordinate: N/A
 Barrier Area: Controls and Mechanisms
 Barrier Type: Coat Hook - Height
 Code 2010 ADAS 308.2
 References:

Barrier Description: Clothing hooks not max. 48" high AFF

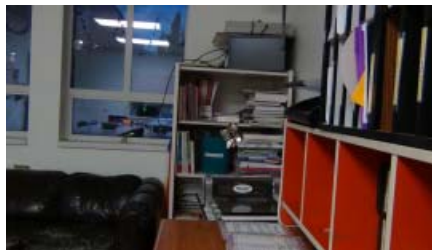
Barrier Description: Use of control involves low reach of less than 15" above floor or more than 48" high

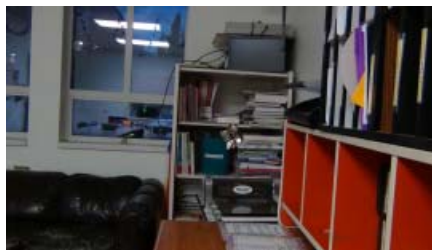
Barrier Description: Mailbox opening is above 48" high

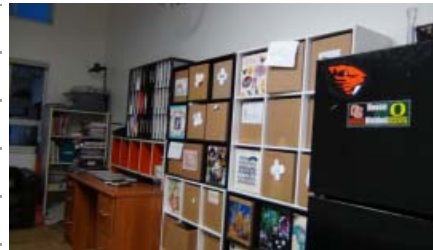
Field Date: 11/12/2015 Report Date: 12/1/2015 Barrier #: 28N
 Bldg Name: Child Care Center Reference Dwg: 3 of 3
 Location: Floor 1 - Break Room 148
 X Coordinate: N/A Y Coordinate: N/A
 Barrier Area: Alarms
 Barrier Type: Horn/Strobe - Common Use Area
 Code: 2010 ADAS 702.1
 References:

Barrier Description: No horn/strobes in common use areas

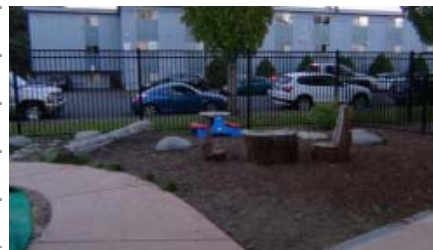
Field Date: 11/12/2015 Report Date: 12/1/2015 Barrier #: 29
 Bldg Name: Child Care Center Reference Dwg: 1 of 3
 Location: Exterior - East Playground
 X Coordinate: N/A Y Coordinate: N/A
 Barrier Area: Clear Floor Space
 Barrier Type: Abrupt Change in Level
 Code: 2010 ADAS 303.3
 References:

Barrier Description: Change in level greater than 1/2" in clear floor space

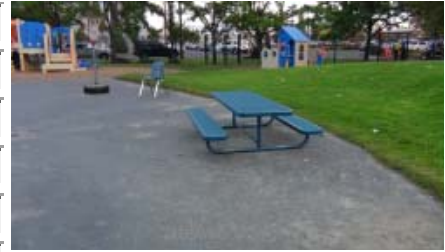
Field Date: 11/12/2015 Report Date: 12/1/2015 Barrier #: 30A
 Bldg Name: Child Care Center Reference Dwg: 1 of 3
 Location: Exterior - South Playground
 X Coordinate: N/A Y Coordinate: N/A
 Barrier Area: Counters and Tables
 Barrier Type: Table - Knee Clearance
 Code: 2010 ADAS 305.3
 References:

Barrier Description: Knee clearance not min. 27" high, 19" deep or 30" wide

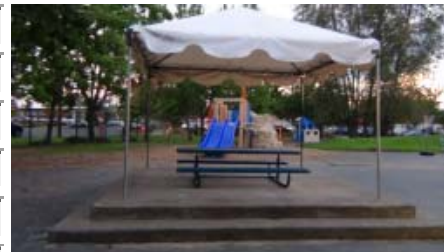
Field Date: 11/12/2015 Report Date: 12/1/2015 Barrier #: 30B
 Bldg Name: Child Care Center Reference Dwg: 1 of 3
 Location: Exterior - South Playground
 X Coordinate: N/A Y Coordinate: N/A
 Barrier Area: Counters and Tables
 Barrier Type: Table - Clear Floor Space
 Code: 2010 ADAS 305.3
 References:

Barrier Description: Clear floor space 30" x 48" not provided at table

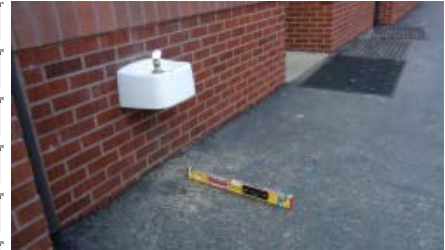
Field Date: 11/12/2015 Report Date: 12/1/2015 Barrier #: 30E
 Bldg Name: Child Care Center Reference Dwg: 1 of 3
 Location: Exterior - South Playground
 X Coordinate: N/A Y Coordinate: N/A
 Barrier Area: Drinking Fountains
 Barrier Type: Knee Clearance
 Code: 2010 ADAS 306.3
 References:

Barrier Description: Fountain allows only side approach

Rec. Solution: Replace fountain with accessible unit

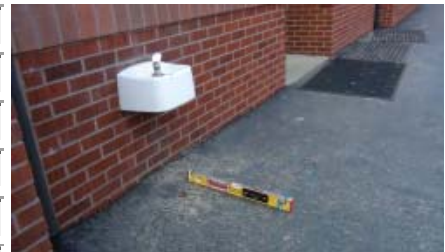
Field Date: 11/12/2015 Report Date: 12/1/2015 Barrier #: 30F
 Bldg Name: Child Care Center Reference Dwg: 1 of 3
 Location: Exterior - South Playground
 X Coordinate: N/A Y Coordinate: N/A
 Barrier Area: Drinking Fountains
 Barrier Type: Maneuvering Clearance
 Code: 2010 ADAS 602.2
 References:

Barrier Description: Level wheelchair space of min. 30" x 48" not located at fountain centered at 15"
