OREGON STATE UNIVERSITY (OSU)

CHILD CARE CENTER

ADA ASSESSMENT & SURVEY

Re: ADA Accessibility Survey and Assessment – Child Care Center

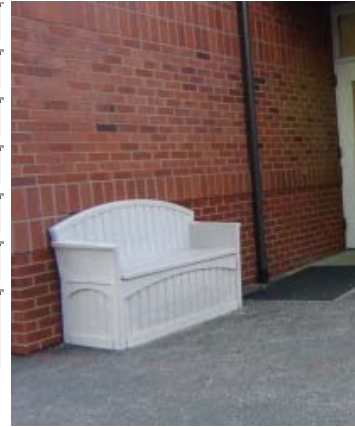
Field Date: 11/12/2015 Report Date: 12/1/2015 Barrier #: 30G
 Bldg Name: Child Care Center Reference Dwg: 1 of 3
 Location: Exterior - South Playground
 X Coordinate: N/A Y Coordinate: N/A
 Barrier Area: Corridors
 Barrier Type: Bench - Seat Height
 Code: 2010 ADAS 903.5
 References:

Barrier Description: Bench seat 17" to 19" above ground

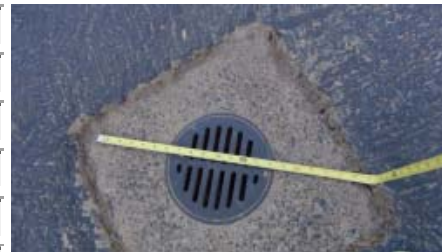
Barrier Description: Grate in pedestrian route has openings that exceed 1/2"

Rec. Solution: Replace grates

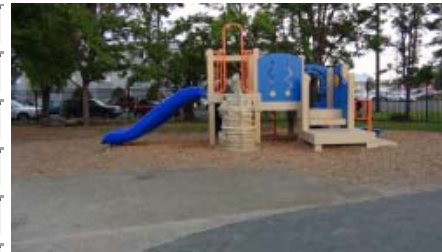
Field Date: 11/12/2015 Report Date: 12/1/2015 Barrier #: 301
 Bldg Name: Child Care Center Reference Dwg: 1 of 3
 Location: Exterior - South Playground
 X Coordinate: N/A Y Coordinate: N/A
 Barrier Area: Classrooms
 Barrier Type: Play Surface - Firm/Stable
 Code: 2010 ADAS 1008.2.6.1
 References:

Barrier Description: Play surface not firm, stable, and slip resistant

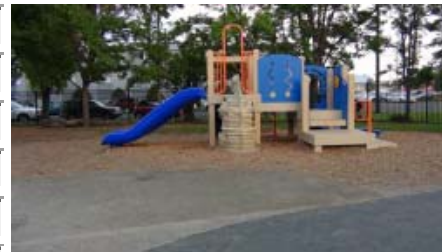
Field Date: 11/12/2015 Report Date: 12/1/2015 Barrier #: 30J
 Bldg Name: Child Care Center Reference Dwg: 1 of 3
 Location: Exterior - South Playground
 X Coordinate: N/A Y Coordinate: N/A
 Barrier Area: Classrooms
 Barrier Type: Play Surface - Use Zone
 Code: 2010 ADAS 1008.2.6.1.2
 References:

Barrier Description: Play surface not attenuated per ASTM 1951 to absorb a falling child (possible head trauma)

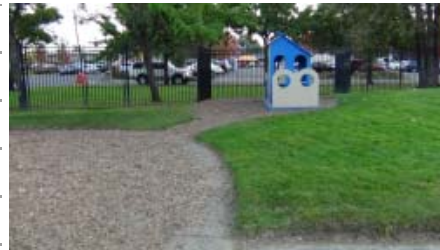
Field Date: 11/12/2015 Report Date: 12/1/2015 Barrier #: 30K
 Bldg Name: Child Care Center Reference Dwg: 1 of 3
 Location: Exterior - South Playground
 X Coordinate: N/A Y Coordinate: N/A
 Barrier Area: Classrooms
 Barrier Type: Play Surface - Firm/Stable
 Code: 2010 ADAS 1008.2.6.1
 References:

Barrier Description: Play surface not firm, stable, and slip resistant

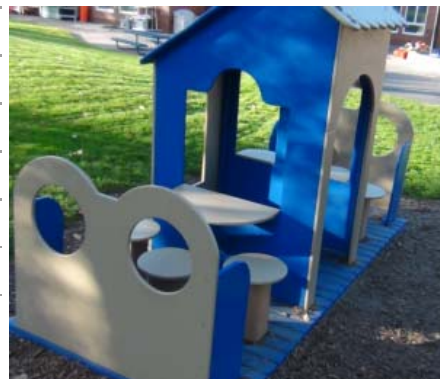
Field Date: 11/12/2015 Report Date: 12/1/2015 Barrier #: 30L
 Bldg Name: Child Care Center Reference Dwg: 1 of 3
 Location: Exterior - South Playground
 X Coordinate: N/A Y Coordinate: N/A
 Barrier Area: Classrooms
 Barrier Type: Play Table
 Code: 2010 ADAS 1008.4.3
 References:

Barrier Description: Play table knee clearance not min. 30" wide

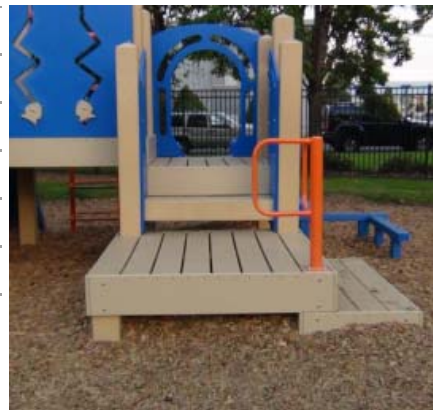
Field Date: 11/12/2015 Report Date: 12/1/2015 Barrier #: 30M
 Bldg Name: Child Care Center Reference Dwg: 1 of 3
 Location: Exterior - South Playground
 X Coordinate: N/A Y Coordinate: N/A
 Barrier Area: Classrooms
 Barrier Type: Transfer Support
 Code: 2010 ADAS 1008.3.1.1
 References:

Barrier Description: No means of transfer support (grip) provided at platform
