OREGON STATE UNIVERSITY (OSU)

PHARMACY BUILDING

ADA ASSESSMENT & SURVEY

Re: ADA Accessibility Survey and Assessment – Pharmacy Building

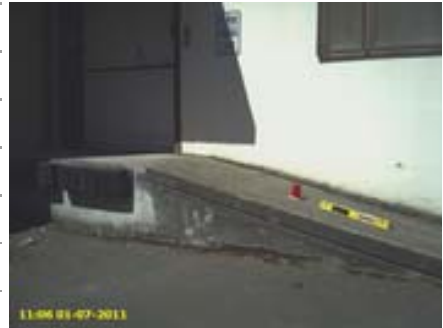
Field Date: 7/1/2011 Report Date: 7/1/2011 Barrier #: 468A
 Bldg Name: Pharmacy Building Reference Dwg: 1 of 6
 Location: Exterior - Northeast Entrance
 X Coordinate: 7479088.184 Y Coordinate: 340081.089
 Barrier Area: Ramps
 Barrier Type: Handrail
 Code: OSSC 1109.7.6 and 2010 ADAS 505.2
 References:

Performance Standard: No Quantity: LF As-built : 225

Barrier Description: No handrail provided at both sides

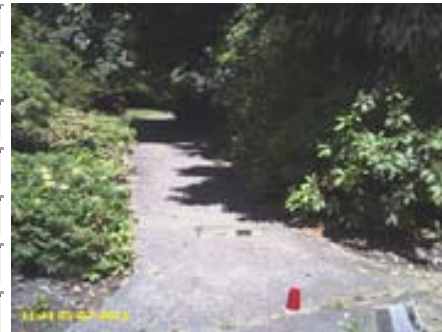
Field Date: 7/1/2011 Report Date: 7/1/2011 Barrier #: 477A
 Bldg Name: Pharmacy Building Reference Dwg: 1 of 6
 Location: Exterior - North Walkway
 X Coordinate: 7479121.853 Y Coordinate: 340137.049
 Barrier Area: Walkways
 Barrier Type: Cross Slope - Existing (5.0% or more)
 Code: OSSC 1103.2.4.3 and 2010 ADAS 403.3
 References:

Performance Standard: No Quantity: LF As-built : 45

Barrier Description: Cross slope exceeds 2.0% (5.0% or more)

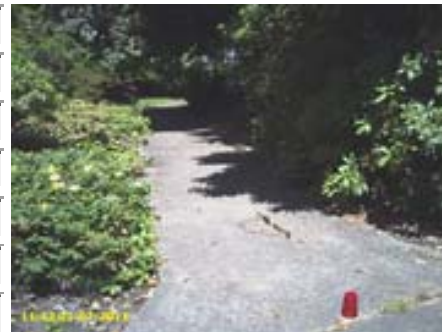
Field Date: 7/1/2011 Report Date: 7/1/2011 Barrier #: 477B
 Bldg Name: Pharmacy Building Reference Dwg: 1 of 6
 Location: Exterior - North Walkway
 X Coordinate: 7479122.161 Y Coordinate: 340137.771
 Barrier Area: Walkways
 Barrier Type: Running Slope - Existing (8.3% or more)
 Code: OSSC 1103.2.4.3 and 2010 ADAS 403.3
 References:

Performance Standard: No Quantity: LF As-built : 45

Barrier Description: Walkway running slope exceeds 5.0% (8.3% or more)

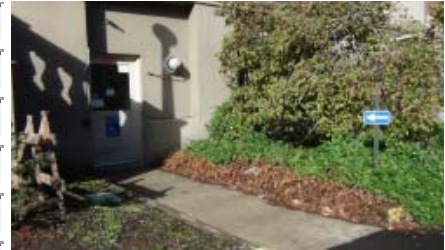
Field Date: 10/29/2015 Report Date 11/16/2015 Barrier #: 1A
 Bldg Name: Pharmacy Building Reference Dwg: 2 of 6
 Location: Floor 1 - Southeast Accessible Entrance
 X Coordinate: N/A Y Coordinate: N/A
 Barrier Area: Clear Floor Space
 Barrier Type: Accessible Route
 Code: 2010 ADAS 305
 References:

Performance Standard: No Quantity: JOB As-built : 1

Barrier Description: Clear floor space does not adjoin an accessible route or another space

Barrier Severity: 2 Recommended Cost Est \$175.00 Facility Function: Public Status: Open

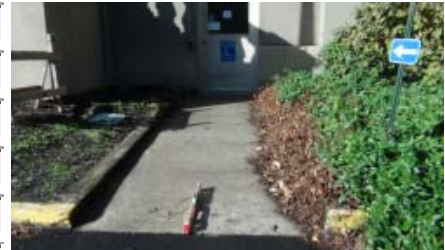
Field Date: 10/29/2015 Report Date 11/16/2015 Barrier #: 1B
 Bldg Name: Pharmacy Building Reference Dwg: 2 of 6
 Location: Floor 1 - Southeast Accessible Entrance
 X Coordinate: N/A Y Coordinate: N/A
 Barrier Area: Clear Floor Space
 Barrier Type: Floor Surface - Slope
 Code: 2010 ADAS 302 & 303
 References:

Performance Standard: No Quantity: SF As-built : 4

Barrier Description: Floor surface slope exceeds 2.0%

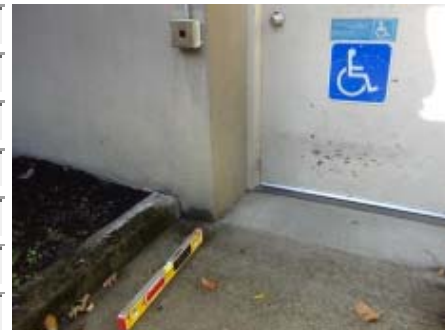
Barrier Description: Door/Gate threshold bevel at max 1/2" lip exceeds 1:2 or 50% slope

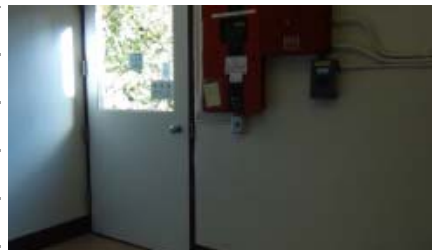
Field Date: 10/29/2015 Report Date 11/16/2015 Barrier #: 1G
 Bldg Name: Pharmacy Building Reference Dwg: 2 of 6
 Location: Floor 1 - Southeast Accessible Entrance
 X Coordinate: N/A Y Coordinate: N/A
 Barrier Area: Corridors
 Barrier Type: Protruding Object
 Code: 2010 ADAS 307
 References:

Barrier Description: Protruding object in in circulation path protrudes more than 4" between 27" and 80" high

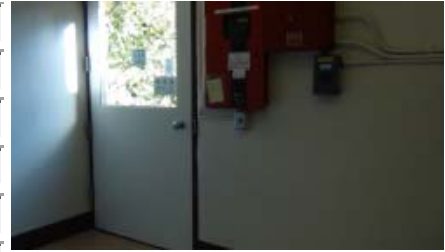
Barrier Description: ISA symbol at automatic door opening device not min. 4" x 4" in size

Rec. Solution: Recommended: Provide ISA symbol min. 4" x 4" in size

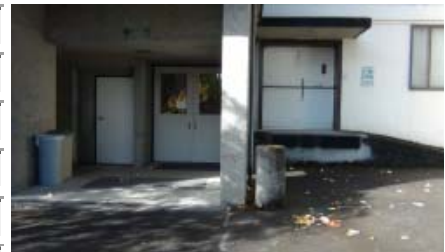
Field Date: 10/29/2015 Report Date 11/16/2015 Barrier #: 2A
 Bldg Name: Pharmacy Building Reference Dwg: 2 of 6
 Location: Floor 1 - Northeast Entrance
 X Coordinate: N/A Y Coordinate: N/A
 Barrier Area: Signage
 Barrier Type: ISA - Non-Accessible Entry
 Code: 2010 ADAS 216.6
 References:

Barrier Description: Sign directing people to accessible entrance needed where all doors are not accessible

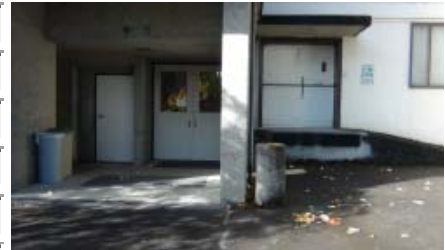
Field Date: 10/29/2015 Report Date 11/16/2015 Barrier #: 2C
 Bldg Name: Pharmacy Building Reference Dwg: 2 of 6
 Location: Floor 1 - Northeast Entrance
 X Coordinate: N/A Y Coordinate: N/A
 Barrier Area: Doors or Gates
 Barrier Type: Hardware - Operation
 Code 2010 ADAS 404.2.7
 References:

Barrier Description: Hardware not operable with a closed fist

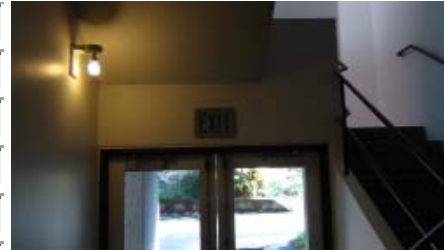
Barrier Description: Door opening force exceeds 5 lbf

Rec. Solution: Replace or adjust existing closer

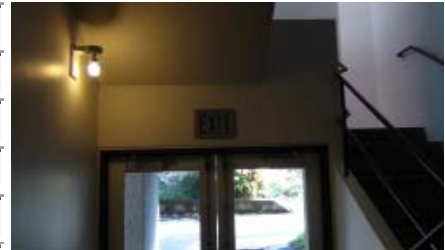
Barrier Description: Door closer lacks min. 5 second sweep period

Rec. Solution: Replace or adjust existing closer

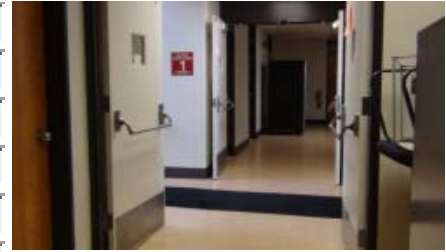
Barrier Description: No tactile characters at sign identifying permanent rooms and spaces with visual signs

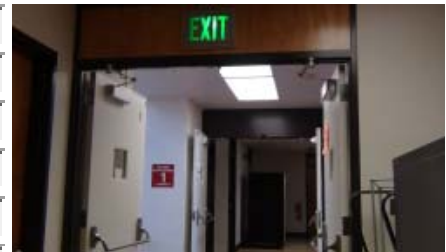
Field Date: 10/29/2015 Report Date 11/16/2015 Barrier #: 4B
 Bldg Name: Pharmacy Building Reference Dwg: 2 of 6
 Location: Floor 1 - Central Corridor
 X Coordinate: N/A Y Coordinate: N/A
 Barrier Area: Signage
 Barrier Type: Tactile Exit Signs - Door
 Code 2010 ADAS 216.4.1
 References:

Barrier Description: Ground floor doors that exit to exterior lacks tactile exit sign

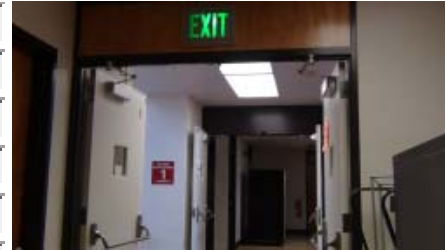
Field Date: 10/29/2015 Report Date 11/16/2015 Barrier #: 4C
 Bldg Name: Pharmacy Building Reference Dwg: 2 of 6
 Location: Floor 1 - Central Corridor
 X Coordinate: N/A Y Coordinate: N/A
 Barrier Area: Doors or Gates
 Barrier Type: Vision Lights - Existing
 Code 2010 ADAS 404.2.11
 References:

Barrier Description: View panels in or adjacent to doors or gates not max. 43" above floor or ground

Rec. Solution: Replace door/gate or vision panel

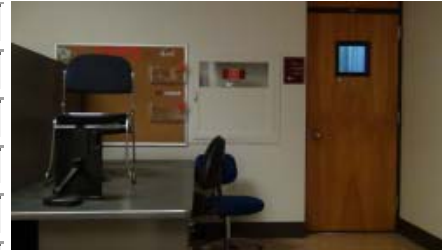
Field Date: 10/29/2015 Report Date: 11/16/2015 Barrier #: 4G
 Bldg Name: Pharmacy Building Reference Dwg: 2 of 6
 Location: Floor 1 - Central Corridor
 X Coordinate: N/A Y Coordinate: N/A
 Barrier Area: Alarms
 Barrier Type: Fire Extinguisher - Side Reach
 Code: 2010 ADAS 308.2.2
 References:

Barrier Description: Fire extinguisher forward or side reach exceeds 48"

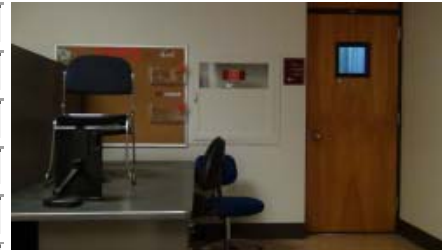
Barrier Description: Control or mechanism not at min. 15" or max. 48" high

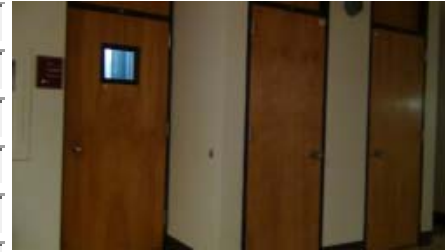
Field Date: 10/29/2015 Report Date 11/16/2015 Barrier #: 4I
 Bldg Name: Pharmacy Building Reference Dwg: 2 of 6
 Location: Floor 1 - Central Corridor
 X Coordinate: N/A Y Coordinate: N/A
 Barrier Area: Corridors
 Barrier Type: Strobe
 Code 2010 ADAS 702.1
 References:

Barrier Description: No strobe provided in corridor where horn is provided where fire alarm exists in building

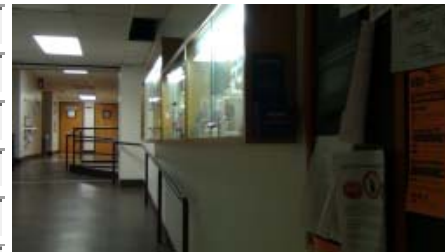
Field Date: 10/29/2015 Report Date 11/16/2015 Barrier #: 4J
 Bldg Name: Pharmacy Building Reference Dwg: 2 of 6
 Location: Floor 1 - Central Corridor
 X Coordinate: N/A Y Coordinate: N/A
 Barrier Area: Corridors
 Barrier Type: Protruding Object
 Code 2010 ADAS 307
 References:

Barrier Description: Protruding object in in circulation path protrudes more than 4" between 27" and 80" high

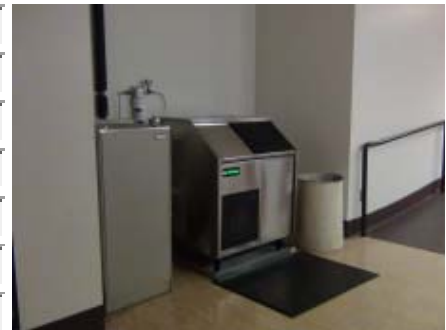
Field Date: 10/29/2015 Report Date: 11/16/2015 Barrier #: 4L
 Bldg Name: Pharmacy Building Reference Dwg: 2 of 6
 Location: Floor 1 - Central Corridor
 X Coordinate: N/A Y Coordinate: N/A
 Barrier Area: Drinking Fountains
 Barrier Type: Bubbler height
 Code: 2010 ADAS 602.4
 References:

Barrier Description: Bubbler height exceeds 36"

Rec. Solution: Replace drinking fountain with accessible unit or remount existing

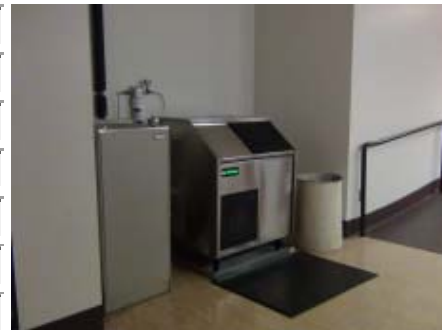
Field Date: 10/29/2015 Report Date 11/16/2015 Barrier #: 4N
 Bldg Name: Pharmacy Building Reference Dwg: 2 of 6
 Location: Floor 1 - Central Corridor
 X Coordinate: N/A Y Coordinate: N/A
 Barrier Area: Drinking Fountains
 Barrier Type: Hi-Low Unit
 Code: 2010 ADAS 211.2 & 602.7
 References:

Barrier Description: No hi-low drinking fountain provided in facility

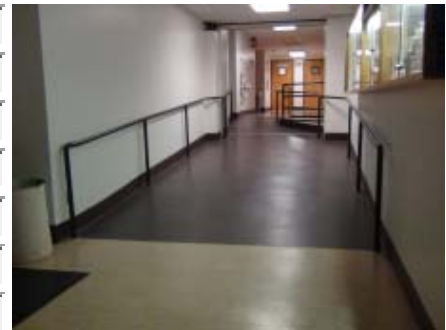
Field Date: 10/29/2015 Report Date 11/16/2015 Barrier #: 4P
 Bldg Name: Pharmacy Building Reference Dwg: 2 of 6
 Location: Floor 1 - Central Corridor
 X Coordinate: N/A Y Coordinate: N/A
 Barrier Area: Ramps
 Barrier Type: Edge Protection - Wheel Guides
 Code 2010 ADAS 405.9
 References:

A ramp provides access from one level of the corridor to the upper level. The ramp was identified with an excessive slope, no wheel guides at the bottom of the handrails and the surface of the ramp did not appear to be slip-resistant. Exit stairways located on the east and west sides of each floor were identified with heavy double doors at the stairway entries and no accessible handrails or guardrails, handrail extensions and grip height, as is common in historic structures with original handrails and guardrails. The ramp also caused a severe cross slope at the entrance door for one of the classrooms on the basement level. A sink where deionized water is available was also

Barrier Description: No wheel guides where the ramp surface is not bounded by a wall

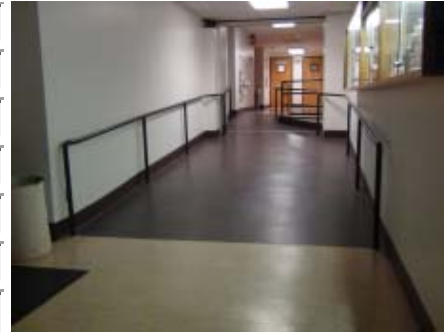
Field Date: 10/29/2015 Report Date 11/16/2015 Barrier #: 4Q
 Bldg Name: Pharmacy Building Reference Dwg: 2 of 6
 Location: Floor 1 - Central Corridor
 X Coordinate: N/A Y Coordinate: N/A
 Barrier Area: Ramps
 Barrier Type: Handrail Grip
 Code: 2010 ADAS 505.3
 References:

Barrier Description: Handrail grip is not continuous

Rec. Solution: Replace handrails at both sides of ramp

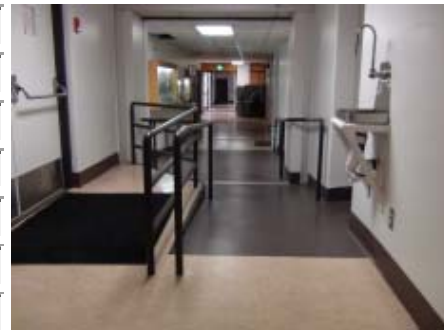
Barrier Description: Floor surface not slip-resistant

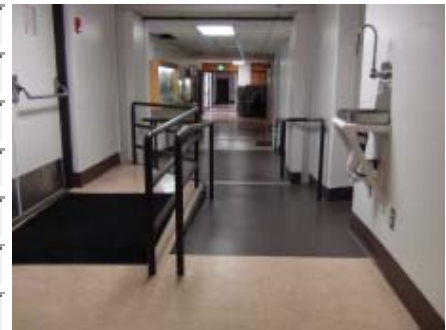
Field Date: 10/29/2015 Report Date 11/16/2015 Barrier #: 4T
 Bldg Name: Pharmacy Building Reference Dwg: 2 of 6
 Location: Floor 1 - Central Corridor
 X Coordinate: N/A Y Coordinate: N/A
 Barrier Area: Corridors
 Barrier Type: Protruding Object
 Code: 2010 ADAS 307
 References:

Barrier Description: Protruding object in in circulation path protrudes more than 4" between 27" and 80" high

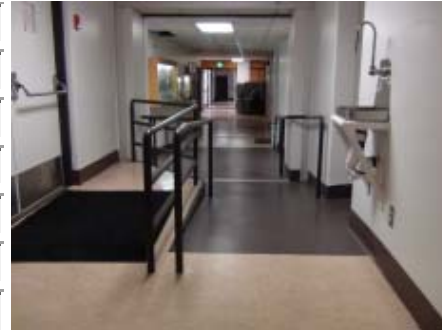
Field Date: 10/29/2015 Report Date 11/16/2015 Barrier #: 4U
 Bldg Name: Pharmacy Building Reference Dwg: 2 of 6
 Location: Floor 1 - Central Corridor
 X Coordinate: N/A Y Coordinate: N/A
 Barrier Area: Classrooms
 Barrier Type: Sink Faucet - Operation
 Code: 2010 ADAS 606.4 & 309
 References:

Barrier Description: Faucets lack controls and operating mechanisms involve tight grasping, pinching or twisting of the wrist

Rec. Solution: Replace faucet

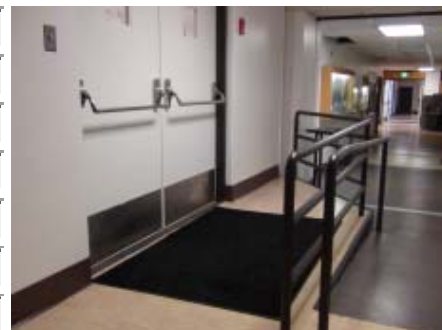
Field Date: 10/29/2015 Report Date 11/16/2015 Barrier #: 5A
 Bldg Name: Pharmacy Building Reference Dwg: 2 of 6
 Location: Floor 1 - Exit Stairway
 X Coordinate: N/A Y Coordinate: N/A
 Barrier Area: Doors or Gates
 Barrier Type: Vision Lights - Existing
 Code: 2010 ADAS 404.2.11
 References:

Barrier Description: View panels in or adjacent to doors or gates not max. 43" above floor or ground

Rec. Solution: Replace door/gate or vision panel

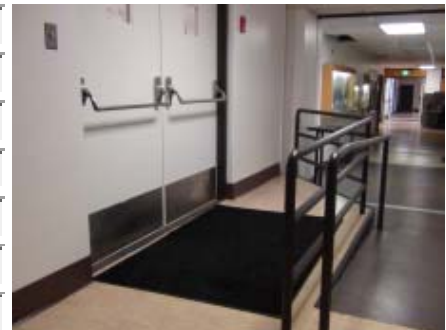
Barrier Description: Door closer lacks min. 5 second sweep period or does not stop 5" from door frame

Rec. Solution: Replace or adjust existing closer

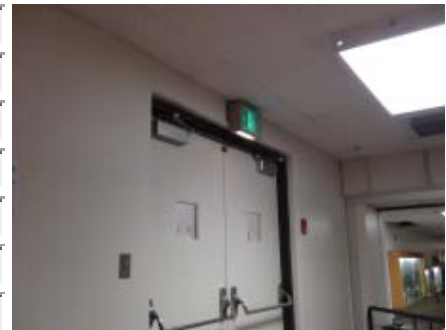
Field Date: 10/29/2015 Report Date 11/16/2015 Barrier #: 5E
 Bldg Name: Pharmacy Building Reference Dwg: 2 of 6
 Location: Floor 1 - Exit Stairway
 X Coordinate: N/A Y Coordinate: N/A
 Barrier Area: Signage
 Barrier Type: Tactile Exit Signs - Stairway
 Code: Performance Standard
 References:

Barrier Description: Door leading directly into an exit stairway lacks tactile exit sign

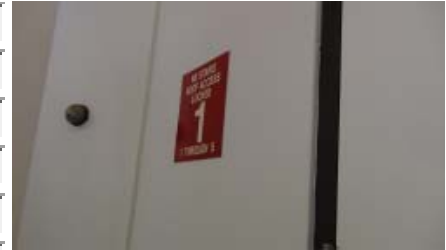
Field Date: 10/29/2015 Report Date 11/16/2015 Barrier #: 5F
 Bldg Name: Pharmacy Building Reference Dwg: 2 of 6
 Location: Floor 1 - Exit Stairway
 X Coordinate: N/A Y Coordinate: N/A
 Barrier Area: Stairways
 Barrier Type: Sign - Enclosed Exit Stairway Discharge
 Code: ICC A117.1
 References:

Barrier Description: Tactile stairway signage not provided to indicate stair level or discharge level

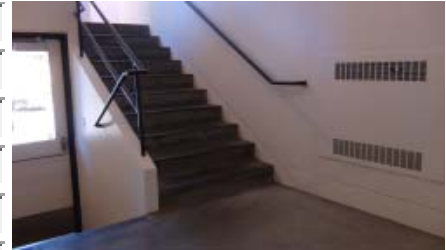
Field Date: 10/29/2015 Report Date 11/16/2015 Barrier #: 5H
 Bldg Name: Pharmacy Building Reference Dwg: 2 of 6
 Location: Floor 1 - Exit Stairway
 X Coordinate: N/A Y Coordinate: N/A
 Barrier Area: Stairways
 Barrier Type: Handrail Extension - Top
 Code: 2010 ADAS 505.10.2
 References:

Barrier Description: Extension does not extend horizontally above landing for min. 12" from first riser nosing

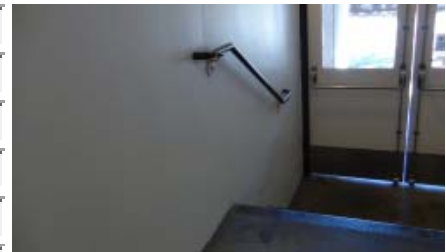
Field Date: 10/29/2015 Report Date 11/16/2015 Barrier #: 5I
 Bldg Name: Pharmacy Building Reference Dwg: 2 of 6
 Location: Floor 1 - Exit Stairway
 X Coordinate: N/A Y Coordinate: N/A
 Barrier Area: Stairways
 Barrier Type: Handrail Extension - Top
 Code: 2010 ADAS 505.10.2
 References:

Barrier Description: Extension does not extend horizontally above landing for min. 12" from first riser nosing

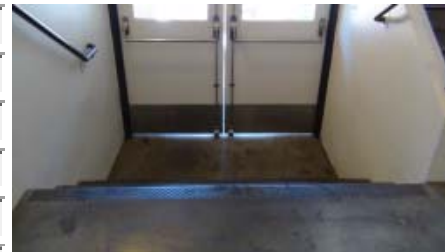
Field Date: 10/29/2015 Report Date 11/16/2015 Barrier #: 5K
 Bldg Name: Pharmacy Building Reference Dwg: 2 of 6
 Location: Floor 1 - Exit Stairway
 X Coordinate: N/A Y Coordinate: N/A
 Barrier Area: Stairways
 Barrier Type: Contrasting Color - ADA
 Code: 2010 ADAS Advisory 504.4
 References:

Barrier Description: No contrasting color on each tread of interior stairway

Rec. Solution: Recommended: Consider providing contrasting color on each tread

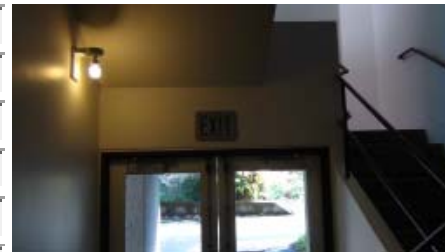
Field Date: 10/29/2015 Report Date: 11/16/2015 Barrier #: 5M
 Bldg Name: Pharmacy Building Reference Dwg: 2 of 6
 Location: Floor 1 - Exit Stairway
 X Coordinate: N/A Y Coordinate: N/A
 Barrier Area: Alarms
 Barrier Type: Horn/Strobe - Common Use Area
 Code: 2010 ADAS 702.1
 References:

Barrier Description: No horn/strobes in common use areas

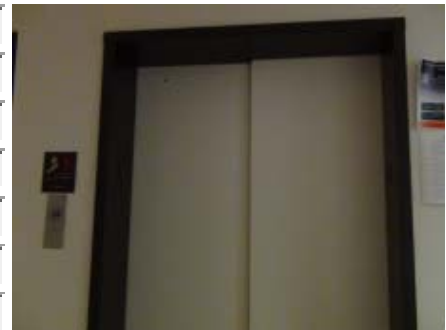
Field Date: 10/29/2015 Report Date 11/16/2015 Barrier #: 6B
 Bldg Name: Pharmacy Building Reference Dwg: 2 of 6
 Location: Floor 1 - Elevator
 X Coordinate: N/A Y Coordinate: N/A
 Barrier Area: Signage
 Barrier Type: Evacuation Plan
 Code: Performance Standard
 References:

Barrier Description: No evacuation plan provided

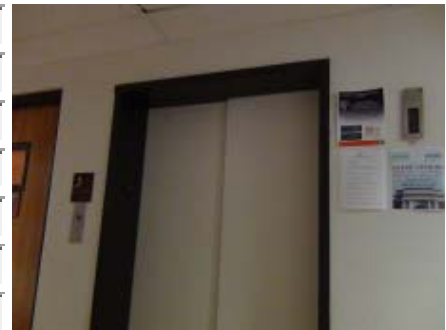
Field Date: 10/29/2015 Report Date 11/16/2015 Barrier #: 6D
 Bldg Name: Pharmacy Building Reference Dwg: 2 of 6
 Location: Floor 1 - Elevator
 X Coordinate: N/A Y Coordinate: N/A
 Barrier Area: Elevators
 Barrier Type: Hall Call Buttons - Registration
 Code: 2010 ADAS 407.2.1.5
 References:

Barrier Description: Visual indication not provided to show each call registered and extinguished when answered

Rec. Solution: Replace hall call buttons

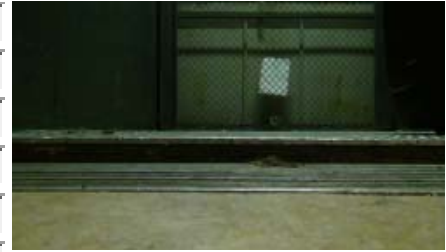
Field Date: 10/29/2015 Report Date 11/16/2015 Barrier #: 6E
 Bldg Name: Pharmacy Building Reference Dwg: 2 of 6
 Location: Floor 1 - Elevator
 X Coordinate: N/A Y Coordinate: N/A
 Barrier Area: Elevators
 Barrier Type: Threshold
 Code 2010 ADAS 407.4.4
 References:

Barrier Description: Elevator car landing is not level with entry. (Overtravel or undertravel identified)

Rec. Solution: Adjust to maintain car in level condition within 1/2" of the landing, irrespective of load.

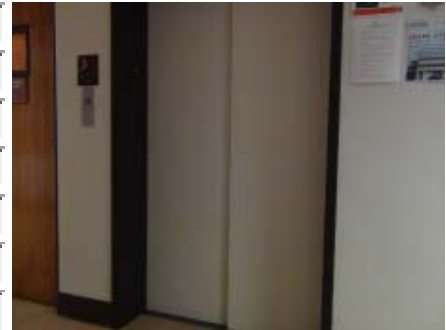
Field Date: 10/29/2015 Report Date 11/16/2015 Barrier #: 6F
 Bldg Name: Pharmacy Building Reference Dwg: 2 of 6
 Location: Floor 1 - Elevator
 X Coordinate: N/A Y Coordinate: N/A
 Barrier Area: Elevators
 Barrier Type: Door Delay Duration
 Code 2010 ADAS 407.3.3.3
 References:

Barrier Description: Door reopening devices does not remain effective for 20 seconds minimum

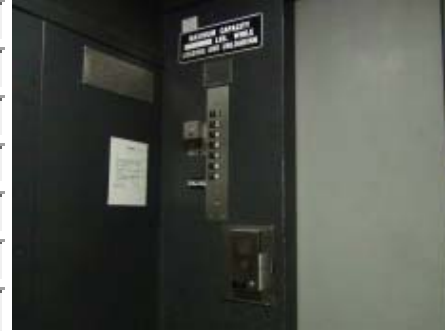
Field Date: 10/29/2015 Report Date 11/16/2015 Barrier #: 6G
 Bldg Name: Pharmacy Building Reference Dwg: 2 of 6
 Location: Floor 1 - Elevator
 X Coordinate: N/A Y Coordinate: N/A
 Barrier Area: Elevators
 Barrier Type: Handrails - None Provided
 Code Performance Standard
 References:

Barrier Description: No handrail provided within elevator car

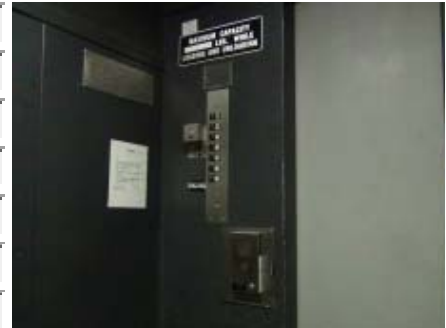
Field Date: 10/29/2015 Report Date 11/16/2015 Barrier #: 6H
 Bldg Name: Pharmacy Building Reference Dwg: 2 of 6
 Location: Floor 1 - Elevator
 X Coordinate: N/A Y Coordinate: N/A
 Barrier Area: Elevators
 Barrier Type: Car Control Buttons - Location
 Code 2010 ADAS 407.4.6.1 & 409.4.6
 References:

Barrier Description: Car control buttons located above 48" from finish floor measured at the centerline

Rec. Solution: Replace control panel

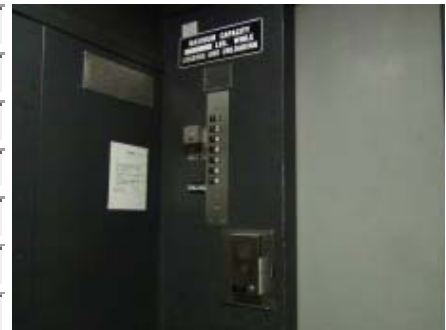
Field Date: 10/29/2015 Report Date 11/16/2015 Barrier #: 6J
 Bldg Name: Pharmacy Building Reference Dwg: 2 of 6
 Location: Floor 1 - Elevator
 X Coordinate: N/A Y Coordinate: N/A
 Barrier Area: Elevators
 Barrier Type: Emergency Controls
 Code: 2010 ADAS 407.4.6.4.1
 References:

Barrier Description: Emergency controls (incl. emergency stop and alarm) are located below 35"

Rec. Solution: Replace emergency controls

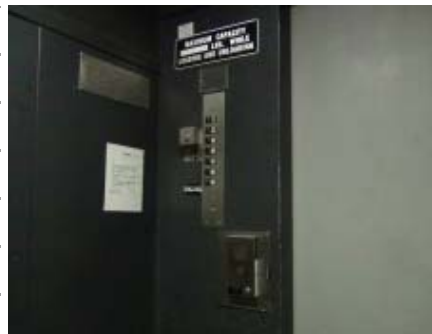
Field Date: 10/29/2015 Report Date 11/16/2015 Barrier #: 6K
 Bldg Name: Pharmacy Building Reference Dwg: 2 of 6
 Location: Floor 1 - Elevator
 X Coordinate: N/A Y Coordinate: N/A
 Barrier Area: Elevators
 Barrier Type: Emergency Controls - 2-way
 Code: 2010 ADAS 407.4.9 & ASME A17.1
 References:

Barrier Description: Emergency two-way communication system not provided

Rec. Solution: Replace emergency system

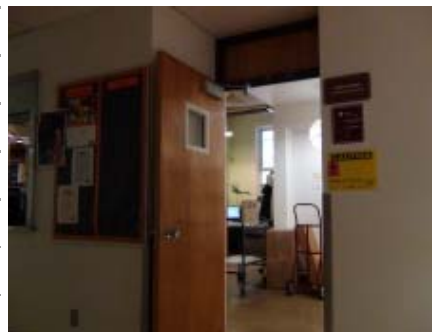
Barrier Description: No tactile characters at sign identifying permanent rooms and spaces with visual signs

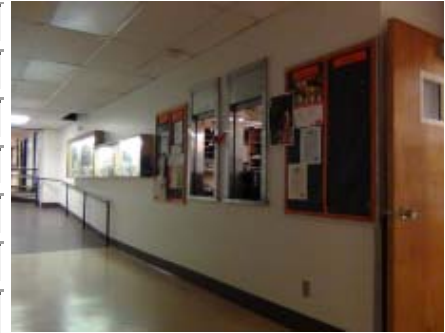
Barrier Description: No section at least 3 feet long between 28" and 34" provided at existing counter

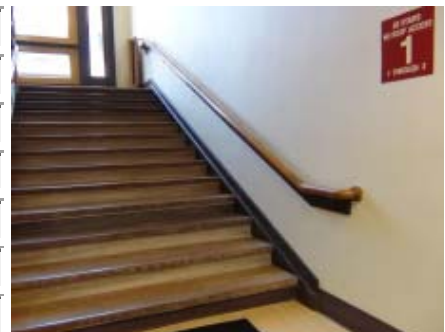
Field Date: 10/30/2015 Report Date 11/16/2015 Barrier #: 8A
 Bldg Name: Pharmacy Building Reference Dwg: 2 of 6
 Location: Floor 1 - East Stairway
 X Coordinate: N/A Y Coordinate: N/A
 Barrier Area: Stairways
 Barrier Type: Sign - Enclosed Exit Stairway Level
 Code: ICC A117.1
 References:

Barrier Description: Tactile stairway signage not provided to indicate floor level

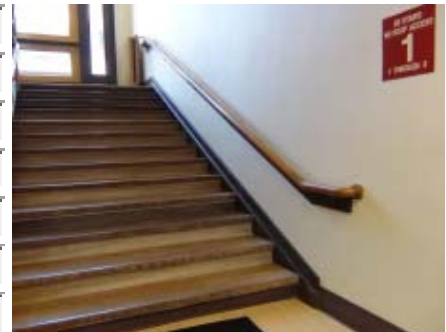
Field Date: 10/30/2015 Report Date: 11/16/2015 Barrier #: 8C
 Bldg Name: Pharmacy Building Reference Dwg: 2 of 6
 Location: Floor 1 - East Stairway
 X Coordinate: N/A Y Coordinate: N/A
 Barrier Area: Stairways
 Barrier Type: Contrasting Color - ADA
 Code: 2010 ADAS Advisory 504.4
 References:

Barrier Description: No contrasting color on each tread of interior stairway

Rec. Solution: Recommended: Consider providing contrasting color on each tread

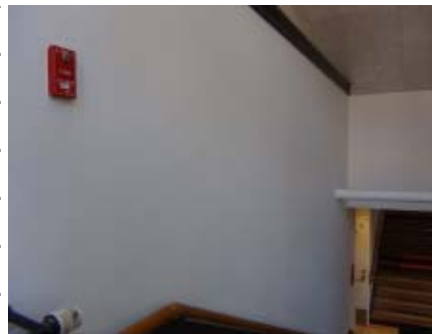
Field Date: 10/30/2015 Report Date: 11/16/2015 Barrier #: 8D
 Bldg Name: Pharmacy Building Reference Dwg: 2 of 6
 Location: Floor 1 - East Stairway
 X Coordinate: N/A Y Coordinate: N/A
 Barrier Area: Alarms
 Barrier Type: Fire Pull - Height
 Code: 2010 ADAS 308.2.2
 References:

Barrier Description: Fire pulls not between 42" and 48" high

Rec. Solution: Replace fire pull when remodeling

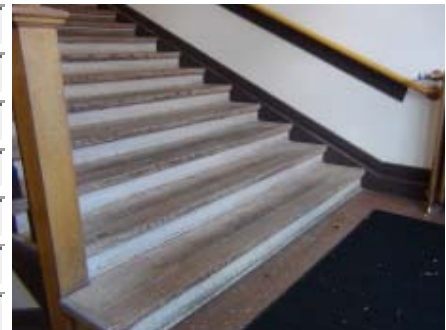
Field Date: 10/30/2015 Report Date 11/16/2015 Barrier #: 8I
 Bldg Name: Pharmacy Building Reference Dwg: 2 of 6
 Location: Floor 1 - East Stairway
 X Coordinate: N/A Y Coordinate: N/A
 Barrier Area: Stairways
 Barrier Type: Handrail Extension
 Code: 2010 ADAS 505.10.2
 References:

Barrier Description: Handrail extension does not return to wall, guard or landing surface

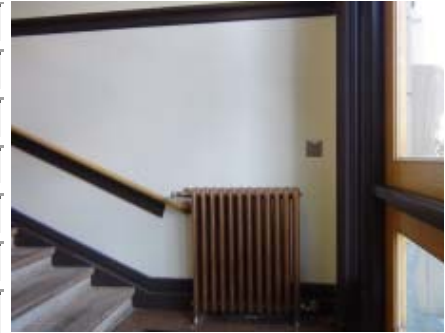
Field Date: 10/30/2015 Report Date: 11/16/2015 Barrier #: 8J
 Bldg Name: Pharmacy Building Reference Dwg: 2 of 6
 Location: Floor 1 - East Stairway
 X Coordinate: N/A Y Coordinate: N/A
 Barrier Area: Stairways
 Barrier Type: Handrail Height
 Code: 2010 ADAS 505.10.2
 References:

Barrier Description: Handrail grip measured at center not 34"- 38" high

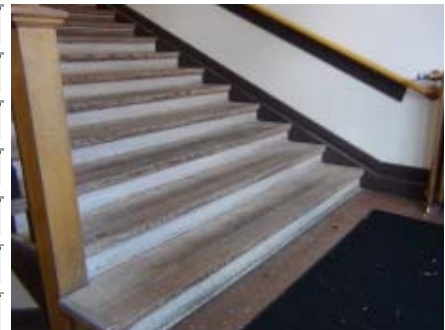
Field Date: 10/30/2015 Report Date: 11/16/2015 Barrier #: 8K
 Bldg Name: Pharmacy Building Reference Dwg: 2 of 6
 Location: Floor 1 - East Stairway
 X Coordinate: N/A Y Coordinate: N/A
 Barrier Area: Stairways
 Barrier Type: Riser Height - Existing
 Code: 2010 ADAS 504.2
 References:

Barrier Description: Stair riser height or tread width is not consistent

Rec. Solution: No remediation recommended in historic structure

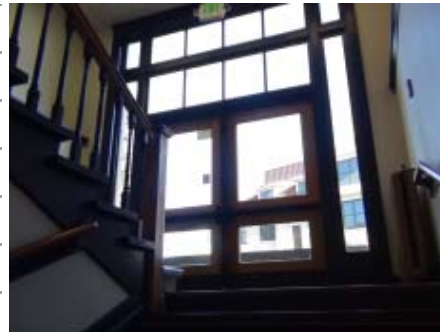
Field Date: 10/30/2015 Report Date 11/16/2015 Barrier #: 8L
 Bldg Name: Pharmacy Building Reference Dwg: 2 of 6
 Location: Floor 1 - East Stairway
 X Coordinate: N/A Y Coordinate: N/A
 Barrier Area: Stairways
 Barrier Type: Sign - Enclosed Exit Stairway Door
 Code: 2010 ADAS 216.4.1
 References:

Barrier Description: Door leading directly into an exit stairway lacks tactile exit sign

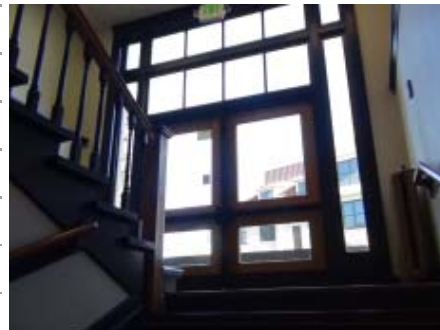
Field Date: 10/30/2015 Report Date 11/16/2015 Barrier #: 8M
 Bldg Name: Pharmacy Building Reference Dwg: 2 of 6
 Location: Floor 1 - East Stairway
 X Coordinate: N/A Y Coordinate: N/A
 Barrier Area: Alarms
 Barrier Type: Horn/Strobe - Common Use Area
 Code: 2010 ADAS 702.1
 References:

Barrier Description: No horn/strobes in common use areas

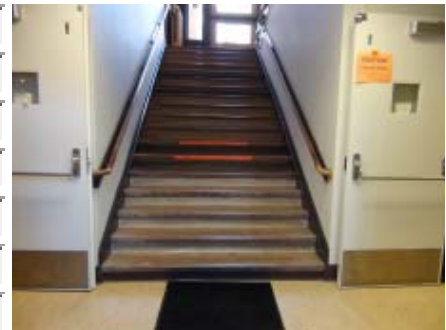
Field Date: 10/30/2015 Report Date 11/16/2015 Barrier #: 9B
 Bldg Name: Pharmacy Building Reference Dwg: 2 of 6
 Location: Floor 1 - West Stairway
 X Coordinate: N/A Y Coordinate: N/A
 Barrier Area: Stairways
 Barrier Type: Sign - Enclosed Exit Stairway Discharge
 Code: ICC A117.1
 References:

Barrier Description: Tactile stairway signage not provided to indicate stair level or discharge level

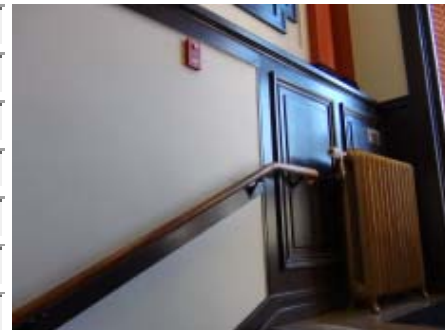
Field Date: 10/30/2015 Report Date 11/16/2015 Barrier #: 9D
 Bldg Name: Pharmacy Building Reference Dwg: 2 of 6
 Location: Floor 1 - West Stairway
 X Coordinate: N/A Y Coordinate: N/A
 Barrier Area: Alarms
 Barrier Type: Fire Pull - Accessible Route
 Code: 2010 ADAS 308.2.2
 References:

Barrier Description: Fire pull not on accessible route

Rec. Solution: Replace fire pull when remodeling

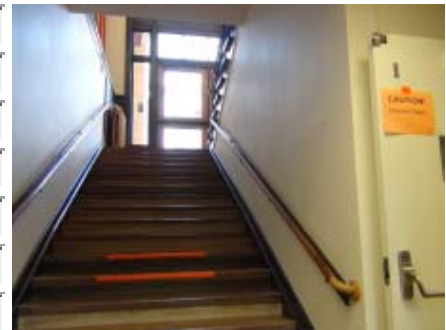
Field Date: 10/30/2015 Report Date 11/16/2015 Barrier #: 9F
 Bldg Name: Pharmacy Building Reference Dwg: 2 of 6
 Location: Floor 1 - West Stairway
 X Coordinate: N/A Y Coordinate: N/A
 Barrier Area: Stairways
 Barrier Type: Handrail Height
 Code: 2010 ADAS 505.10.2
 References:

Barrier Description: Handrail grip measured at center not 34"- 38" high

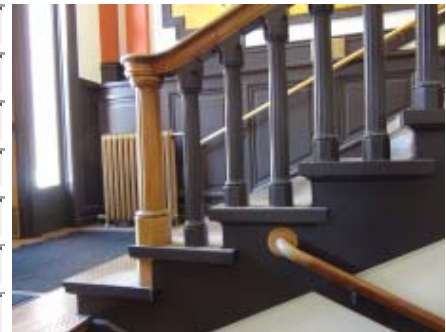
Field Date: 10/30/2015 Report Date: 11/16/2015 Barrier #: 9H
 Bldg Name: Pharmacy Building Reference Dwg: 2 of 6
 Location: Floor 1 - West Stairway
 X Coordinate: N/A Y Coordinate: N/A
 Barrier Area: Stairways
 Barrier Type: Handrail - Both Sides
 Code: ADAAG 4.9.4* & 2010 ADAS 505.10.2
 References:

Barrier Description: No handrail provided at both sides of stairway

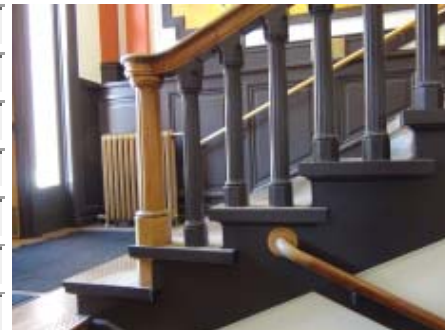
Field Date: 10/30/2015 Report Date 11/16/2015 Barrier #: 9J
 Bldg Name: Pharmacy Building Reference Dwg: 2 of 6
 Location: Floor 1 - West Stairway
 X Coordinate: N/A Y Coordinate: N/A
 Barrier Area: Stairways
 Barrier Type: Handrail Height
 Code: 2010 ADAS 505.10.2
 References:

Barrier Description: Handrail grip measured at center not 34"- 38" high

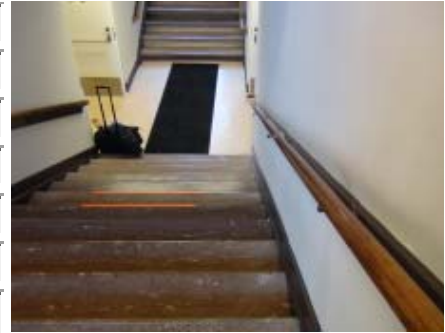
Field Date: 10/30/2015 Report Date 11/16/2015 Barrier #: 9K
 Bldg Name: Pharmacy Building Reference Dwg: 2 of 6
 Location: Floor 1 - West Stairway
 X Coordinate: N/A Y Coordinate: N/A
 Barrier Area: Stairways
 Barrier Type: Riser Height - Existing
 Code: 2010 ADAS 504.2
 References:

Barrier Description: Stair riser height or tread width is not consistent

Rec. Solution: No remediation recommended in historic structure

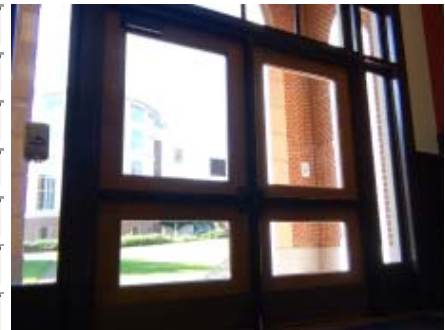
Field Date: 10/30/2015 Report Date 11/16/2015 Barrier #: 9L
 Bldg Name: Pharmacy Building Reference Dwg: 2 of 6
 Location: Floor 1 - West Stairway
 X Coordinate: N/A Y Coordinate: N/A
 Barrier Area: Stairways
 Barrier Type: Sign - Enclosed Exit Stairway Door
 Code: 2010 ADAS 216.4.1
 References:

Barrier Description: Door leading directly into an exit stairway lacks tactile exit sign

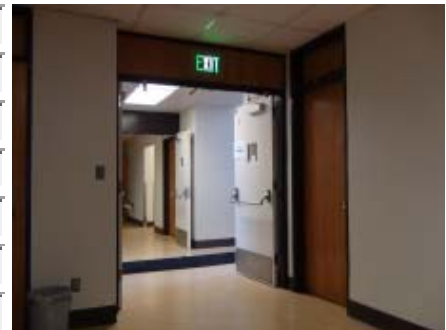
Field Date: 10/30/2015 Report Date 11/16/2015 Barrier #: 10B
 Bldg Name: Pharmacy Building Reference Dwg: 2 of 6
 Location: Floor 1 - Southeast Corridor
 X Coordinate: N/A Y Coordinate: N/A
 Barrier Area: Doors or Gates
 Barrier Type: Vision Lights - Existing
 Code: 2010 ADAS 404.2.11
 References:

Barrier Description: View panels in or adjacent to doors or gates not max. 43" above floor or ground

Rec. Solution: Replace door/gate or vision panel

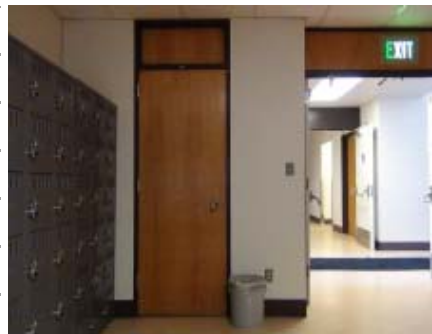
Barrier Description: Light switch control box top edge not at max. 48" high

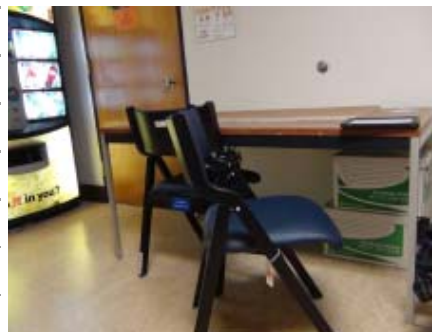
Field Date: 10/30/2015 Report Date: 11/16/2015 Barrier #: 10F
 Bldg Name: Pharmacy Building Reference Dwg: 2 of 6
 Location: Floor 1 - Southeast Corridor
 X Coordinate: N/A Y Coordinate: N/A
 Barrier Area: Counters and Tables
 Barrier Type: Table - Knee Clearance
 Code: 2010 ADAS 305.3
 References:

Barrier Description: Knee clearance not min. 27" high, 19" deep or 30" wide

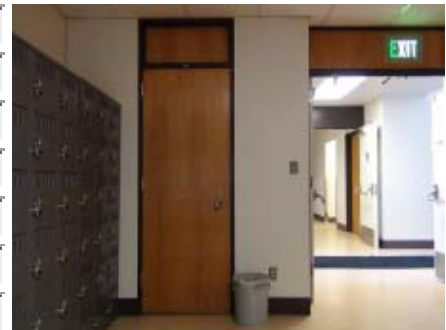
Field Date: 10/30/2015 Report Date 11/16/2015 Barrier #: 10H
 Bldg Name: Pharmacy Building Reference Dwg: 2 of 6
 Location: Floor 1 - Southeast Corridor
 X Coordinate: N/A Y Coordinate: N/A
 Barrier Area: Corridors
 Barrier Type: Strobe
 Code 2010 ADAS 702.1
 References:

Barrier Description: No strobe provided in corridor where horn is provided where fire alarm exists in building

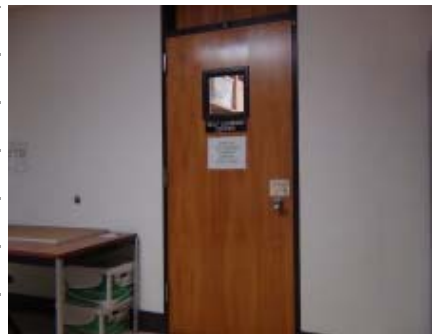
Field Date: 10/30/2015 Report Date 11/16/2015 Barrier #: 11A
 Bldg Name: Pharmacy Building Reference Dwg: 2 of 6
 Location: Floor 1 - Self-learning Lounge 101
 X Coordinate: N/A Y Coordinate: N/A
 Barrier Area: Signage
 Barrier Type: Permanent Room/Space - Tactile Characters
 Code 2010 ADAS 216.2
 References:

Barrier Description: No tactile characters at sign identifying permanent rooms and spaces with visual signs

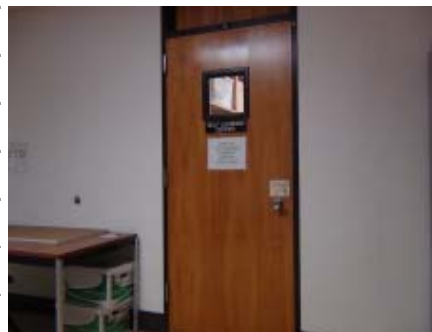
Field Date: 10/30/2015 Report Date 11/16/2015 Barrier #: 11B
 Bldg Name: Pharmacy Building Reference Dwg: 2 of 6
 Location: Floor 1 - Self-learning Lounge 101
 X Coordinate: N/A Y Coordinate: N/A
 Barrier Area: Doors or Gates
 Barrier Type: Vision Lights - Existing
 Code 2010 ADAS 404.2.11
 References:

Barrier Description: View panels in or adjacent to doors or gates not max. 43" above floor or ground

Rec. Solution: Replace door/gate or vision panel

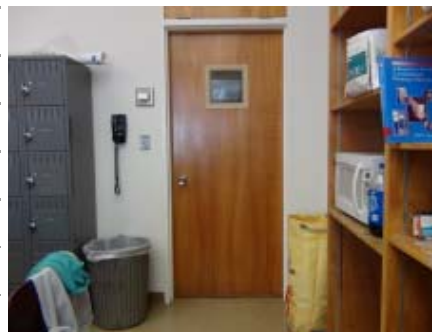
Field Date: 10/30/2015 Report Date 11/16/2015 Barrier #: 11D
 Bldg Name: Pharmacy Building Reference Dwg: 2 of 6
 Location: Floor 1 - Self-learning Lounge 101
 X Coordinate: N/A Y Coordinate: N/A
 Barrier Area: Doors or Gates
 Barrier Type: Front App/push 12" SEC
 Code: 2010 ADAS Figure 404.2.4.1
 References:

Barrier Description: Door/Gate at push side with min. 48" lacks min. 12" strike edge clearance with latch/closer

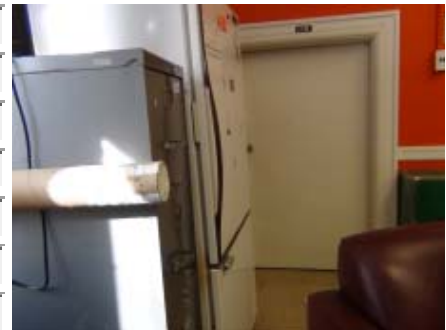
Field Date: 10/30/2015 Report Date: 11/16/2015 Barrier #: 11F
 Bldg Name: Pharmacy Building Reference Dwg: 2 of 6
 Location: Floor 1 - Self-learning Lounge 101
 X Coordinate: N/A Y Coordinate: N/A
 Barrier Area: Controls and Mechanisms
 Barrier Type: Clear Floor Space - Stored Elements
 Code: 2010 ADAS 305.3
 References:

Barrier Description: Clear floor space for wheelchair not provided at control or mechanism

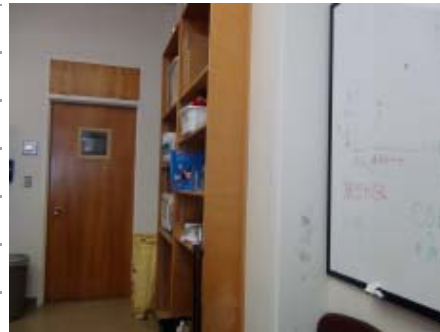
Field Date: 10/30/2015 Report Date 11/16/2015 Barrier #: 11G
 Bldg Name: Pharmacy Building Reference Dwg: 2 of 6
 Location: Floor 1 - Self-learning Lounge 101
 X Coordinate: N/A Y Coordinate: N/A
 Barrier Area: Classrooms
 Barrier Type: Shelves or Cabinets
 Code: 2010 ADAS 603.4
 References:

Barrier Description: Shelf or cabinet not mounted between 40" and 48" above floor or ground

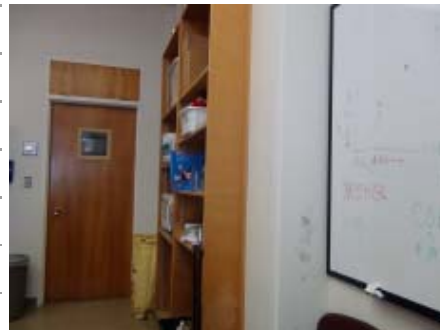
Field Date: 10/30/2015 Report Date 11/16/2015 Barrier #: 11H
 Bldg Name: Pharmacy Building Reference Dwg: 2 of 6
 Location: Floor 1 - Self-learning Lounge 101
 X Coordinate: N/A Y Coordinate: N/A
 Barrier Area: Classrooms
 Barrier Type: Electrical Switches - High Unobstructed
 Code: 2010 ADAS 308.2.1
 References:

Barrier Description: Light switch control box top edge not at max. 48" high

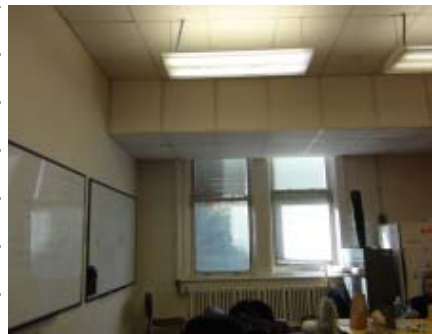
Field Date: 10/30/2015 Report Date: 11/16/2015 Barrier #: 111
 Bldg Name: Pharmacy Building Reference Dwg: 2 of 6
 Location: Floor 1 - Self-learning Lounge 101
 X Coordinate: N/A Y Coordinate: N/A
 Barrier Area: Alarms
 Barrier Type: Horn/Strobe - Common Use Area
 Code: 2010 ADAS 702.1
 References:

Barrier Description: No horn/strobes in common use areas

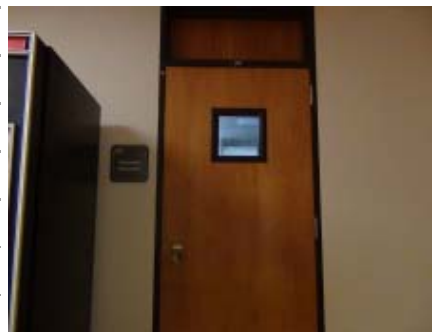
Field Date: 10/30/2015 Report Date: 11/16/2015 Barrier #: 12A
 Bldg Name: Pharmacy Building Reference Dwg: 2 of 6
 Location: Floor 1 - Classroom 107
 X Coordinate: N/A Y Coordinate: N/A
 Barrier Area: Classrooms
 Barrier Type: Door Vision Lights
 Code: 2010 ADAS 404.2.11
 References:

Barrier Description: View panels in or adjacent to doors or gates not max. 43" above floor or ground

Rec. Solution: Replace door/gate or vision panel

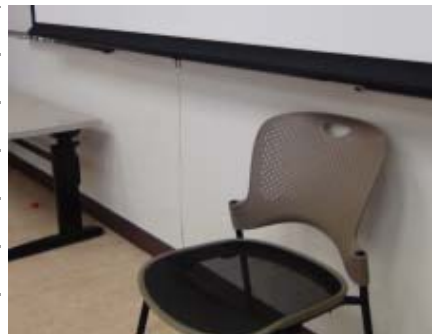
Code 2010 ADAS 305.3

Barrier Description: Screen pull not at max. 48" high for side reach

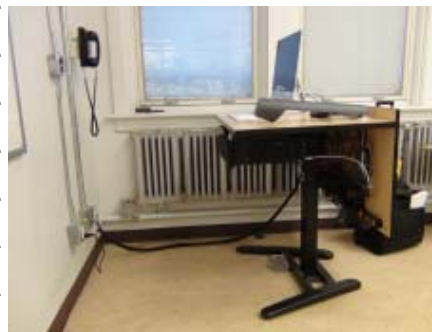
Code 2010 ADAS 504.2

Barrier Description: Podium knee clearance not min. 27" high, 19" deep or 30" wide

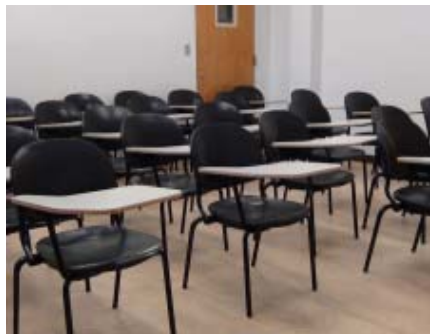
Code: 2010 ADAS 902

Barrier Description: At least 1 desk or 5% of all desks not accessible

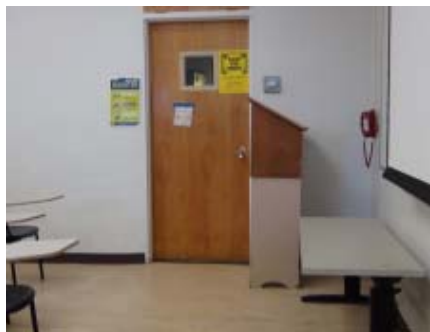
Code: 2010 ADAS 305.3

Barrier Description: Knee clearance not min. 27" high, 19" deep or 30" wide

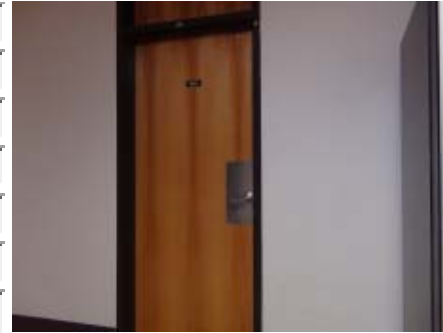
Field Date: 10/30/2015 Report Date 11/16/2015 Barrier #: 13A
 Bldg Name: Pharmacy Building Reference Dwg: 2 of 6
 Location: Floor 1 - Men's Restroom Entry Vestibule 109
 X Coordinate: N/A Y Coordinate: N/A
 Barrier Area: Signage
 Barrier Type: Permanent Room/Space - Tactile Characters
 Code 2010 ADAS 216.2
 References:

Barrier Description: No tactile characters at sign identifying permanent rooms and spaces with visual signs

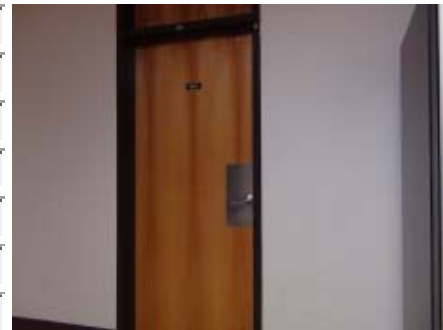
Field Date: 11/1/2015 Report Date 11/16/2015 Barrier #: 13B
 Bldg Name: Pharmacy Building Reference Dwg: 2 of 6
 Location: Floor 1 - Men's Restroom Entry Vestibule 109
 X Coordinate: N/A Y Coordinate: N/A
 Barrier Area: Restrooms
 Barrier Type: Sign - ISA at Accessible Restroom
 Code 2010 ADAS 216.8
 References:

Barrier Description: No ISA symbol on wall sign posted at accessible toilet room

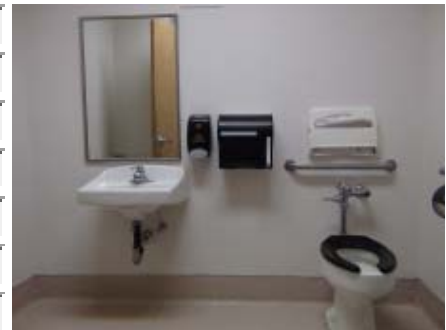
Field Date: 10/30/2015 Report Date 11/16/2015 Barrier #: 14D
 Bldg Name: Pharmacy Building Reference Dwg: 2 of 6
 Location: Floor 1 - Men's Accessible Restroom 109B
 X Coordinate: N/A Y Coordinate: N/A
 Barrier Area: Restrooms
 Barrier Type: Lavatory - Knee Clearance
 Code: 2010 ADAS 606.2 & 306
 References:

Barrier Description: Lavatory bottom apron/edge not at least 27" high

Rec. Solution: Replace lavatory

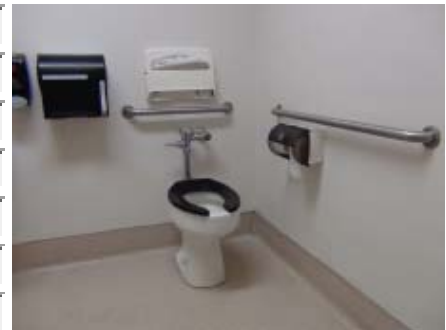
Field Date: 10/30/2015 Report Date 11/16/2015 Barrier #: 14J
 Bldg Name: Pharmacy Building Reference Dwg: 2 of 6
 Location: Floor 1 - Men's Accessible Restroom 109B
 X Coordinate: N/A Y Coordinate: N/A
 Barrier Area: Restrooms
 Barrier Type: Toilet Centerline
 Code: 2010 ADAS 604.2
 References:

Barrier Description: Water closet centerline not between 16" and 18" O. C.

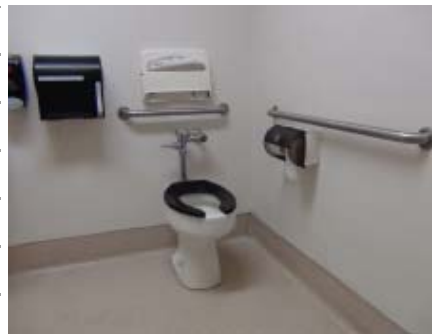
Field Date: 10/30/2015 Report Date 11/16/2015 Barrier #: 14K
 Bldg Name: Pharmacy Building Reference Dwg: 2 of 6
 Location: Floor 1 - Men's Accessible Restroom 109B
 X Coordinate: N/A Y Coordinate: N/A
 Barrier Area: Restrooms
 Barrier Type: Seat Cover Dispenser
 Code: 2010 ADAS 307.2
 References:

Barrier Description: Seat cover dispenser not located on an accessible route. Blocked by water closet

Rec. Solution: Replace or remount dispenser on an accessible route with clear floor space

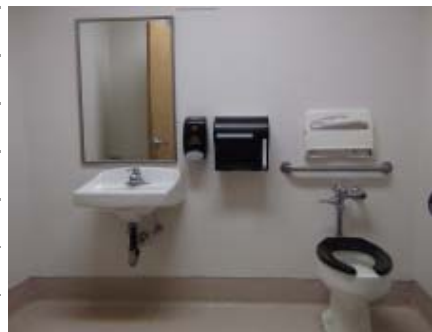
Field Date: 10/30/2015 Report Date 11/16/2015 Barrier #: 14L
 Bldg Name: Pharmacy Building Reference Dwg: 2 of 6
 Location: Floor 1 - Men's Accessible Restroom 109B
 X Coordinate: N/A Y Coordinate: N/A
 Barrier Area: Restrooms
 Barrier Type: Alarm - Horn/Strobe
 Code: 2010 ADAS 702.1
 References:

Barrier Description: Where a fire alarm is installed, no horn/strobe provided

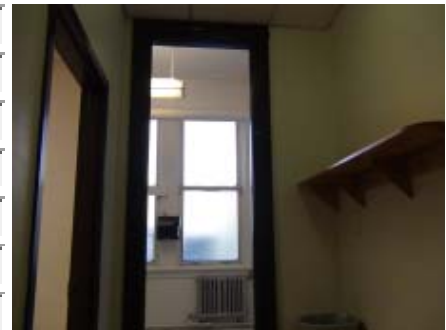
Field Date: 10/30/2015 Report Date: 11/16/2015 Barrier #: 15B
 Bldg Name: Pharmacy Building Reference Dwg: 2 of 6
 Location: Floor 1 - Multi-accommodation Toilet Room 109A
 X Coordinate: N/A Y Coordinate: N/A
 Barrier Area: Restrooms
 Barrier Type: Door Clear Width
 Code: 2010 ADAS 404.2.3
 References:

Barrier Description: Door clear width is not min. 32"

Rec. Solution: Replace door/gate and frame

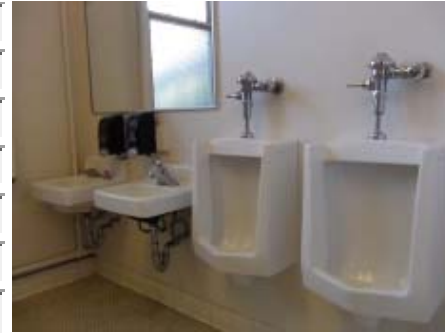
Field Date: 10/30/2015 Report Date 11/16/2015 Barrier #: 15C
 Bldg Name: Pharmacy Building Reference Dwg: 2 of 6
 Location: Floor 1 - Multi-accommodation Toilet Room 109A
 X Coordinate: N/A Y Coordinate: N/A
 Barrier Area: Restrooms
 Barrier Type: Lavatory - Knee Clearance
 Code: 2010 ADAS 606.2 & 306
 References:

Barrier Description: Lavatory bottom apron/edge not at least 27" high

Rec. Solution: Replace lavatory

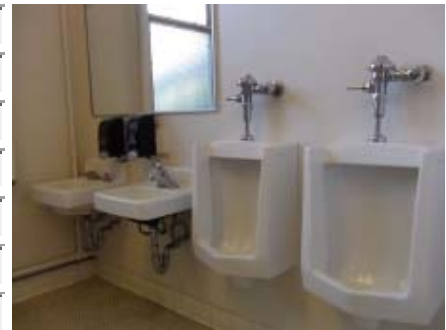
Field Date: 10/30/2015 Report Date 11/16/2015 Barrier #: 15D
 Bldg Name: Pharmacy Building Reference Dwg: 2 of 6
 Location: Floor 1 - Multi-accommodation Toilet Room 109A
 X Coordinate: N/A Y Coordinate: N/A
 Barrier Area: Restrooms
 Barrier Type: Lavatory - Drainpipes
 Code: 2010 ADAS 606.5
 References:

Barrier Description: Hot water and drainpipes accessible under lavatory not insulated or covered

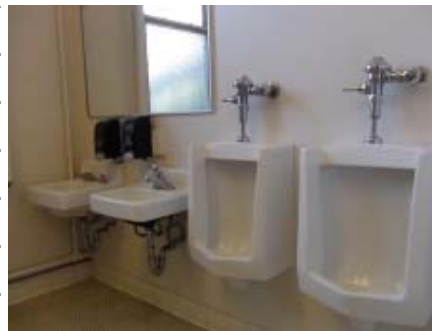
Field Date: 10/30/2015 Report Date 11/16/2015 Barrier #: 15E
 Bldg Name: Pharmacy Building Reference Dwg: 2 of 6
 Location: Floor 1 - Multi-accommodation Toilet Room 109A
 X Coordinate: N/A Y Coordinate: N/A
 Barrier Area: Restrooms
 Barrier Type: Mirror
 Code: 2010 ADAS 603.3
 References:

Barrier Description: Mirror at lavatory/countertop not max. 40" AFF at edge of reflecting surface

Rec. Solution: Replace or remount mirror

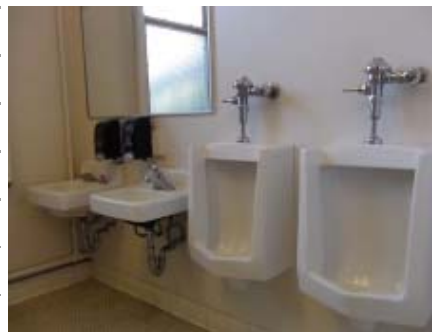
Field Date: 10/30/2015 Report Date 11/16/2015 Barrier #: 15F
 Bldg Name: Pharmacy Building Reference Dwg: 2 of 6
 Location: Floor 1 - Multi-accommodation Toilet Room 109A
 X Coordinate: N/A Y Coordinate: N/A
 Barrier Area: Restrooms
 Barrier Type: Urinal - Rim
 Code: 2010 ADAS 605.2
 References:

Barrier Description: Min. 1 urinal has no elongated rim projecting at least 13-1/2" from wall

Rec. Solution: Replace urinal

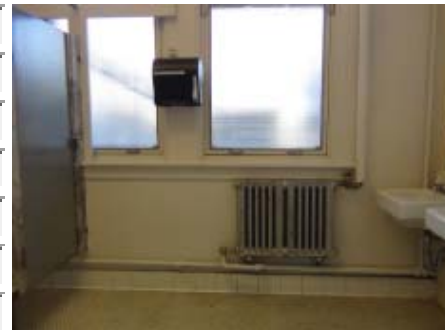
Field Date: 10/30/2015 Report Date: 11/16/2015 Barrier #: 15H
 Bldg Name: Pharmacy Building Reference Dwg: 2 of 6
 Location: Floor 1 - Multi-accommodation Toilet Room 109A
 X Coordinate: N/A Y Coordinate: N/A
 Barrier Area: Restrooms
 Barrier Type: Dispensers - Protruding Object
 Code: 2010 ADAS 307.2
 References:

Barrier Description: Protruding dispenser creates protruding hazard in path of travel

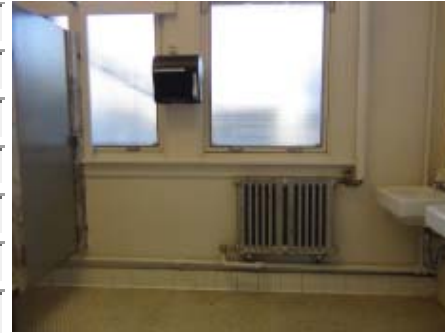
Field Date: 10/30/2015 Report Date 11/16/2015 Barrier #: 15I
 Bldg Name: Pharmacy Building Reference Dwg: 2 of 6
 Location: Floor 1 - Multi-accommodation Toilet Room 109A
 X Coordinate: N/A Y Coordinate: N/A
 Barrier Area: Restrooms
 Barrier Type: Dispensers - Height
 Code: 2010 ADAS 307.2
 References:

Barrier Description: Dispenser control point or operating mechanism not max. 48" AFF

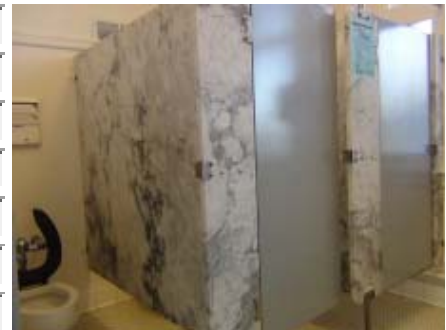
Field Date: 10/30/2015 Report Date 11/16/2015 Barrier #: 15J
 Bldg Name: Pharmacy Building Reference Dwg: 2 of 6
 Location: Floor 1 - Multi-accommodation Toilet Room 109A
 X Coordinate: N/A Y Coordinate: N/A
 Barrier Area: Restrooms
 Barrier Type: Stall - Unobstructed Access
 Code: 2010 ADAS 403.5.1
 References:

Barrier Description: Stall lacks clear, unobstructed access path of at least min. 36" to door

Rec. Solution: Replace compartment

Barrier Severity: 2 Recommended Cost Est \$4,950.00 Facility Function: Public Status: Open

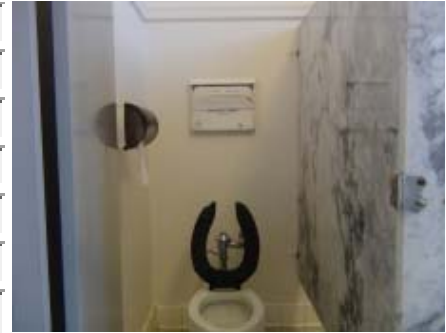
Field Date: 10/30/2015 Report Date 11/16/2015 Barrier #: 15K
 Bldg Name: Pharmacy Building Reference Dwg: 2 of 6
 Location: Floor 1 - Multi-accommodation Toilet Room 109A
 X Coordinate: N/A Y Coordinate: N/A
 Barrier Area: Restrooms
 Barrier Type: Toilet Stall - Door Hardware
 Code 2010 ADAS 604.8.1.2
 References:

Barrier Description: Inside of compartment door lacks a loop or U-pull below latch

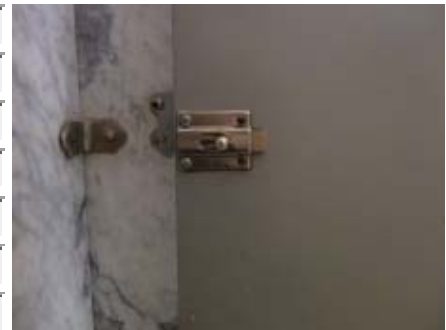
Field Date: 10/30/2015 Report Date 11/16/2015 Barrier #: 15L
 Bldg Name: Pharmacy Building Reference Dwg: 2 of 6
 Location: Floor 1 - Multi-accommodation Toilet Room 109A
 X Coordinate: N/A Y Coordinate: N/A
 Barrier Area: Restrooms
 Barrier Type: Toilet Stall - Door Hardware
 Code 2010 ADAS 604.8.1.2
 References:

Barrier Description: Outside of compartment door lacks a loop or U-pull below latch

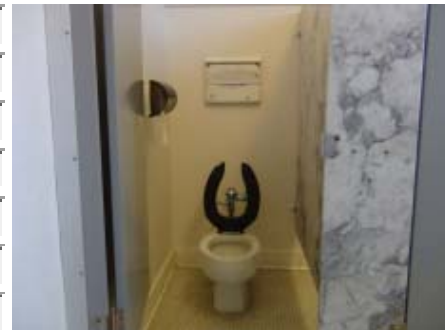
Field Date: 10/30/2015 Report Date: 11/16/2015 Barrier #: 15P
 Bldg Name: Pharmacy Building Reference Dwg: 2 of 6
 Location: Floor 1 - Multi-accommodation Toilet Room 109A
 X Coordinate: N/A Y Coordinate: N/A
 Barrier Area: Restrooms
 Barrier Type: Accessible Route
 Code: 2010 ADAS 402 & 403
 References:

Performance Standard: No Quantity: SF As-built : 1
 Barrier Description: Accessible route not provided to restroom (min. 36" clear width)

Findings: No min. 36" clear width provided
