OREGON STATE UNIVERSITY (OSU)

PHARMACY BUILDING

ADA ASSESSMENT & SURVEY

Re: ADA Accessibility Survey and Assessment – Pharmacy Building

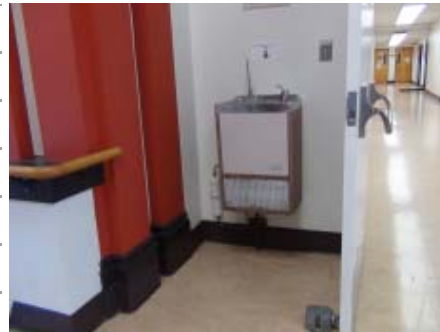
Field Date: 10/31/2015 Report Date 11/16/2015 Barrier #: 16C
 Bldg Name: Pharmacy Building Reference Dwg: 3 of 6
 Location: Floor 2 - Central Lobby
 X Coordinate: N/A Y Coordinate: N/A
 Barrier Area: Drinking Fountains
 Barrier Type: Bubbler height
 Code: 2010 ADAS 602.4
 References:

Barrier Description: Bubbler height exceeds 36"

Rec. Solution: Replace drinking fountain with accessible unit or remount existing

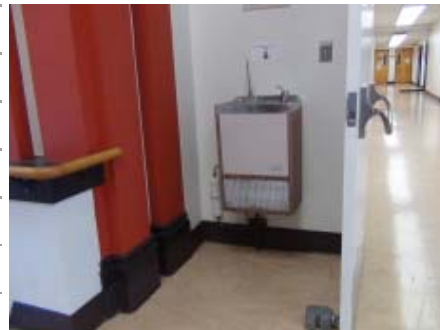
Field Date: 10/31/2015 Report Date 11/16/2015 Barrier #: 16D
 Bldg Name: Pharmacy Building Reference Dwg: 3 of 6
 Location: Floor 2 - Central Lobby
 X Coordinate: N/A Y Coordinate: N/A
 Barrier Area: Drinking Fountains
 Barrier Type: Hi-Low Unit
 Code: 2010 ADAS 211.2 & 602.7
 References:

Barrier Description: No hi-low drinking fountain provided on each floor of building

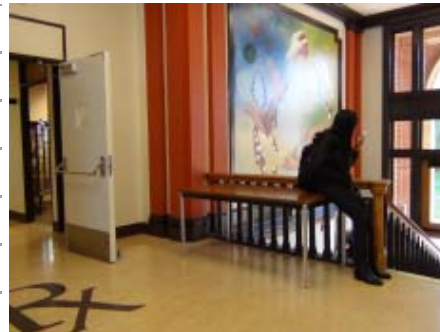
Field Date: 10/31/2015 Report Date 11/16/2015 Barrier #: 16E
 Bldg Name: Pharmacy Building Reference Dwg: 3 of 6
 Location: Floor 2 - Central Lobby
 X Coordinate: N/A Y Coordinate: N/A
 Barrier Area: Counters and Tables
 Barrier Type: Table - Knee Clearance
 Code: 2010 ADAS 305.3
 References:

Barrier Description: Knee clearance not min. 27" high, 19" deep or 30" wide

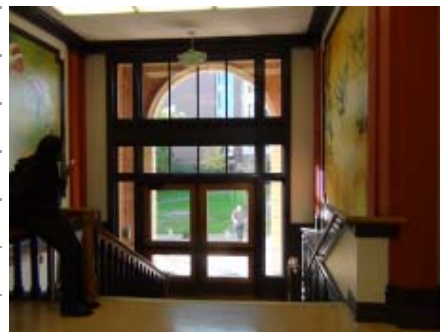
Field Date: 10/31/2015 Report Date 11/16/2015 Barrier #: 16F
 Bldg Name: Pharmacy Building Reference Dwg: 3 of 6
 Location: Floor 2 - Central Lobby
 X Coordinate: N/A Y Coordinate: N/A
 Barrier Area: Stairways
 Barrier Type: Sign - Enclosed Exit Stairway Level
 Code: ICC A117.1
 References:

Barrier Description: Tactile stairway signage not provided to indicate floor level

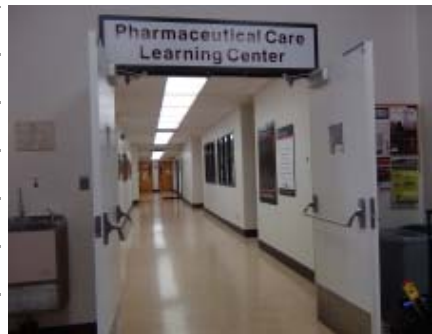
Field Date: 10/31/2015 Report Date: 11/16/2015 Barrier #: 17A
 Bldg Name: Pharmacy Building Reference Dwg: 3 of 6
 Location: Floor 2 - North Central Corridor
 X Coordinate: N/A Y Coordinate: N/A
 Barrier Area: Corridors
 Barrier Type: Sign - Permanent Room/Space
 Code: 2010 ADAS 703.1
 References:

Barrier Description: No sign with raised characters and Braille at permanent room or space with visual sign

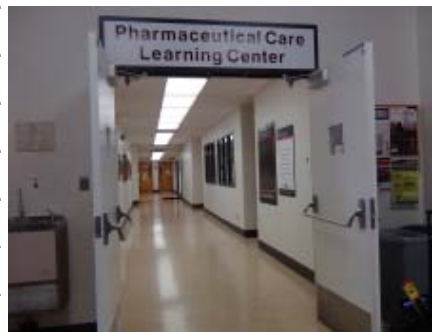
Field Date: 10/31/2015 Report Date: 11/16/2015 Barrier #: 17B
 Bldg Name: Pharmacy Building Reference Dwg: 3 of 6
 Location: Floor 2 - North Central Corridor
 X Coordinate: N/A Y Coordinate: N/A
 Barrier Area: Signage
 Barrier Type: Tactile Exit Signs - Passage
 Code: Performance Standard
 References:

Barrier Description: Exit thru an exit enclosure/exit passageway lacks tactile exit sign

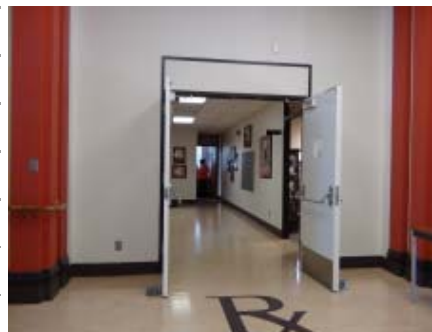
Field Date: 10/31/2015 Report Date 11/16/2015 Barrier #: 17D
 Bldg Name: Pharmacy Building Reference Dwg: 3 of 6
 Location: Floor 2 - North Central Corridor
 X Coordinate: N/A Y Coordinate: N/A
 Barrier Area: Corridors
 Barrier Type: Vision Lights in Doors
 Code: 2010 ADAS 404.2.11
 References:

Barrier Description: Doors or gates with view panels or side lights adjacent to doors not max. 43" high

Rec. Solution: Replace door or vision panel in door

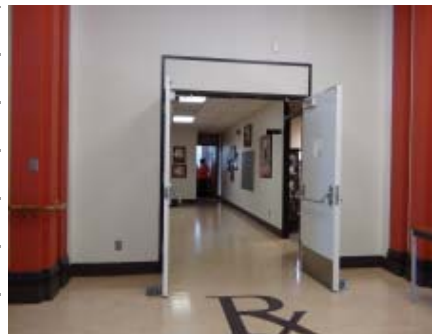
Field Date: 10/31/2015 Report Date 11/16/2015 Barrier #: 17E
 Bldg Name: Pharmacy Building Reference Dwg: 3 of 6
 Location: Floor 2 - North Central Corridor
 X Coordinate: N/A Y Coordinate: N/A
 Barrier Area: Corridors
 Barrier Type: Door Closer - Interior Automatic Door
 Code: 2010 ADAS 404.2.9
 References:

Barrier Description: Door opening force exceeds 5 lbf

Rec. Solution: No remediation recommended. Fire doors are propped open at all times.

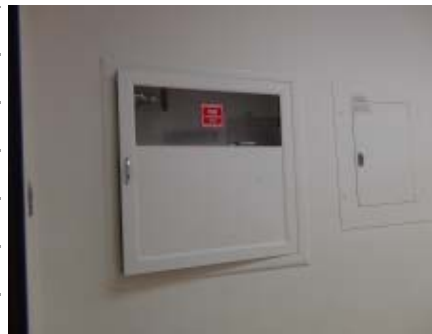
Barrier Description: Fire extinguisher forward or side reach exceeds 48"

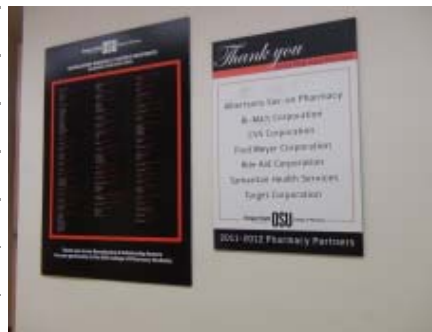
Barrier Description: No Braille/tactile information on visual sign

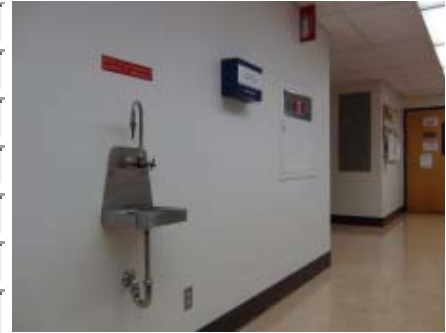
Barrier Description: Protruding object in in circulation path protrudes more than 4" between 27" and 80" high

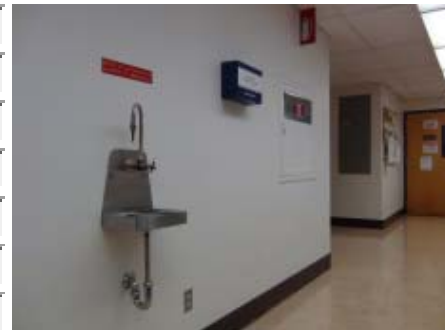
Barrier Description: Control or mechanism not at min. 15" or max. 48" high

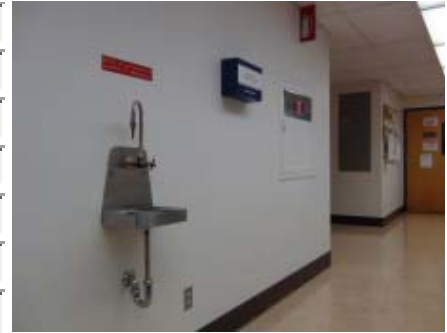
Field Date: 10/31/2015 Report Date 11/16/2015 Barrier #: 17M
 Bldg Name: Pharmacy Building Reference Dwg: 3 of 6
 Location: Floor 2 - North Central Corridor
 X Coordinate: N/A Y Coordinate: N/A
 Barrier Area: Classrooms
 Barrier Type: Sink - Exposed Pipes
 Code: 2010 ADAS 606.5
 References:

Barrier Description: Exposed hot water/drain pipes not insulated or configured so as to protect against contact

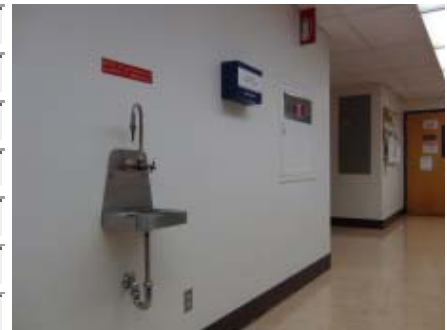
Field Date: 10/31/2015 Report Date 11/16/2015 Barrier #: 17N
 Bldg Name: Pharmacy Building Reference Dwg: 3 of 6
 Location: Floor 2 - North Central Corridor
 X Coordinate: N/A Y Coordinate: N/A
 Barrier Area: Classrooms
 Barrier Type: Sink Faucet - Operation
 Code: 2010 ADAS 606.4 & 309
 References:

Barrier Description: Faucets lack controls and operating mechanisms involve tight grasping, pinching or twisting of the wrist

Rec. Solution: Replace faucet

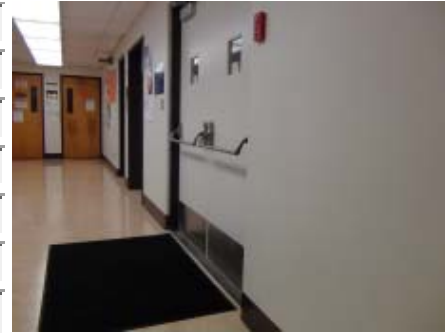
Field Date: 10/31/2015 Report Date 11/16/2015 Barrier #: 170
 Bldg Name: Pharmacy Building Reference Dwg: 3 of 6
 Location: Floor 2 - North Central Corridor
 X Coordinate: N/A Y Coordinate: N/A
 Barrier Area: Corridors
 Barrier Type: Door Mat
 Code: 2010 ADAS 302.2 & Advisory 302.2
 References:

Barrier Description: Recessed doormat not anchored to floor (possible trip hazard)

Rec. Solution: Replace door mat

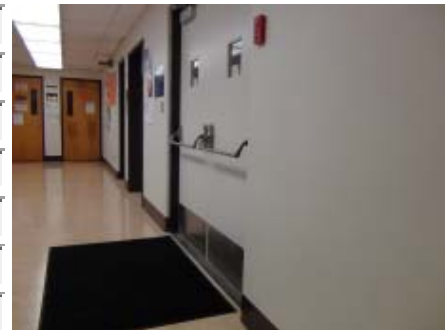
Field Date: 10/31/2015 Report Date 11/16/2015 Barrier #: 17P
 Bldg Name: Pharmacy Building Reference Dwg: 3 of 6
 Location: Floor 2 - North Central Corridor
 X Coordinate: N/A Y Coordinate: N/A
 Barrier Area: Corridors
 Barrier Type: Fire Alarm - Pull Actuator Height
 Code: 2010 ADAS 308.2.2
 References:

Barrier Description: Fire pulls not between 42" and 48" high

Rec. Solution: Replace fire pull when remodeling

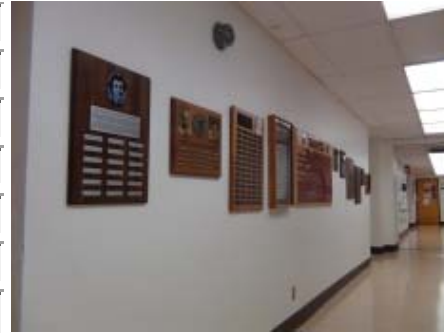
Field Date: 10/31/2015 Report Date 11/16/2015 Barrier #: 17Q
 Bldg Name: Pharmacy Building Reference Dwg: 3 of 6
 Location: Floor 2 - North Central Corridor
 X Coordinate: N/A Y Coordinate: N/A
 Barrier Area: Drinking Fountains
 Barrier Type: Hi-Low Unit
 Code: 2010 ADAS 211.2 & 602.7
 References:

Barrier Description: No hi-low drinking fountain provided on each floor of building

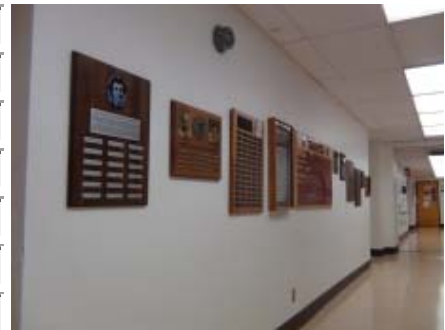
Field Date: 10/31/2015 Report Date 11/16/2015 Barrier #: 17R
 Bldg Name: Pharmacy Building Reference Dwg: 3 of 6
 Location: Floor 2 - North Central Corridor
 X Coordinate: N/A Y Coordinate: N/A
 Barrier Area: Corridors
 Barrier Type: Strobe
 Code: 2010 ADAS 702.1
 References:

Barrier Description: No strobe provided in corridor where horn is provided where fire alarm exists in building

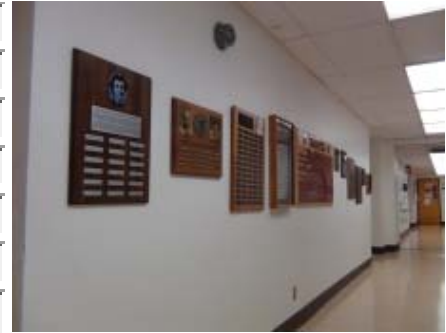
Field Date: 10/31/2015 Report Date 11/16/2015 Barrier #: 17S
 Bldg Name: Pharmacy Building Reference Dwg: 3 of 6
 Location: Floor 2 - North Central Corridor
 X Coordinate: N/A Y Coordinate: N/A
 Barrier Area: Corridors
 Barrier Type: Actuator/Control - Side Reach High Unobstructed
 Code 2010 ADAS 305.3
 References:

Barrier Description: Control or mechanism not at min. 15" or max. 48" high

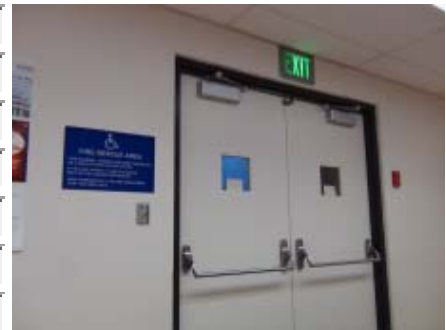
Field Date: 10/31/2015 Report Date 11/16/2015 Barrier #: 18A
 Bldg Name: Pharmacy Building Reference Dwg: 3 of 6
 Location: Floor 2 - North Stairway
 X Coordinate: N/A Y Coordinate: N/A
 Barrier Area: Signage
 Barrier Type: Tactile Exit Signs - Stairway
 Code Performance Standard
 References:

Barrier Description: Door leading directly into an exit stairway lacks tactile exit sign

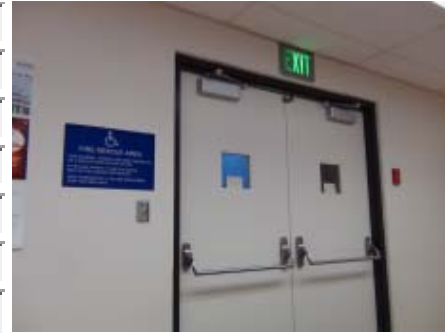
Field Date: 10/31/2015 Report Date 11/16/2015 Barrier #: 18B
 Bldg Name: Pharmacy Building Reference Dwg: 3 of 6
 Location: Floor 2 - North Stairway
 X Coordinate: N/A Y Coordinate: N/A
 Barrier Area: Doors or Gates
 Barrier Type: Vision Lights - Existing
 Code: 2010 ADAS 404.2.11
 References:

Barrier Description: View panels in or adjacent to doors or gates not max. 43" above floor or ground

Rec. Solution: Replace door/gate or vision panel

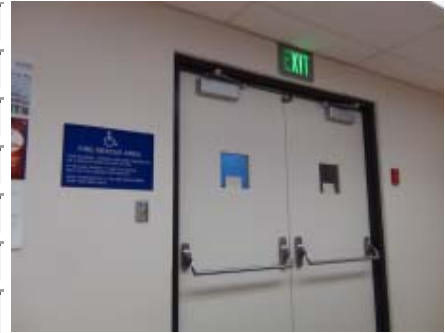
Field Date: 10/31/2015 Report Date: 11/16/2015 Barrier #: 18D
 Bldg Name: Pharmacy Building Reference Dwg: 3 of 6
 Location: Floor 2 - North Stairway
 X Coordinate: N/A Y Coordinate: N/A
 Barrier Area: Doors or Gates
 Barrier Type: Door Closer - Interior Sweep Period
 Code: 2010 ADAS 404.2.8.1
 References:

Barrier Description: Door closer lacks min. 5 second sweep period or does not stop 5" from door frame

Rec. Solution: Replace or adjust existing closer

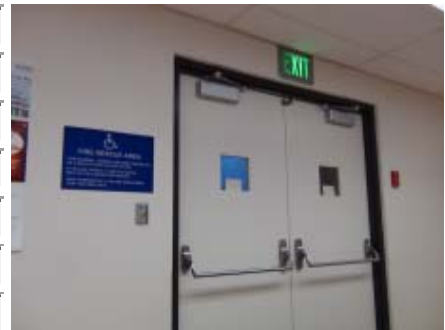
Field Date: 10/31/2015 Report Date: 11/16/2015 Barrier #: 18E
 Bldg Name: Pharmacy Building Reference Dwg: 3 of 6
 Location: Floor 2 - North Stairway
 X Coordinate: N/A Y Coordinate: N/A
 Barrier Area: Doors or Gates
 Barrier Type: Vision Lights - Existing
 Code: 2010 ADAS 404.2.11
 References:

Barrier Description: View panels in or adjacent to doors or gates not max. 43" above floor or ground

Rec. Solution: Replace door/gate or vision panel

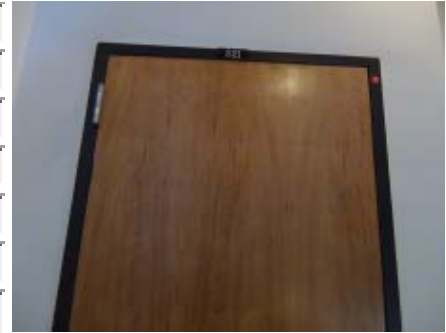
Field Date: 10/31/2015 Report Date 11/16/2015 Barrier #: 18H
 Bldg Name: Pharmacy Building Reference Dwg: 3 of 6
 Location: Floor 2 - North Stairway
 X Coordinate: N/A Y Coordinate: N/A
 Barrier Area: Signage
 Barrier Type: Permanent Room/Space - Tactile Characters
 Code 2010 ADAS 216.2
 References:

Barrier Description: No tactile characters at sign identifying permanent rooms and spaces with visual signs

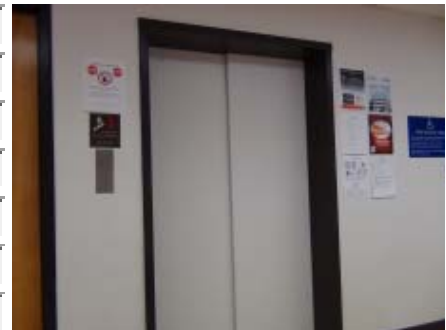
Field Date: 10/31/2015 Report Date 11/16/2015 Barrier #: 19A
 Bldg Name: Pharmacy Building Reference Dwg: 3 of 6
 Location: Floor 2 - Elevator
 X Coordinate: N/A Y Coordinate: N/A
 Barrier Area: Elevators
 Barrier Type: Hall Call Buttons - 42" High
 Code 2010 ADAS 407.2.1
 References:

Barrier Description: The centerline of the hall call buttons not max. 42" above the floor

Rec. Solution: Replace hall call buttons

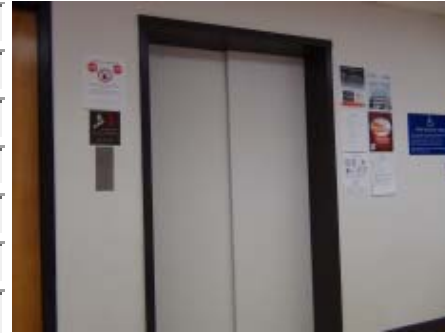
Field Date: 10/31/2015 Report Date 11/16/2015 Barrier #: 19B
 Bldg Name: Pharmacy Building Reference Dwg: 3 of 6
 Location: Floor 2 - Elevator
 X Coordinate: N/A Y Coordinate: N/A
 Barrier Area: Elevators
 Barrier Type: Hall Call Buttons
 Code: 2010 ADAS 407.4.5
 References:

Barrier Description: Hall call buttons not internally illuminated with a white light over the entire button surface

Rec. Solution: Replace hall call buttons

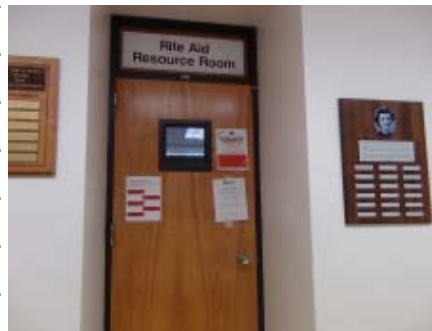
Field Date: 10/31/2015 Report Date: 11/16/2015 Barrier #: 20A
 Bldg Name: Pharmacy Building Reference Dwg: 3 of 6
 Location: Floor 2 - Rite Aid Resource Room 235
 X Coordinate: N/A Y Coordinate: N/A
 Barrier Area: Signage
 Barrier Type: Permanent Room/Space - Tactile Characters
 Code: 2010 ADAS 216.2
 References:

Barrier Description: No tactile characters at sign identifying permanent rooms and spaces with visual signs

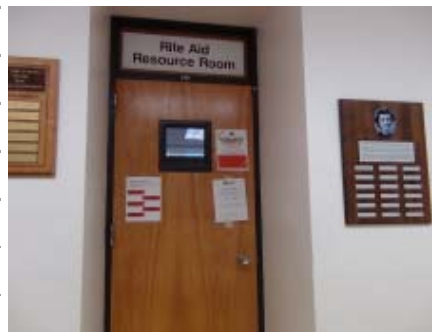
Field Date: 10/31/2015 Report Date: 11/16/2015 Barrier #: 20B
 Bldg Name: Pharmacy Building Reference Dwg: 3 of 6
 Location: Floor 2 - Rite Aid Resource Room 235
 X Coordinate: N/A Y Coordinate: N/A
 Barrier Area: Signage
 Barrier Type: ISA - Directional Sign
 Code: 2010 ADAS 216.6 Advisory
 References:

Barrier Description: No directional signage provided where accessible route diverges from main route

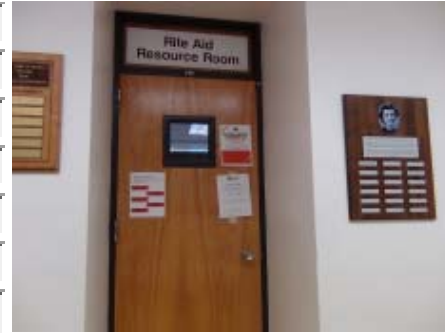
Field Date: 10/31/2015 Report Date 11/16/2015 Barrier #: 20C
 Bldg Name: Pharmacy Building Reference Dwg: 3 of 6
 Location: Floor 2 - Rite Aid Resource Room 235
 X Coordinate: N/A Y Coordinate: N/A
 Barrier Area: Doors or Gates
 Barrier Type: Vision Lights - New Construction
 Code: 2010 ADAS 404.2.11
 References:

Barrier Description: View panels in or adjacent to doors or gates not max. 43" above floor or ground

Barrier Severity: 2 Recommended Cost Est \$4,500.00 Facility Function: Public Status: Open

Rec. Solution: Replace door/gate or vision panel

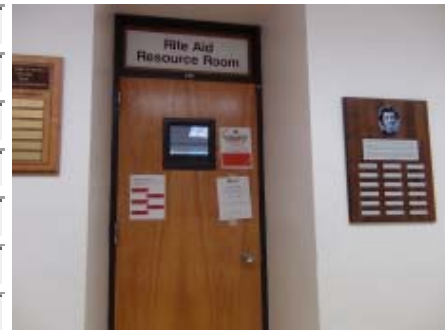
Field Date: 10/31/2015 Report Date 11/16/2015 Barrier #: 20D
 Bldg Name: Pharmacy Building Reference Dwg: 3 of 6
 Location: Floor 2 - Rite Aid Resource Room 235
 X Coordinate: N/A Y Coordinate: N/A
 Barrier Area: Doors or Gates
 Barrier Type: Door Closer - Interior Automatic Door
 Code: 2010 ADAS 404.2.9
 References:

Barrier Description: Door opening force exceeds 5 lbf

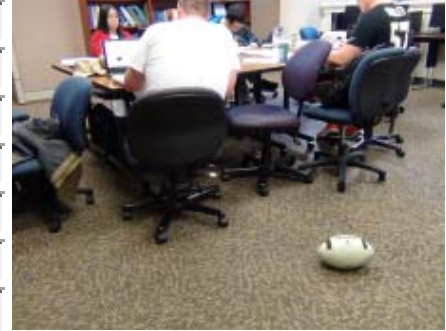
Field Date: 10/31/2015 Report Date 11/16/2015 Barrier #: 20G
 Bldg Name: Pharmacy Building Reference Dwg: 3 of 6
 Location: Floor 2 - Rite Aid Resource Room 235
 X Coordinate: N/A Y Coordinate: N/A
 Barrier Area: Counters and Tables
 Barrier Type: Table - Knee Clearance
 Code: 2010 ADAS 305.3
 References:

Barrier Description: Knee clearance not min. 27" high, 19" deep or 30" wide

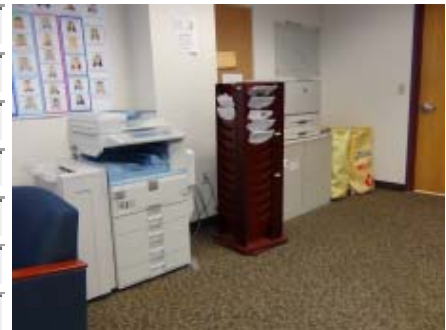
Field Date: 10/31/2015 Report Date 11/16/2015 Barrier #: 20H
 Bldg Name: Pharmacy Building Reference Dwg: 3 of 6
 Location: Floor 2 - Rite Aid Resource Room 235
 X Coordinate: N/A Y Coordinate: N/A
 Barrier Area: Controls and Mechanisms
 Barrier Type: Actuator/Control - Hi/low Reach
 Code: 2010 ADAS 308.2.2
 References:

Barrier Description: Use of control involves low reach of less than 15" above floor or more than 48" high

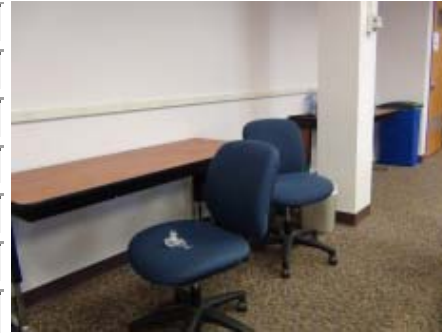
Field Date: 10/31/2015 Report Date: 11/16/2015 Barrier #: 201
 Bldg Name: Pharmacy Building Reference Dwg: 3 of 6
 Location: Floor 2 - Rite Aid Resource Room 235
 X Coordinate: N/A Y Coordinate: N/A
 Barrier Area: Controls and Mechanisms
 Barrier Type: Electrical Outlets - Hi/Low Reach
 Code: 2010 ADAS 308.2.2
 References:

Barrier Description: Use of outlet involves low reach of less than 15" above floor or more than 48" high

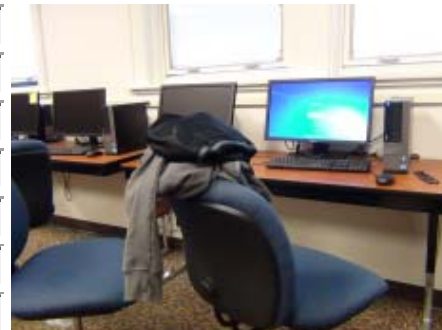
Field Date: 10/31/2015 Report Date: 11/16/2015 Barrier #: 20J
 Bldg Name: Pharmacy Building Reference Dwg: 3 of 6
 Location: Floor 2 - Rite Aid Resource Room 235
 X Coordinate: N/A Y Coordinate: N/A
 Barrier Area: Controls and Mechanisms
 Barrier Type: Electrical Outlets - Side Reach Obstructed (10"-24")
 Code: 2010 ADAS 305.3
 References:

Barrier Description: Outlet located over an 10" to 24" obstruction max. 34" high located above 46"

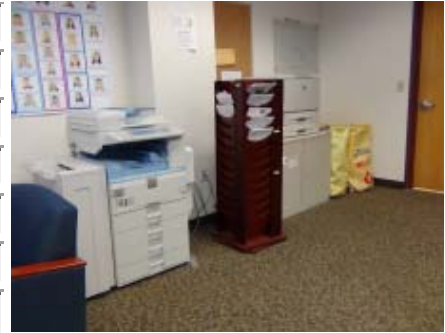
Field Date: 10/31/2015 Report Date 11/16/2015 Barrier #: 20K
 Bldg Name: Pharmacy Building Reference Dwg: 3 of 6
 Location: Floor 2 - Rite Aid Resource Room 235
 X Coordinate: N/A Y Coordinate: N/A
 Barrier Area: Controls and Mechanisms
 Barrier Type: Actuator/Control - Hi/low Reach
 Code: 2010 ADAS 308.2.2
 References:

Barrier Description: Use of control involves low reach of less than 15" above floor or more than 48" high

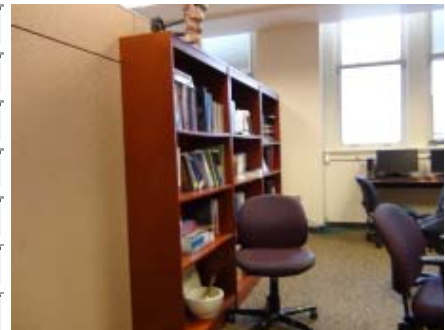
Field Date: 10/31/2015 Report Date 11/16/2015 Barrier #: 20L
 Bldg Name: Pharmacy Building Reference Dwg: 3 of 6
 Location: Floor 2 - Rite Aid Resource Room 235
 X Coordinate: N/A Y Coordinate: N/A
 Barrier Area: Controls and Mechanisms
 Barrier Type: Shelves or Cabinets
 Code: 2010 ADAS 305.3
 References:

Barrier Description: Shelf or cabinet not mounted max. 48" above floor or ground

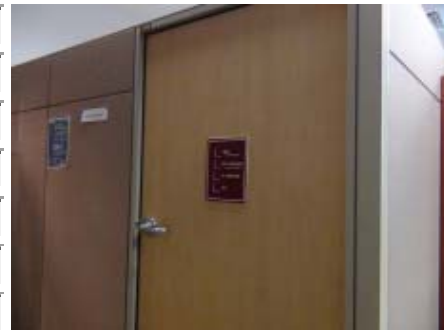
Field Date: 10/31/2015 Report Date 11/16/2015 Barrier #: 21A
 Bldg Name: Pharmacy Building Reference Dwg: 3 of 6
 Location: Floor 2 - Office Room 235B
 X Coordinate: N/A Y Coordinate: N/A
 Barrier Area: Signage
 Barrier Type: Permanent Room/Space - Tactile Characters
 Code: 2010 ADAS 216.2
 References:

Barrier Description: No tactile characters at sign identifying permanent rooms and spaces with visual signs

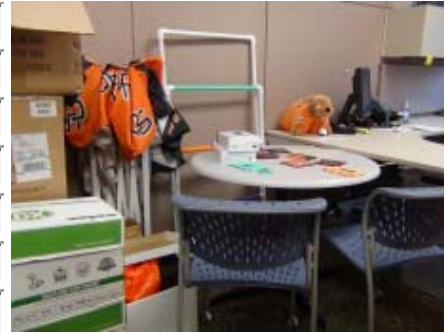
Field Date: 10/31/2015 Report Date 11/16/2015 Barrier #: 21B
 Bldg Name: Pharmacy Building Reference Dwg: 3 of 6
 Location: Floor 2 - Office Room 235B
 X Coordinate: N/A Y Coordinate: N/A
 Barrier Area: Counters and Tables
 Barrier Type: Table - Pedestal Base
 Code 2010 ADAS 306.2.2 & 306.2.3
 References:

Barrier Description: Knee clearance not min. 27" high, 19" deep or 30" wide

Barrier Severity: 2 Recommended Cost Est \$450.00 Facility Function: Public Status: Open

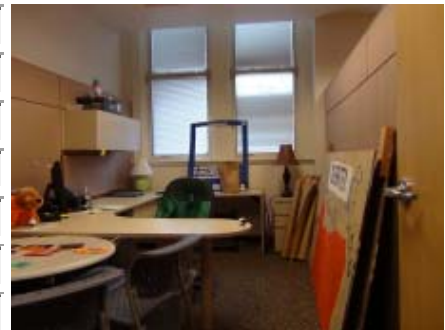
Field Date: 10/31/2015 Report Date 11/16/2015 Barrier #: 21C
 Bldg Name: Pharmacy Building Reference Dwg: 3 of 6
 Location: Floor 2 - Office Room 235B
 X Coordinate: N/A Y Coordinate: N/A
 Barrier Area: Counters and Tables
 Barrier Type: Table - Clear Floor Space
 Code 2010 ADAS 305.3
 References:

Barrier Description: Clear floor space 30" x 48" not provided at table

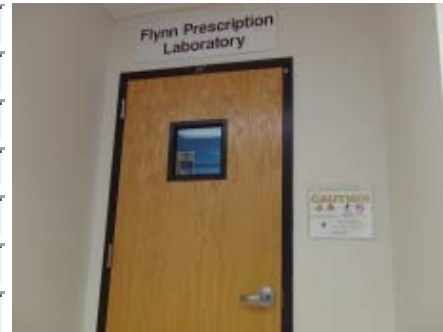
Field Date: 10/31/2015 Report Date: 11/16/2015 Barrier #: 22A
 Bldg Name: Pharmacy Building Reference Dwg: 3 of 6
 Location: Floor 2 - Flynn Prescription Laboratory 237
 X Coordinate: N/A Y Coordinate: N/A
 Barrier Area: Signage
 Barrier Type: Permanent Room/Space - Tactile Characters
 Code: 2010 ADAS 216.2
 References:

Barrier Description: No tactile characters at sign identifying permanent rooms and spaces with visual signs

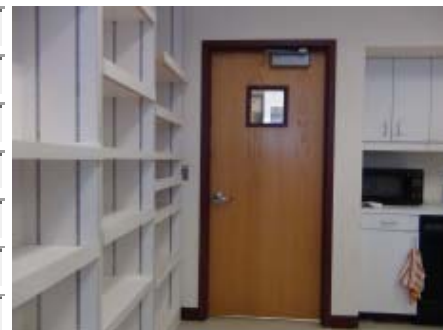
Field Date: 10/31/2015 Report Date: 11/16/2015 Barrier #: 22B
 Bldg Name: Pharmacy Building Reference Dwg: 3 of 6
 Location: Floor 2 - Flynn Prescription Laboratory 237
 X Coordinate: N/A Y Coordinate: N/A
 Barrier Area: Doors or Gates
 Barrier Type: Vision Lights - Existing
 Code: 2010 ADAS 404.2.11
 References:

Barrier Description: View panels in or adjacent to doors or gates not max. 43" above floor or ground

Rec. Solution: Replace door/gate or vision panel

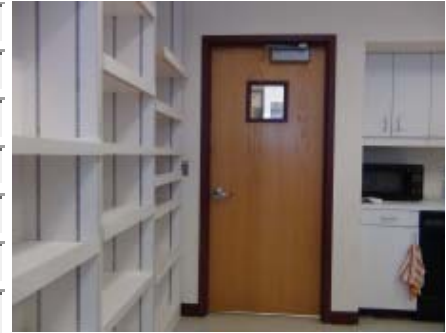
Field Date: 10/31/2015 Report Date 11/16/2015 Barrier #: 22C
 Bldg Name: Pharmacy Building Reference Dwg: 3 of 6
 Location: Floor 2 - Flynn Prescription Laboratory 237
 X Coordinate: N/A Y Coordinate: N/A
 Barrier Area: Doors or Gates
 Barrier Type: Door Closer - Interior Automatic Door
 Code: 2010 ADAS 404.2.9
 References:

Barrier Description: Door opening force exceeds 5 lbf

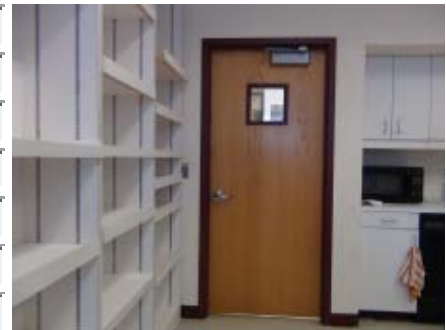
Field Date: 10/31/2015 Report Date 11/16/2015 Barrier #: 22D
 Bldg Name: Pharmacy Building Reference Dwg: 3 of 6
 Location: Floor 2 - Flynn Prescription Laboratory 237
 X Coordinate: N/A Y Coordinate: N/A
 Barrier Area: Doors or Gates
 Barrier Type: Door Closer - Interior Sweep Period
 Code: 2010 ADAS 404.2.8.1
 References:

Barrier Description: Door closer lacks min. 5 second sweep period or does not stop 5" from door frame

Barrier Severity: 2 Recommended Cost Est \$0.00 Facility Function: Public Status: Open

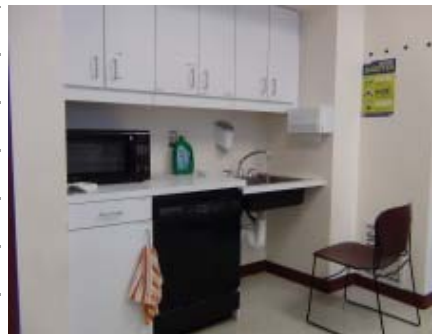
Field Date: 10/31/2015 Report Date 11/16/2015 Barrier #: 22G
 Bldg Name: Pharmacy Building Reference Dwg: 3 of 6
 Location: Floor 2 - Flynn Prescription Laboratory 237
 X Coordinate: N/A Y Coordinate: N/A
 Barrier Area: Counters and Tables
 Barrier Type: Counter - Surface Height
 Code: 2010 ADAS 902.3
 References:

Barrier Description: No section at least 3 feet long between 28" and 34" provided at existing counter

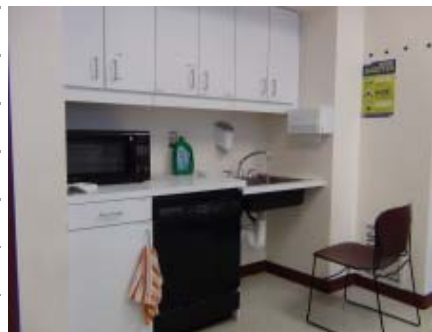
Field Date: 10/31/2015 Report Date 11/16/2015 Barrier #: 22H
 Bldg Name: Pharmacy Building Reference Dwg: 3 of 6
 Location: Floor 2 - Flynn Prescription Laboratory 237
 X Coordinate: N/A Y Coordinate: N/A
 Barrier Area: Classrooms
 Barrier Type: Sink - Knee Clearance
 Code: 2010 ADAS 606.2 & 306
 References:

Barrier Description: Knee clearance of at least 30" wide and 8" deep at 27" high with 11" depth at 9" high

Rec. Solution: Replace cabinet and remount sink

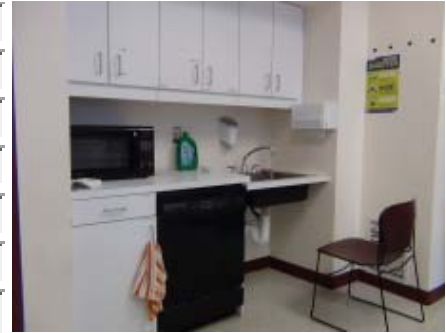
Field Date: 10/31/2015 Report Date 11/16/2015 Barrier #: 221
 Bldg Name: Pharmacy Building Reference Dwg: 3 of 6
 Location: Floor 2 - Flynn Prescription Laboratory 237
 X Coordinate: N/A Y Coordinate: N/A
 Barrier Area: Laboratory Facilities
 Barrier Type: Actuator/Control - Side Reach Obstructed (10"-24")
 Code: 2010 ADAS 305.3
 References:

Barrier Description: Control or mechanism over an 10" to 24" obstruction max. 34" high located above 46"

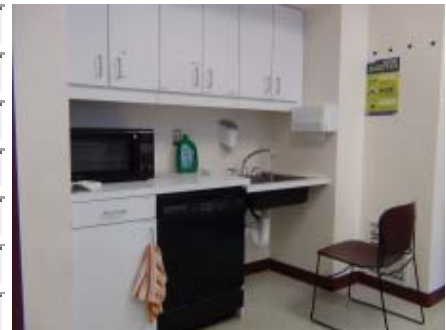
Field Date: 10/31/2015 Report Date 11/16/2015 Barrier #: 22J
 Bldg Name: Pharmacy Building Reference Dwg: 3 of 6
 Location: Floor 2 - Flynn Prescription Laboratory 237
 X Coordinate: N/A Y Coordinate: N/A
 Barrier Area: Laboratory Facilities
 Barrier Type: Electrical Outlets - Side Reach Obstructed (10"-24")
 Code: 2010 ADAS 306.3.2
 References:

Barrier Description: Outlet located over an 10" to 24" obstruction max. 34" high located above 46"

Barrier Severity: 2 Recommended Cost Est \$175.00 Facility Function: Public Status: Open

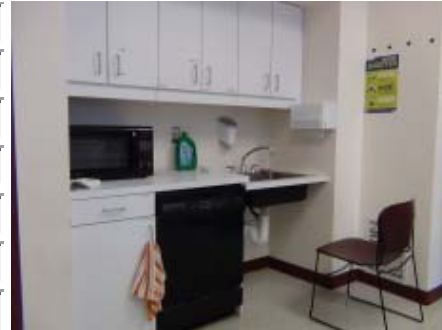
Field Date: 10/31/2015 Report Date: 11/16/2015 Barrier #: 22K
 Bldg Name: Pharmacy Building Reference Dwg: 3 of 6
 Location: Floor 2 - Flynn Prescription Laboratory 237
 X Coordinate: N/A Y Coordinate: N/A
 Barrier Area: Laboratory Facilities
 Barrier Type: Shelves or Cabinet
 Code: 2010 ADAS 603.4
 References:

Barrier Description: Shelf or cabinet not mounted between 40" and 48" above floor or ground

Barrier Severity: 2 Recommended Cost Est: \$75.00 Facility Function: Public Status: Open

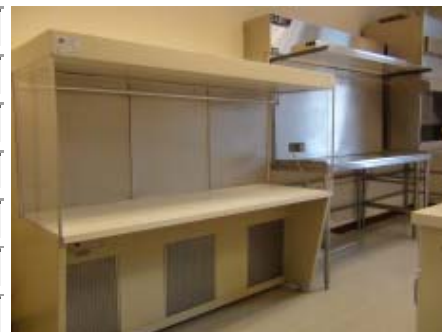
Field Date: 10/31/2015 Report Date: 11/16/2015 Barrier #: 22L
 Bldg Name: Pharmacy Building Reference Dwg: 3 of 6
 Location: Floor 2 - Flynn Prescription Laboratory 237
 X Coordinate: N/A Y Coordinate: N/A
 Barrier Area: Laboratory Facilities
 Barrier Type: Fume Hood - Knee Clearance
 Code: 2010 ADAS 305.3
 References:

Barrier Description: Knee clearance not min. 27" high, 19" deep or 30" wide

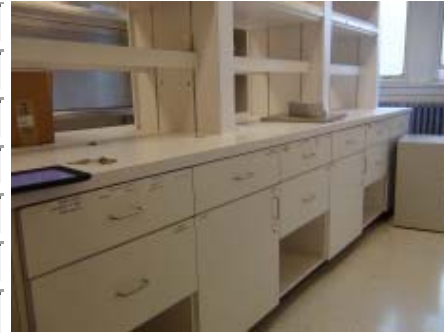
Field Date: 10/31/2015 Report Date 11/16/2015 Barrier #: 22M
 Bldg Name: Pharmacy Building Reference Dwg: 3 of 6
 Location: Floor 2 - Flynn Prescription Laboratory 237
 X Coordinate: N/A Y Coordinate: N/A
 Barrier Area: Laboratory Facilities
 Barrier Type: Biosafety Cabinet - Work Surface Rim
 Code: 2010 ADAS 902
 References:

Barrier Description: Work surface height exceeds 34" high

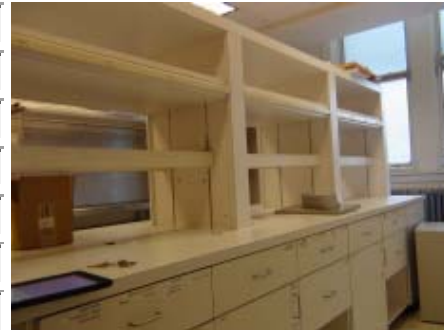
Field Date: 10/31/2015 Report Date 11/16/2015 Barrier #: 22N
 Bldg Name: Pharmacy Building Reference Dwg: 3 of 6
 Location: Floor 2 - Flynn Prescription Laboratory 237
 X Coordinate: N/A Y Coordinate: N/A
 Barrier Area: Laboratory Facilities
 Barrier Type: Alarm - Horn/Strobe
 Code: 2010 ADAS 702.1
 References:

Barrier Description: Where a fire alarm is installed, no horn/strobe provided

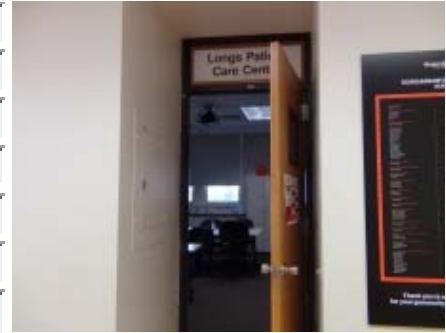
Barrier Description: No tactile characters at sign identifying permanent rooms and spaces with visual signs

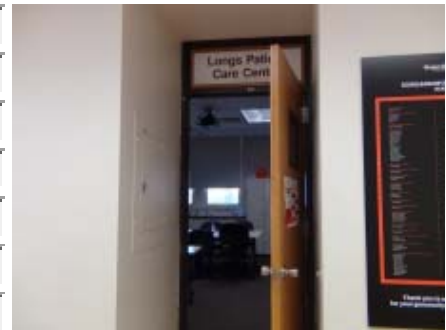
Barrier Description: No directional signage provided where accessible route diverges from main route

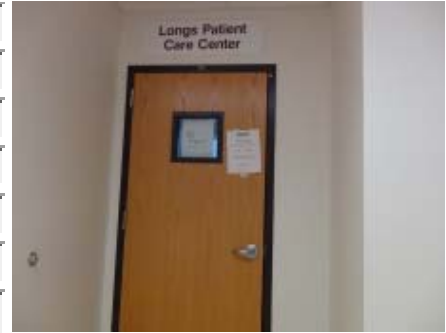
Barrier Description: View panels in or adjacent to doors or gates not max. 43" above floor or ground

Rec. Solution: Replace door/gate or vision panel

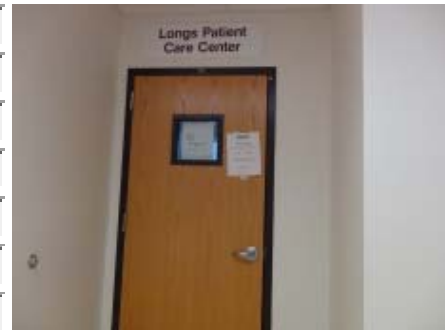
Barrier Description: Door opening force exceeds 5 lbf

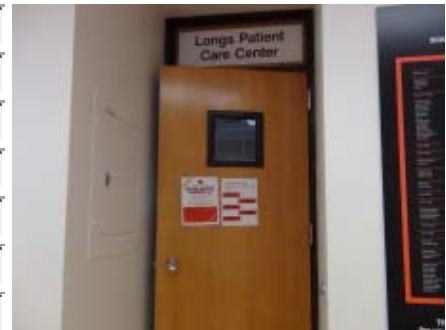
Barrier Description: Hardware not operable with a closed fist

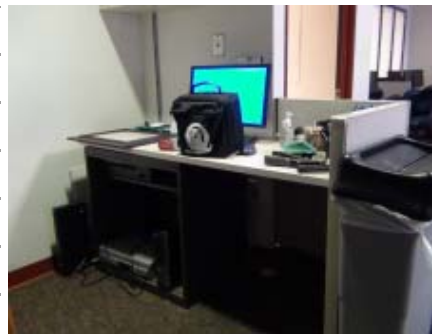
Barrier Description: Knee clearance of at least 27" high, 30" wide and 8" deep not provided

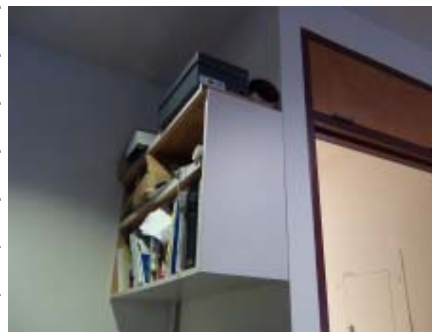
Barrier Description: Shelf or cabinet not mounted max. 48" above floor or ground

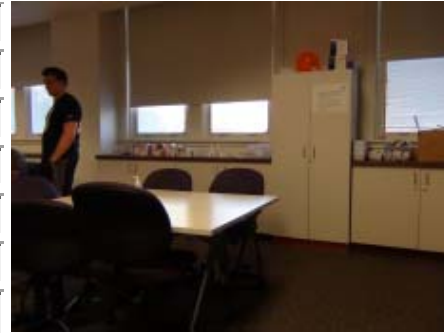
Barrier Description: Knee clearance not min. 27" high, 19" deep or 30" wide

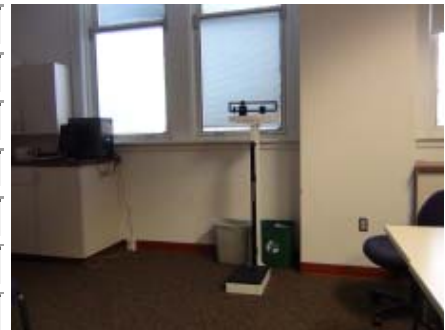
Barrier Description: Clear floor space of min. 30" by 48" not provided at public scale

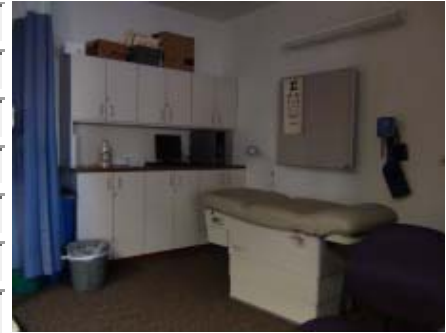
Field Date: 10/31/2015 Report Date 11/16/2015 Barrier #: 23K
 Bldg Name: Pharmacy Building Reference Dwg: 3 of 6
 Location: Floor 2 - Longs Patient Care Center
 X Coordinate: N/A Y Coordinate: N/A
 Barrier Area: Clear Floor Space
 Barrier Type: Accessible Route
 Code: 2010 ADAS 305
 References:

Barrier Description: Clear floor space does not adjoin an accessible route or another space

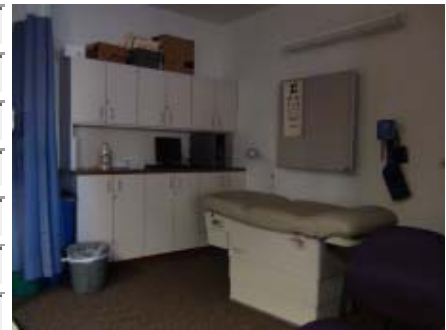
Barrier Description: Knee clearance not min. 27" high, 19" deep or 30" wide

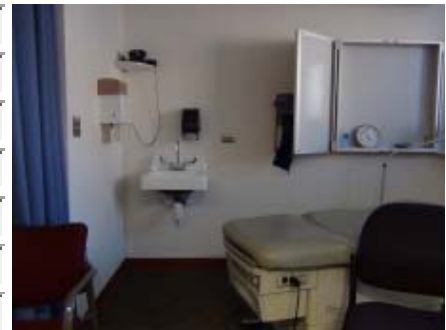
Barrier Description: Knee clearance of at least 30" wide and 8" deep at 27" high with 11" depth at 9" high

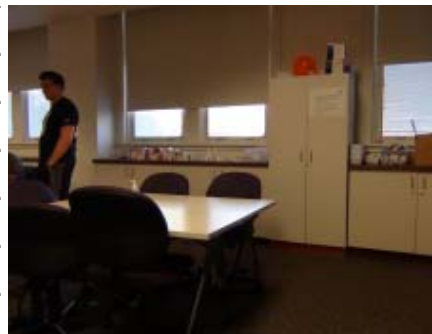
Barrier Description: No section at least 3 feet long between 28" and 34" provided at existing counter

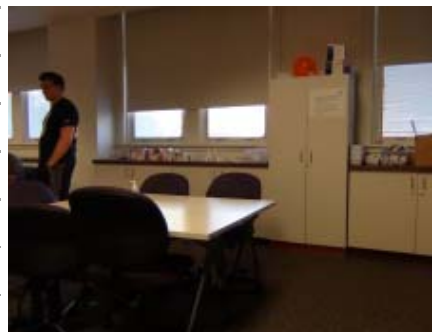
Barrier Description: Knee clearance not min. 27" high, 19" deep or 30" wide

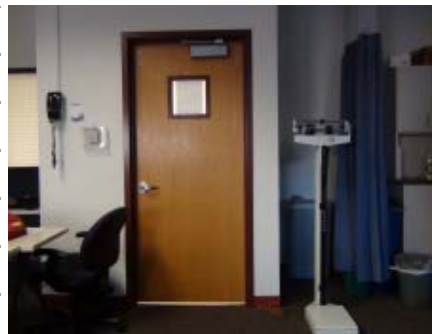
Barrier Description: Use of control involves low reach of less than 15" above floor or more than 48" high

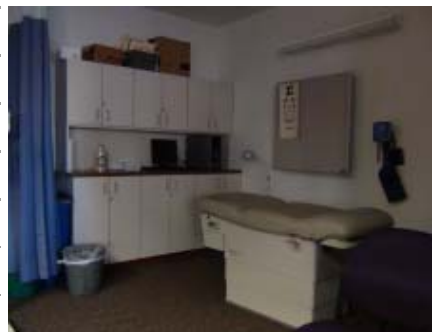
Field Date: 10/31/2015 Report Date 11/16/2015 Barrier #: 23R
 Bldg Name: Pharmacy Building Reference Dwg: 3 of 6
 Location: Floor 2 - Longs Patient Care Center
 X Coordinate: N/A Y Coordinate: N/A
 Barrier Area: Alarms
 Barrier Type: Horn/Strobe - Common Use Area
 Code: 2010 ADAS 702.1
 References:

Barrier Description: No horn/strobes in common use areas

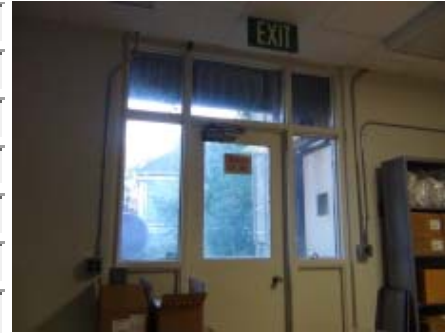
Field Date: 10/31/2015 Report Date 11/16/2015 Barrier #: 24A
 Bldg Name: Pharmacy Building Reference Dwg: 3 of 6
 Location: Floor 2 - North Exit Stairway
 X Coordinate: N/A Y Coordinate: N/A
 Barrier Area: Signage
 Barrier Type: Tactile Exit Signs - Stairway
 Code Performance Standard
 References:

Barrier Description: Door leading directly into an exit stairway lacks tactile exit sign

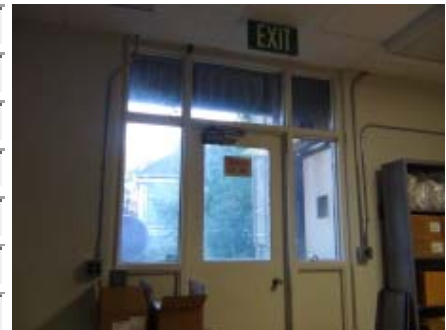
Field Date: 10/31/2015 Report Date 11/16/2015 Barrier #: 24B
 Bldg Name: Pharmacy Building Reference Dwg: 3 of 6
 Location: Floor 2 - North Exit Stairway
 X Coordinate: N/A Y Coordinate: N/A
 Barrier Area: Doors or Gates
 Barrier Type: Hardware - Operation
 Code 2010 ADAS 404.2.7
 References:

Barrier Description: Hardware not operable with a closed fist

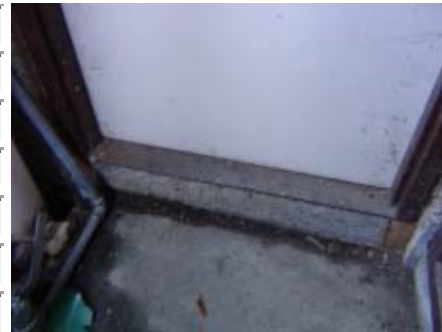
Field Date: 10/31/2015 Report Date 11/16/2015 Barrier #: 24E
 Bldg Name: Pharmacy Building Reference Dwg: 3 of 6
 Location: Floor 2 - North Exit Stairway
 X Coordinate: N/A Y Coordinate: N/A
 Barrier Area: Doors or Gates
 Barrier Type: Threshold - Ramp
 Code: 2010 ADAS 404.2.5
 References:

Barrier Description: Door/Gate threshold exceeds 1/2" in height

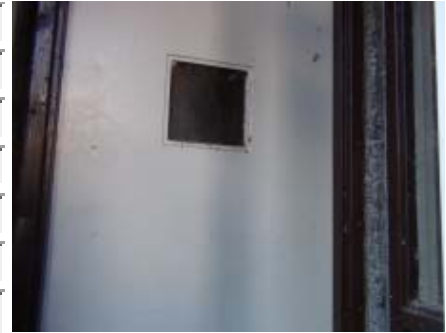
Field Date: 10/31/2015 Report Date 11/16/2015 Barrier #: 24G
 Bldg Name: Pharmacy Building Reference Dwg: 3 of 6
 Location: Floor 2 - North Exit Stairway
 X Coordinate: N/A Y Coordinate: N/A
 Barrier Area: Doors or Gates
 Barrier Type: Clear Width
 Code: 2010 ADAS 404.2.3
 References:

Barrier Description: Clear width passage through door, sliding/folding door or gate is not min. 32"

Rec. Solution: Replace door or gate and frame

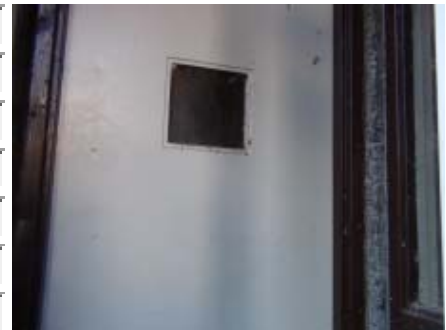
Barrier Description: Door opening force exceeds 5 lbf

Rec. Solution: Replace or adjust existing closer

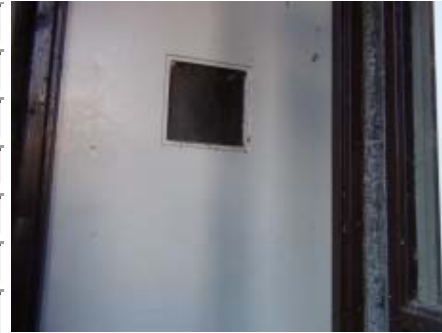
Barrier Description: Door closer lacks min. 5 second sweep period or does not stop 5" from door frame

Rec. Solution: Replace closer or provide automatic door opening device

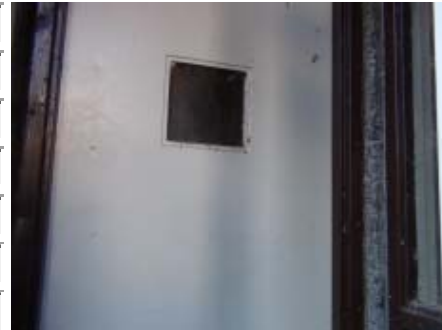
Field Date: 11/1/2015 Report Date: 11/16/2015 Barrier #: 24J
 Bldg Name: Pharmacy Building Reference Dwg: 3 of 6
 Location: Floor 2 - North Exit Stairway
 X Coordinate: N/A Y Coordinate: N/A
 Barrier Area: Doors or Gates
 Barrier Type: Vision Lights - Existing
 Code: 2010 ADAS 404.2.11
 References:

Barrier Description: View panels in or adjacent to doors or gates not max. 43" above floor or ground

Rec. Solution: Replace door/gate or vision panel

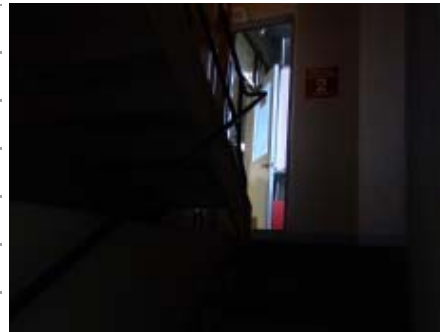
Field Date: 11/1/2015 Report Date 11/16/2015 Barrier #: 24K
 Bldg Name: Pharmacy Building Reference Dwg: 3 of 6
 Location: Floor 2 - North Exit Stairway
 X Coordinate: N/A Y Coordinate: N/A
 Barrier Area: Stairways
 Barrier Type: Sign - Enclosed Exit Stairway Level
 Code: ICC A117.1
 References:

Barrier Description: Tactile stairway signage not provided to indicate floor level

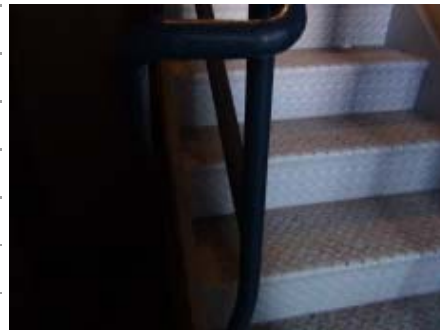
Field Date: 11/1/2015 Report Date 11/16/2015 Barrier #: 24L
 Bldg Name: Pharmacy Building Reference Dwg: 3 of 6
 Location: Floor 2 - North Exit Stairway
 X Coordinate: N/A Y Coordinate: N/A
 Barrier Area: Stairways
 Barrier Type: Handrail Height
 Code: 2010 ADAS 505.10.2
 References:

Barrier Description: Handrail grip measured at center not 34"- 38" high

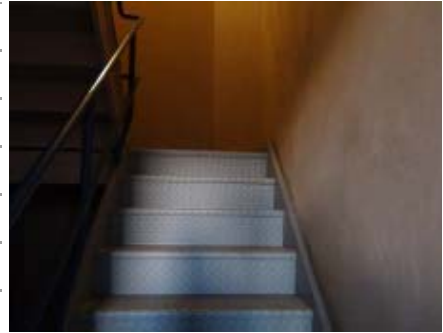
Field Date: 11/1/2015 Report Date 11/16/2015 Barrier #: 24M
 Bldg Name: Pharmacy Building Reference Dwg: 3 of 6
 Location: Floor 2 - North Exit Stairway
 X Coordinate: N/A Y Coordinate: N/A
 Barrier Area: Stairways
 Barrier Type: Contrasting Color - ADA
 Code: 2010 ADAS Advisory 504.4
 References:

Barrier Description: No contrasting color on each tread of interior stairway

Rec. Solution: Recommended: Consider providing contrasting color on each tread

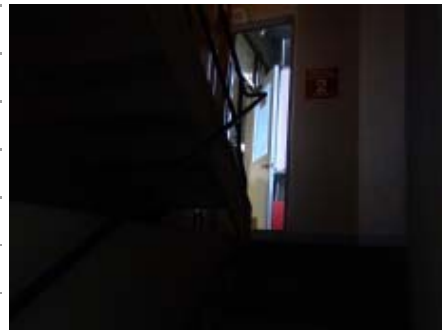
Barrier Description: Guard or handrail have openings that allow passage of a 4" sphere

Rec. Solution: Replace handrails

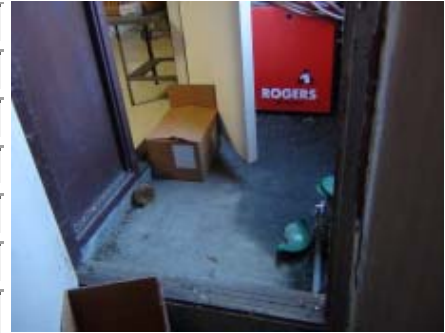
Field Date: 11/1/2015 Report Date 11/16/2015 Barrier #: 240
 Bldg Name: Pharmacy Building Reference Dwg: 3 of 6
 Location: Floor 2 - North Exit Stairway
 X Coordinate: N/A Y Coordinate: N/A
 Barrier Area: Doors or Gates
 Barrier Type: Threshold - Ramp
 Code: 2010 ADAS 404.2.5
 References:

Barrier Description: Door/Gate threshold exceeds 1/2" in height

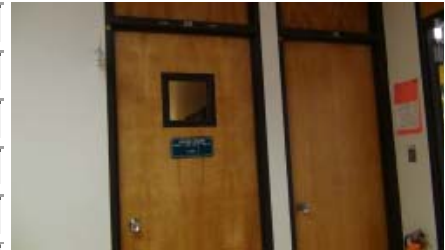
Barrier Description: No tactile characters at sign identifying permanent rooms and spaces with visual signs

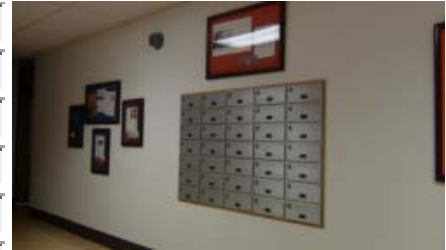
Field Date: 11/1/2015 Report Date: 11/16/2015 Barrier #: 25D
 Bldg Name: Pharmacy Building Reference Dwg: 3 of 6
 Location: Floor 2 - South Central Corridor
 X Coordinate: N/A Y Coordinate: N/A
 Barrier Area: Controls and Mechanisms
 Barrier Type: Actuator/Control - Hi/low Reach
 Code: 2010 ADAS 308.2.2
 References:

Barrier Description: Use of control involves low reach of less than 15" above floor or more than 48" high

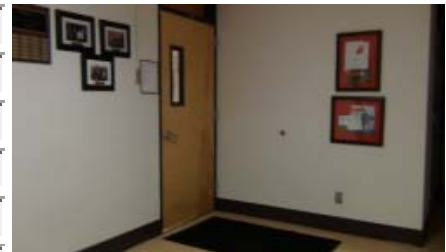
Field Date: 11/1/2015 Report Date: 11/16/2015 Barrier #: 25E
 Bldg Name: Pharmacy Building Reference Dwg: 3 of 6
 Location: Floor 2 - South Central Corridor
 X Coordinate: N/A Y Coordinate: N/A
 Barrier Area: Doors or Gates
 Barrier Type: Doormat
 Code: 2010 ADAS 302.2 & Advisory 302.2
 References:

Barrier Description: Doormat not anchored to floor (possible trip hazard)

Rec. Solution: Secure exiting doormat or replace

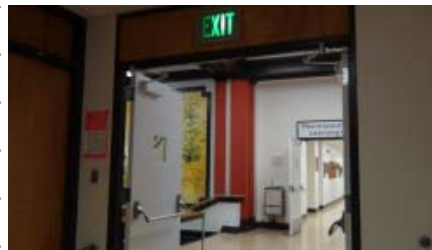
Field Date: 11/1/2015 Report Date: 11/16/2015 Barrier #: 25F
 Bldg Name: Pharmacy Building Reference Dwg: 3 of 6
 Location: Floor 2 - South Central Corridor
 X Coordinate: N/A Y Coordinate: N/A
 Barrier Area: Corridors
 Barrier Type: Horn/Strobe Device
 Code: 2010 ADAS 702.1
 References:

Barrier Description: No horn or strobe in corridor where fire alarm exists in building

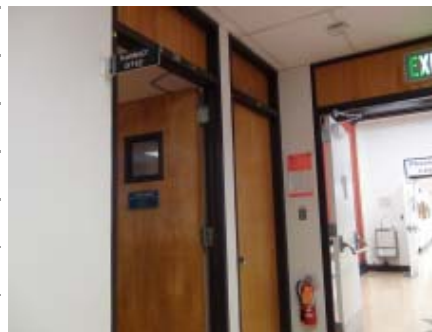
Field Date: 11/1/2015 Report Date: 11/16/2015 Barrier #: 26A
 Bldg Name: Pharmacy Building Reference Dwg: 3 of 6
 Location: Floor 2 - Pharmacy School Office 203
 X Coordinate: N/A Y Coordinate: N/A
 Barrier Area: Signage
 Barrier Type: Permanent Room/Space - Tactile Characters
 Code: 2010 ADAS 216.2
 References:

Barrier Description: No tactile characters at sign identifying permanent rooms and spaces with visual signs

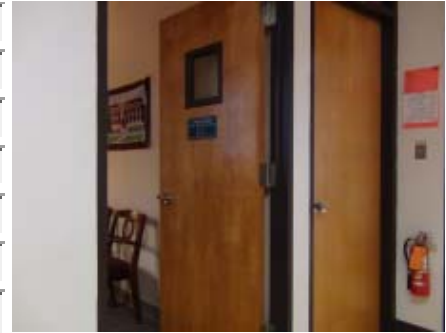
Field Date: 11/1/2015 Report Date: 11/16/2015 Barrier #: 26F
 Bldg Name: Pharmacy Building Reference Dwg: 3 of 6
 Location: Floor 2 - Pharmacy School Office 203
 X Coordinate: N/A Y Coordinate: N/A
 Barrier Area: Controls and Mechanisms
 Barrier Type: Electrical Switches - Height
 Code: 2010 ADAS 308.2
 References:

Barrier Description: Light switch control box top edge not at max. 48" high

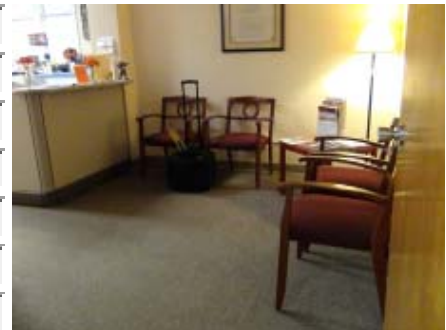
Field Date: 11/1/2015 Report Date: 11/16/2015 Barrier #: 26G
 Bldg Name: Pharmacy Building Reference Dwg: 3 of 6
 Location: Floor 2 - Pharmacy School Office 203
 X Coordinate: N/A Y Coordinate: N/A
 Barrier Area: Clear Floor Space
 Barrier Type: Clear Floor Space - Wheelchair Use
 Code: 2010 ADAS 305
 References:

Barrier Description: Clear floor space of min. 30" by 48" not provided

Barrier Severity: 2 Recommended Cost Est \$0.00 Facility Function: Public Status: Open

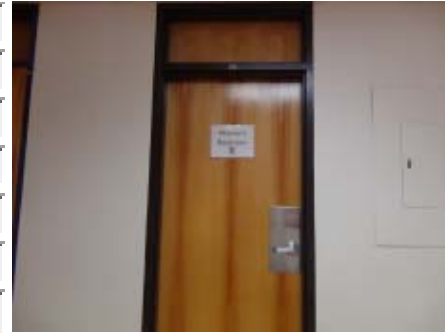
Field Date: 11/1/2015 Report Date: 11/16/2015 Barrier #: 27A
 Bldg Name: Pharmacy Building Reference Dwg: 3 of 6
 Location: Floor 2 - Women's Restroom Entry Vestibule 215
 X Coordinate: N/A Y Coordinate: N/A
 Barrier Area: Restrooms
 Barrier Type: Sign - No Tactile Characters
 Code: 2010 ADAS 703.1
 References:

Barrier Description: No tactile characters at sign identifying permanent rooms and spaces

Rec. Solution: Replace sign

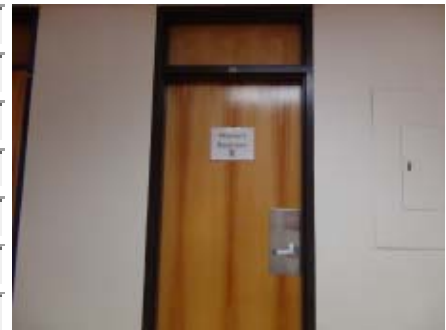
Field Date: 11/1/2015 Report Date: 11/16/2015 Barrier #: 27B
 Bldg Name: Pharmacy Building Reference Dwg: 3 of 6
 Location: Floor 2 - Women's Restroom Entry Vestibule 215
 X Coordinate: N/A Y Coordinate: N/A
 Barrier Area: Restrooms
 Barrier Type: Sign - ISA at Accessible Restroom
 Code: 2010 ADAS 216.8
 References:

Barrier Description: No ISA symbol on wall sign posted at accessible toilet room

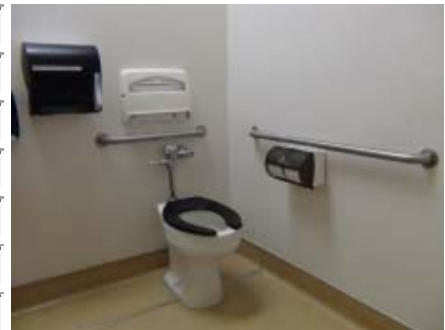
Field Date: 11/1/2015 Report Date 11/16/2015 Barrier #: 28I
 Bldg Name: Pharmacy Building Reference Dwg: 3 of 6
 Location: Floor 2 - Women's Accessible Restroom 215B
 X Coordinate: N/A Y Coordinate: N/A
 Barrier Area: Restrooms
 Barrier Type: Dispensers - Protruding Object
 Code: 2010 ADAS 307.2
 References:

Barrier Description: Protruding dispenser creates protruding hazard in path of travel

Barrier Severity: 2 Recommended Cost Est \$550.00 Facility Function: Public Status: Open

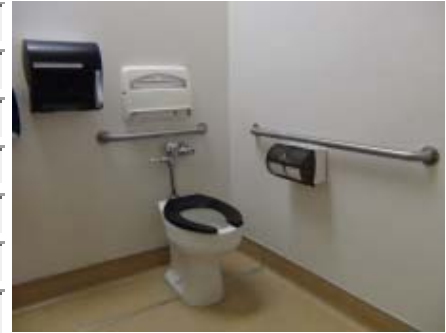
Field Date: 11/1/2015 Report Date: 11/16/2015 Barrier #: 28J
 Bldg Name: Pharmacy Building Reference Dwg: 3 of 6
 Location: Floor 2 - Women's Accessible Restroom 215B
 X Coordinate: N/A Y Coordinate: N/A
 Barrier Area: Restrooms
 Barrier Type: Toilet - Rear Grab Bar
 Code: 2010 ADAS 604.5.2
 References:

Barrier Description: Rear grab bar not centered 12" from wall and 24" on the other side of WC

Rec. Solution: Replace grab bars with reinforcement

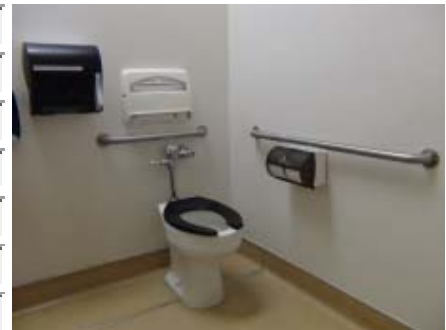
Field Date: 11/1/2015 Report Date: 11/16/2015 Barrier #: 28K
 Bldg Name: Pharmacy Building Reference Dwg: 3 of 6
 Location: Floor 2 - Women's Accessible Restroom 215B
 X Coordinate: N/A Y Coordinate: N/A
 Barrier Area: Restrooms
 Barrier Type: Toilet Paper Dispenser
 Code: 2010 ADAS 609.3
 References:

Barrier Description: Toilet tissue dispenser interferes with use of side grab bar

Barrier Severity: 2 Recommended Cost Est: \$225.00 Facility Function: Public Status: Open

Rec. Solution: Reposition or replace toilet paper dispenser

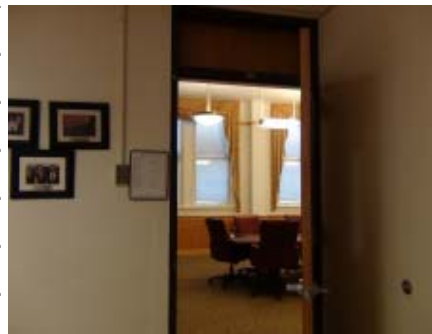
Field Date: 11/1/2015 Report Date: 11/16/2015 Barrier #: 30A
 Bldg Name: Pharmacy Building Reference Dwg: 3 of 6
 Location: Floor 2 - Conference Room 213
 X Coordinate: N/A Y Coordinate: N/A
 Barrier Area: Signage
 Barrier Type: Permanent Room/Space - Tactile Characters
 Code: 2010 ADAS 216.2
 References:

Barrier Description: No tactile characters at sign identifying permanent rooms and spaces with visual signs
