OREGON STATE UNIVERSITY (OSU)

PHARMACY BUILDING

ADA ASSESSMENT & SURVEY

Re: ADA Accessibility Survey and Assessment – Pharmacy Building

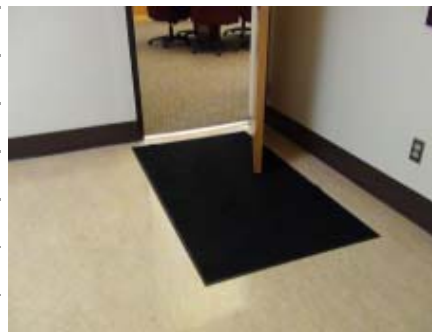
Field Date: 11/1/2015 Report Date: 11/16/2015 Barrier #: 30B
 Bldg Name: Pharmacy Building Reference Dwg: 3 of 6
 Location: Floor 2 - Conference Room 213
 X Coordinate: N/A Y Coordinate: N/A
 Barrier Area: Doors or Gates
 Barrier Type: Doormat
 Code: 2010 ADAS 302.2 & Advisory 302.2
 References:

Barrier Description: Doormat not anchored to floor (possible trip hazard)

Rec. Solution: Secure exiting doormat or replace

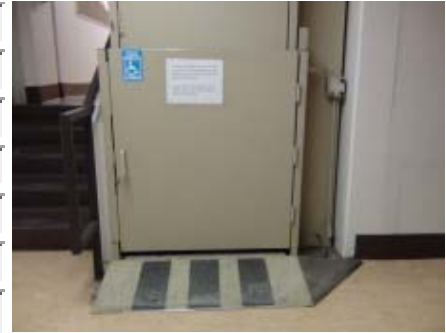
Field Date: 11/2/2015 Report Date: 11/16/2015 Barrier #: 31K
 Bldg Name: Pharmacy Building Reference Dwg: 4 of 6
 Location: Floor 3 - Central Corridor
 X Coordinate: N/A Y Coordinate: N/A
 Barrier Area: Stairways
 Barrier Type: Vertical Access - Lift
 Code: 2010 ADAS 403.1
 References:

Barrier Description: No form of vertical access provided at stairway to reach upper floors

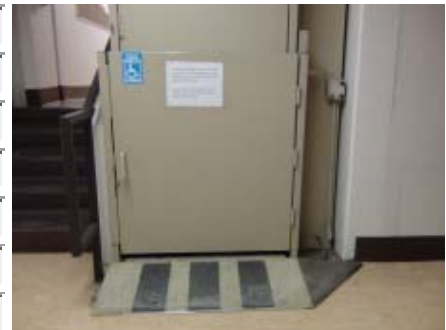
Field Date: 11/2/2015 Report Date: 11/16/2015 Barrier #: 31L
 Bldg Name: Pharmacy Building Reference Dwg: 4 of 6
 Location: Floor 3 - Central Corridor
 X Coordinate: N/A Y Coordinate: N/A
 Barrier Area: Controls and Mechanisms
 Barrier Type: Actuator/Control - Fist Operable
 Code: 2010 ADAS 305.3
 References:

Barrier Description: Control or mechanism not usable with a closed fist

Rec. Solution: Replace operating control

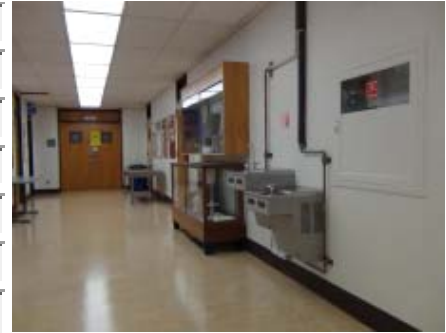
Field Date: 11/2/2015 Report Date: 11/16/2015 Barrier #: 31S
 Bldg Name: Pharmacy Building Reference Dwg: 4 of 6
 Location: Floor 3 - Central Corridor
 X Coordinate: N/A Y Coordinate: N/A
 Barrier Area: Drinking Fountains
 Barrier Type: Alcove - Existing (pre-1992)
 Code: 2010 ADAS 307.2
 References:

Barrier Description: Fountain with a leading edge between 27" and 80" high protrudes more than 4" into the circulation path.

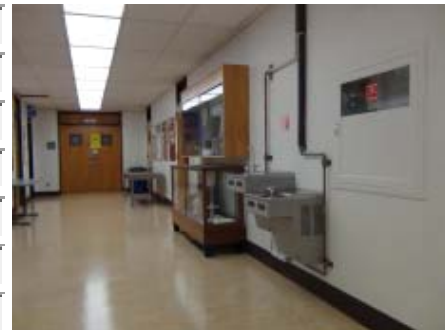
Field Date: 11/2/2015 Report Date: 11/16/2015 Barrier #: 31T
 Bldg Name: Pharmacy Building Reference Dwg: 4 of 6
 Location: Floor 3 - Central Corridor
 X Coordinate: N/A Y Coordinate: N/A
 Barrier Area: Drinking Fountains
 Barrier Type: Knee Clearance
 Code: 2010 ADAS 306.3
 References:

Barrier Description: Knee clearance under fountain not min. 27" high

Rec. Solution: Replace drinking fountain with accessible unit or remount existing

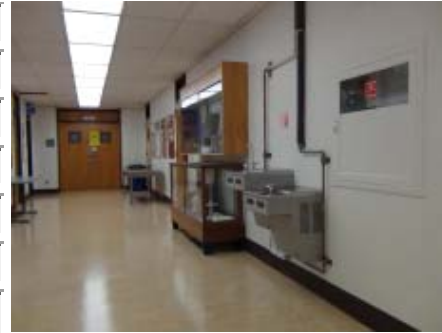
Field Date: 11/2/2015 Report Date: 11/16/2015 Barrier #: 31U
 Bldg Name: Pharmacy Building Reference Dwg: 4 of 6
 Location: Floor 3 - Central Corridor
 X Coordinate: N/A Y Coordinate: N/A
 Barrier Area: Drinking Fountains
 Barrier Type: Spout Location
 Code: 2010 ADAS 602.4
 References:

Barrier Description: Spout not located at max. 5" from rim or max 15" from backsplash

Rec. Solution: Replace fountain with accessible unit

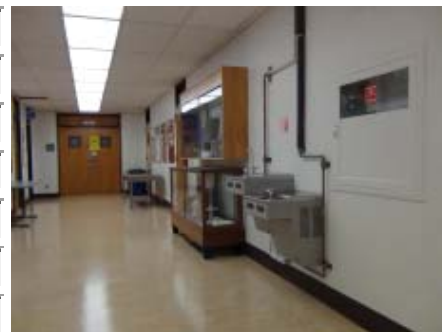
Field Date: 11/2/2015 Report Date: 11/16/2015 Barrier #: 31V
 Bldg Name: Pharmacy Building Reference Dwg: 4 of 6
 Location: Floor 3 - Central Corridor
 X Coordinate: N/A Y Coordinate: N/A
 Barrier Area: Corridors
 Barrier Type: Strobe
 Code: 2010 ADAS 702.1
 References:

Barrier Description: No strobe provided in corridor where horn is provided where fire alarm exists in building

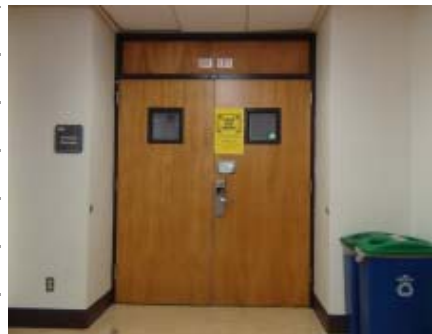
Field Date: 11/2/2015 Report Date: 11/16/2015 Barrier #: 32A
 Bldg Name: Pharmacy Building Reference Dwg: 4 of 6
 Location: Floor 3 - Classroom 302
 X Coordinate: N/A Y Coordinate: N/A
 Barrier Area: Signage
 Barrier Type: Location - 48" to 60" high
 Code: 2010 ADAS 703.4.1
 References:

Barrier Description: Braille/Tactile information on sign not mounted between 48" and 60" from ground or floor

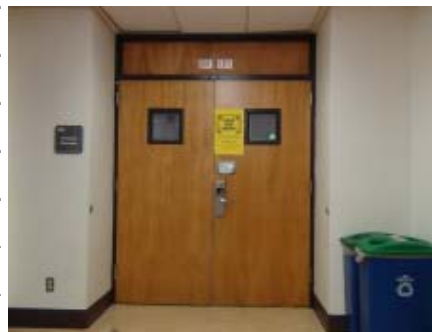
Field Date: 11/2/2015 Report Date: 11/16/2015 Barrier #: 32B
 Bldg Name: Pharmacy Building Reference Dwg: 4 of 6
 Location: Floor 3 - Classroom 302
 X Coordinate: N/A Y Coordinate: N/A
 Barrier Area: Signage
 Barrier Type: Braille - Distance from Characters
 Code: 2010 ADAS 703.3
 References:

Barrier Description: Braille not 3/8" and max. 1/2" directly below the tactile characters

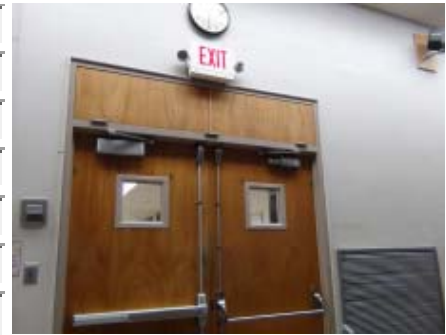
Field Date: 11/2/2015 Report Date: 11/16/2015 Barrier #: 32C
 Bldg Name: Pharmacy Building Reference Dwg: 4 of 6
 Location: Floor 3 - Classroom 302
 X Coordinate: N/A Y Coordinate: N/A
 Barrier Area: Doors or Gates
 Barrier Type: Vision Lights - Existing
 Code: 2010 ADAS 404.2.11
 References:

Barrier Description: View panels in or adjacent to doors or gates not max. 43" above floor or ground

Rec. Solution: Replace door/gate or vision panel

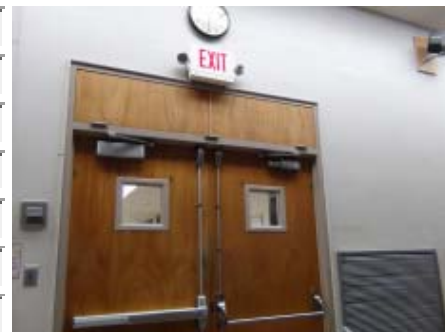
Field Date: 11/2/2015 Report Date: 11/16/2015 Barrier #: 32D
 Bldg Name: Pharmacy Building Reference Dwg: 4 of 6
 Location: Floor 3 - Classroom 302
 X Coordinate: N/A Y Coordinate: N/A
 Barrier Area: Doors or Gates
 Barrier Type: Door Closer - Interior Automatic Door
 Code: 2010 ADAS 404.2.9
 References:

Barrier Description: Door opening force exceeds 5 lbf

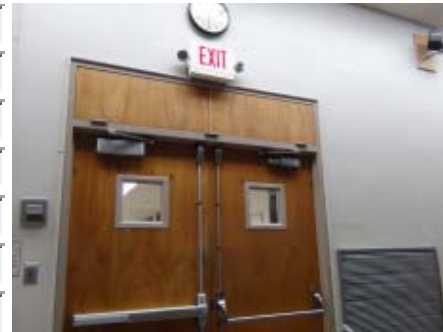
Field Date: 11/2/2015 Report Date: 11/16/2015 Barrier #: 32E
 Bldg Name: Pharmacy Building Reference Dwg: 4 of 6
 Location: Floor 3 - Classroom 302
 X Coordinate: N/A Y Coordinate: N/A
 Barrier Area: Doors or Gates
 Barrier Type: Door Closer - Interior Sweep Period
 Code: 2010 ADAS 404.2.8.1
 References:

Barrier Description: Door closer lacks min. 5 second sweep period or does not stop 5" from door frame

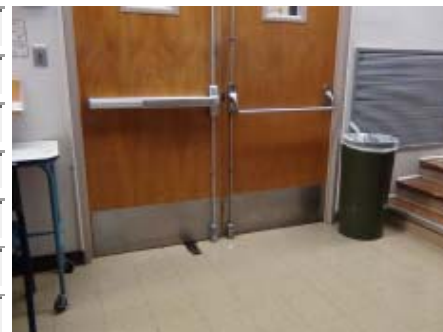
Field Date: 11/2/2015 Report Date: 11/16/2015 Barrier #: 32F
 Bldg Name: Pharmacy Building Reference Dwg: 4 of 6
 Location: Floor 3 - Classroom 302
 X Coordinate: N/A Y Coordinate: N/A
 Barrier Area: Doors or Gates
 Barrier Type: Door 10" Bottom Surface - Door Hardware
 Code: 2010 ADAS 404.2.10
 References:

Barrier Description: Door hardware interrupts min. 10" smooth bottom surface

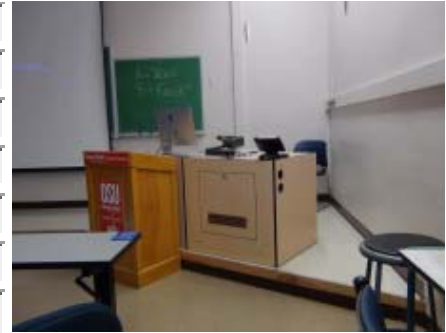
Field Date: 11/2/2015 Report Date: 11/16/2015 Barrier #: 32K
 Bldg Name: Pharmacy Building Reference Dwg: 4 of 6
 Location: Floor 3 - Classroom 302
 X Coordinate: N/A Y Coordinate: N/A
 Barrier Area: Classrooms
 Barrier Type: Accessible Route - Remodel
 Code: 2010 ADAS 305.3
 References:

Barrier Description: Clear floor space does not adjoin an accessible route or another space

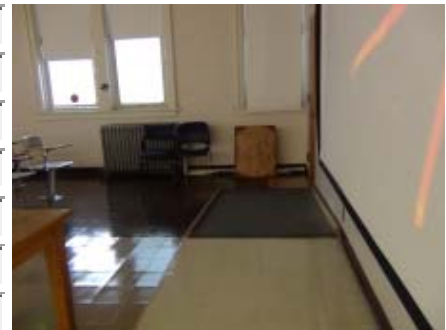
Field Date: 11/2/2015 Report Date: 11/16/2015 Barrier #: 32L
 Bldg Name: Pharmacy Building Reference Dwg: 4 of 6
 Location: Floor 3 - Classroom 302
 X Coordinate: N/A Y Coordinate: N/A
 Barrier Area: Ramps
 Barrier Type: Ramp Landing - Top Landing
 Code: 2010 ADAS 405.7.3
 References:

Barrier Description: Top landing is not min. 60" long

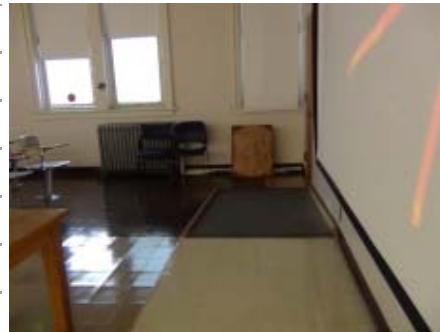
Field Date: 11/2/2015 Report Date: 11/16/2015 Barrier #: 32M
 Bldg Name: Pharmacy Building Reference Dwg: 4 of 6
 Location: Floor 3 - Classroom 302
 X Coordinate: N/A Y Coordinate: N/A
 Barrier Area: Ramps
 Barrier Type: Handrail
 Code: 2010 ADAS 505.2
 References:

Barrier Description: No handrail provided at both sides

Rec. Solution: Replace handrails at both sides of ramp

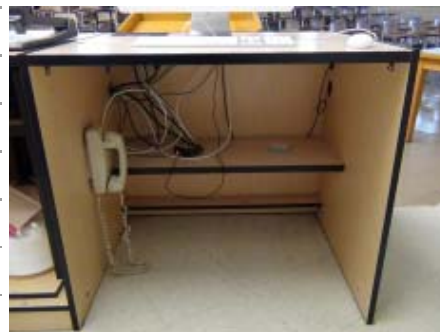
Field Date: 11/2/2015 Report Date: 11/16/2015 Barrier #: 32N
 Bldg Name: Pharmacy Building Reference Dwg: 4 of 6
 Location: Floor 3 - Classroom 302
 X Coordinate: N/A Y Coordinate: N/A
 Barrier Area: Classrooms
 Barrier Type: Podium - Knee Clearance
 Code: 2010 ADAS 504.2
 References:

Barrier Description: Podium knee clearance not min. 27" high, 19" deep or 30" wide

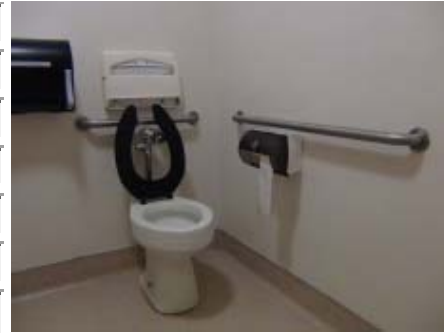
Field Date: 11/2/2015 Report Date: 11/16/2015 Barrier #: 34H
 Bldg Name: Pharmacy Building Reference Dwg: 4 of 6
 Location: Floor 3 - Women's Accessible Restroom 307B
 X Coordinate: N/A Y Coordinate: N/A
 Barrier Area: Restrooms
 Barrier Type: Dispensers - Protruding Object
 Code: 2010 ADAS 307.2
 References:

Barrier Description: Protruding dispenser creates protruding hazard in path of travel

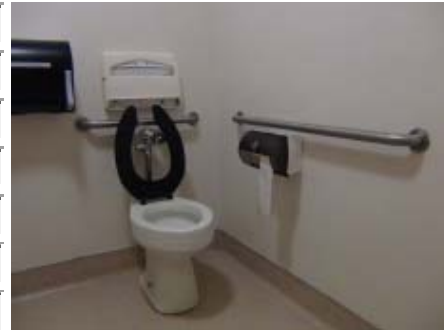
Field Date: 11/2/2015 Report Date: 11/16/2015 Barrier #: 34I
 Bldg Name: Pharmacy Building Reference Dwg: 4 of 6
 Location: Floor 3 - Women's Accessible Restroom 307B
 X Coordinate: N/A Y Coordinate: N/A
 Barrier Area: Restrooms
 Barrier Type: Toilet - Rear Grab Bar
 Code: 2010 ADAS 604.5.2
 References:

Barrier Description: Rear grab bar not centered 12" from wall and 24" on the other side of WC

Rec. Solution: Replace grab bars with reinforcement

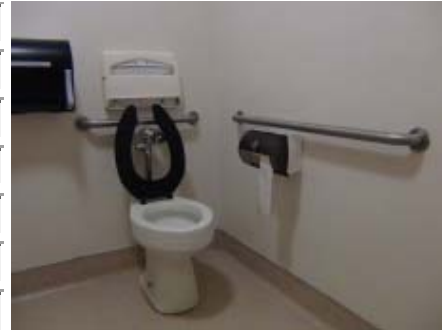
Field Date: 11/2/2015 Report Date: 11/16/2015 Barrier #: 34L
 Bldg Name: Pharmacy Building Reference Dwg: 4 of 6
 Location: Floor 3 - Women's Accessible Restroom 307B
 X Coordinate: N/A Y Coordinate: N/A
 Barrier Area: Restrooms
 Barrier Type: Seat Cover Dispenser
 Code: 2010 ADAS 307.2
 References:

Barrier Description: Seat cover dispenser not located on an accessible route. Blocked by water closet

Rec. Solution: Replace or remount dispenser on an accessible route with clear floor space

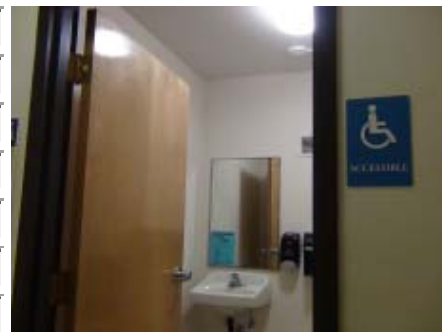
Field Date: 11/2/2015 Report Date: 11/16/2015 Barrier #: 34M
 Bldg Name: Pharmacy Building Reference Dwg: 4 of 6
 Location: Floor 3 - Women's Accessible Restroom 307B
 X Coordinate: N/A Y Coordinate: N/A
 Barrier Area: Restrooms
 Barrier Type: Alarm - Horn/Strobe
 Code: 2010 ADAS 702.1
 References:

Barrier Description: Where a fire alarm is installed, no horn/strobe provided

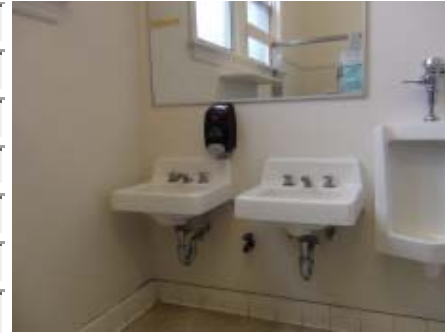
Field Date: 11/2/2015 Report Date 11/16/2015 Barrier #: 35C
Bldg Name: Pharmacy Building Reference Dwg: 4 of 6
Location: Floor 3 - Multi-accommodation Women's Toilet Room 30
X Coordinate: N/A Y Coordinate: N/A
Barrier Area: Restrooms
Barrier Type: Lavatory - Drainpipes
Code 2010 ADAS 606.5
References:

Barrier Description: Hot water and drainpipes accessible under lavatory not insulated or covered

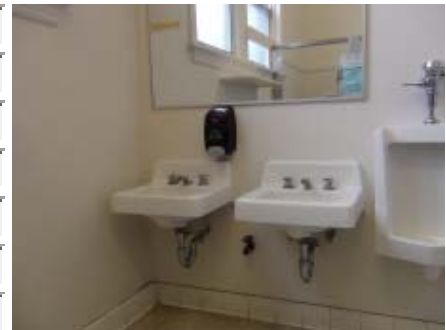
Field Date: 11/2/2015 Report Date 11/16/2015 Barrier #: 35D
Bldg Name: Pharmacy Building Reference Dwg: 4 of 6
Location: Floor 3 - Multi-accommodation Women's Toilet Room 30
X Coordinate: N/A Y Coordinate: N/A
Barrier Area: Restrooms
Barrier Type: Mirror
Code 2010 ADAS 603.3
References:

Barrier Description: Mirror at lavatory/countertop not max. 40" AFF at edge of reflecting surface

Rec. Solution: Replace or remount mirror

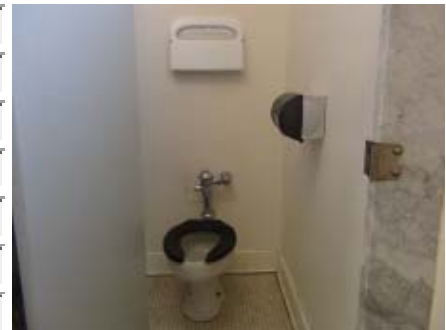
Field Date: 11/2/2015 Report Date 11/16/2015 Barrier #: 35N
 Bldg Name: Pharmacy Building Reference Dwg: 4 of 6
 Location: Floor 3 - Multi-accommodation Women's Toilet Room 30
 X Coordinate: N/A Y Coordinate: N/A
 Barrier Area: Restrooms
 Barrier Type: Toilet Paper Dispenser
 Code 2010 ADAS 604.7
 References:

Barrier Description: Toilet tissue dispenser not within 7" to 9" from front edge of toilet

Rec. Solution: Reposition or replace toilet paper dispenser

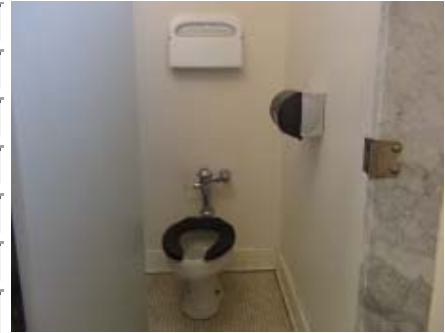
Field Date: 11/2/2015 Report Date: 11/16/2015 Barrier #: 350
 Bldg Name: Pharmacy Building Reference Dwg: 4 of 6
 Location: Floor 3 - Multi-accommodation Women's Toilet Room 30
 X Coordinate: N/A Y Coordinate: N/A
 Barrier Area: Restrooms
 Barrier Type: Toilet Paper Dispenser
 Code: 2010 ADAS 604.7
 References:

Barrier Description: Toilet tissue dispenser not easily reachable from toilet seat

Rec. Solution: Reposition or replace toilet paper dispenser

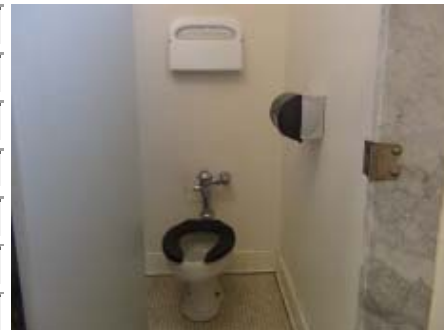
Field Date: 11/2/2015 Report Date: 11/16/2015 Barrier #: 35P
 Bldg Name: Pharmacy Building Reference Dwg: 4 of 6
 Location: Floor 3 - Multi-accommodation Women's Toilet Room 30
 X Coordinate: N/A Y Coordinate: N/A
 Barrier Area: Restrooms
 Barrier Type: Seat Cover Dispenser
 Code: 2010 ADAS 307.2
 References:

Barrier Description: Seat cover dispenser not located on an accessible route. Blocked by water closet

Rec. Solution: Replace or remount dispenser on an accessible route with clear floor space

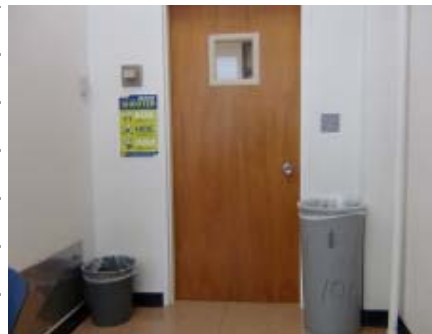
Field Date: 11/2/2015 Report Date: 11/16/2015 Barrier #: 36D
Bldg Name: Pharmacy Building Reference Dwg: 4 of 6
Location: Floor 3 - Classroom 324
X Coordinate: N/A Y Coordinate: N/A
Barrier Area: Classrooms
Barrier Type: Electrical Switches - High Unobstructed
Code: 2010 ADAS 308.2.1
References:

Barrier Description: Light switch control box top edge not at max. 48" high

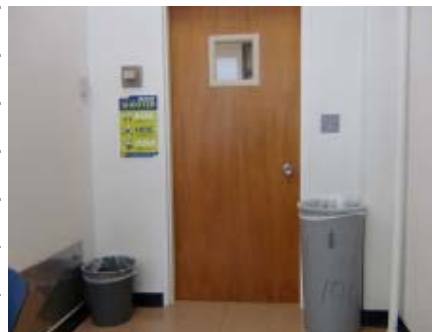
Field Date: 11/2/2015 Report Date: 11/16/2015 Barrier #: 36E
Bldg Name: Pharmacy Building Reference Dwg: 4 of 6
Location: Floor 3 - Classroom 324
X Coordinate: N/A Y Coordinate: N/A
Barrier Area: Classrooms
Barrier Type: Clear Floor Space - Stored Elements
Code: 2010 ADAS 305.3
References:

Barrier Description: Clear floor space for wheelchair not provided at control or mechanism

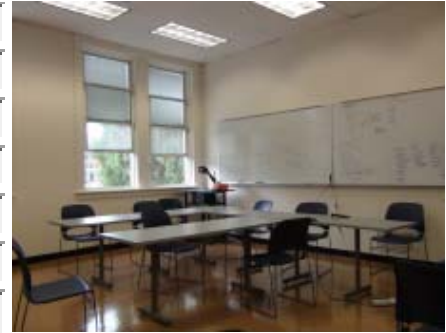
Field Date: 11/2/2015 Report Date: 11/16/2015 Barrier #: 36H
 Bldg Name: Pharmacy Building Reference Dwg: 4 of 6
 Location: Floor 3 - Classroom 324
 X Coordinate: N/A Y Coordinate: N/A
 Barrier Area: Classrooms
 Barrier Type: Accessible Route - Remodel
 Code: 2010 ADAS 305.3
 References:

Barrier Description: Clear floor space does not adjoin an accessible route or another space

Barrier Severity: 2 Recommended Cost Est: \$175.00 Facility Function: Public Status: Open

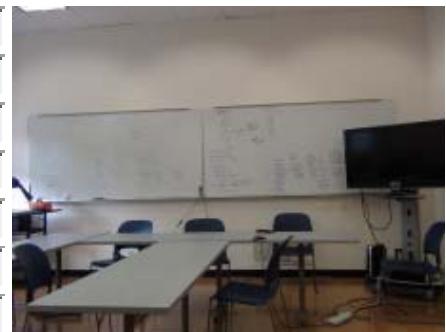
Field Date: 11/2/2015 Report Date: 11/16/2015 Barrier #: 36I
 Bldg Name: Pharmacy Building Reference Dwg: 4 of 6
 Location: Floor 3 - Classroom 324
 X Coordinate: N/A Y Coordinate: N/A
 Barrier Area: Classrooms
 Barrier Type: Alarm - No Horn/Strobe
 Code: 2010 ADAS 702.1
 References:

Barrier Description: Where a fire alarm is installed, no horn/strobe provided

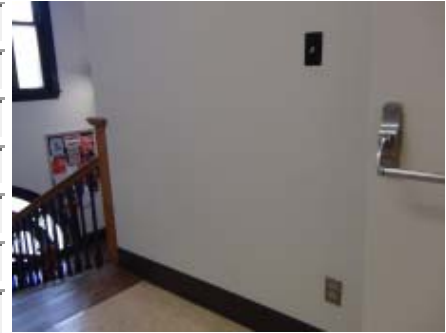
Field Date: 11/3/2015 Report Date: 11/16/2015 Barrier #: 37E
 Bldg Name: Pharmacy Building Reference Dwg: 4 of 6
 Location: Floor 3 - Southeast Exit Stairway
 X Coordinate: N/A Y Coordinate: N/A
 Barrier Area: Controls and Mechanisms
 Barrier Type: Electrical Switches - Height
 Code: 2010 ADAS 308.2
 References:

Barrier Description: Light switch control box top edge not at max. 48" high

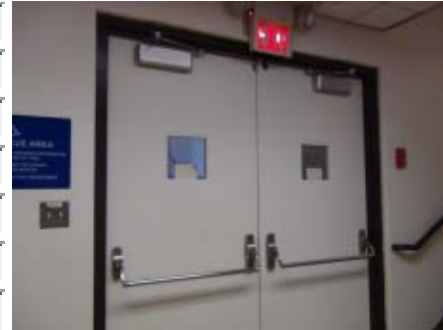
Field Date: 11/3/2015 Report Date: 11/16/2015 Barrier #: 38A
 Bldg Name: Pharmacy Building Reference Dwg: 4 of 6
 Location: Floor 3 - Northeast Exit Stairway
 X Coordinate: N/A Y Coordinate: N/A
 Barrier Area: Signage
 Barrier Type: Tactile Exit Signs - Passage
 Code: Performance Standard
 References:

Barrier Description: Exit thru an exit enclosure/exit passageway lacks tactile exit sign

Barrier Severity: 2 Recommended Cost Est: \$250.00 Facility Function: Public Status: Open

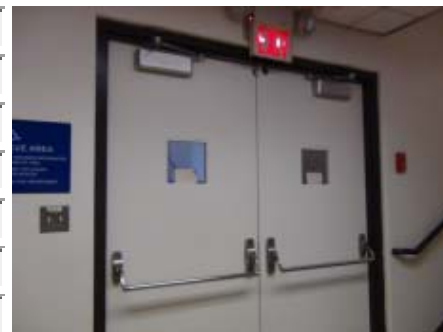
Field Date: 11/3/2015 Report Date: 11/16/2015 Barrier #: 38B
 Bldg Name: Pharmacy Building Reference Dwg: 4 of 6
 Location: Floor 3 - Northeast Exit Stairway
 X Coordinate: N/A Y Coordinate: N/A
 Barrier Area: Doors or Gates
 Barrier Type: Vision Lights - Existing
 Code: 2010 ADAS 404.2.11
 References:

Barrier Description: View panels in or adjacent to doors or gates not max. 43" above floor or ground

Rec. Solution: Replace door/gate or vision panel

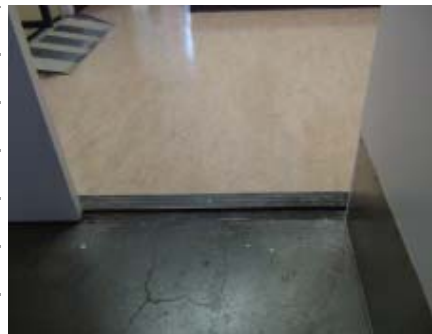
Field Date: 11/3/2015 Report Date: 11/16/2015 Barrier #: 38E
 Bldg Name: Pharmacy Building Reference Dwg: 4 of 6
 Location: Floor 3 - Northeast Exit Stairway
 X Coordinate: N/A Y Coordinate: N/A
 Barrier Area: Doors or Gates
 Barrier Type: Threshold - Height exceeding 1/2"
 Code: 2010 ADAS 404.2.5
 References:

Barrier Description: Door/Gate threshold exceeds 1/2" in height

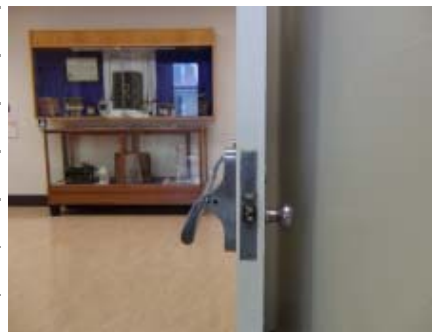
Field Date: 11/3/2015 Report Date: 11/16/2015 Barrier #: 38F
 Bldg Name: Pharmacy Building Reference Dwg: 4 of 6
 Location: Floor 3 - Northeast Exit Stairway
 X Coordinate: N/A Y Coordinate: N/A
 Barrier Area: Doors or Gates
 Barrier Type: Hardware - Operation
 Code: 2010 ADAS 404.2.7
 References:

Barrier Description: Hardware not operable with a closed fist

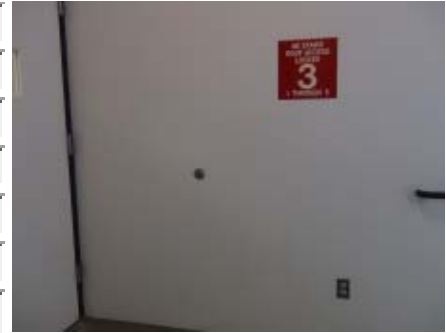
Field Date: 11/3/2015 Report Date: 11/16/2015 Barrier #: 38G
 Bldg Name: Pharmacy Building Reference Dwg: 4 of 6
 Location: Floor 3 - Northeast Exit Stairway
 X Coordinate: N/A Y Coordinate: N/A
 Barrier Area: Stairways
 Barrier Type: Sign - Enclosed Exit Stairway Level
 Code: ICC A117.1
 References:

Barrier Description: Tactile stairway signage not provided to indicate floor level

Barrier Severity: 2 Recommended Cost Est: \$250.00 Facility Function: Public Status: Open

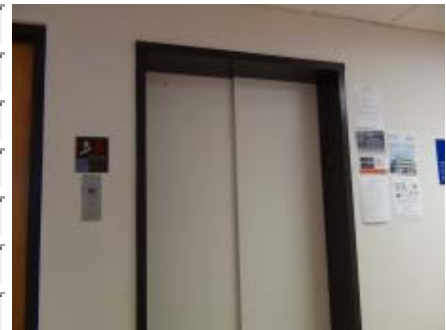
Field Date: 11/3/2015 Report Date: 11/16/2015 Barrier #: 39A
 Bldg Name: Pharmacy Building Reference Dwg: 4 of 6
 Location: Floor 3 - Elevator
 X Coordinate: N/A Y Coordinate: N/A
 Barrier Area: Elevators
 Barrier Type: Hall Call Buttons - 42" High
 Code: 2010 ADAS 407.2.1
 References:

Barrier Description: The centerline of the hall call buttons not max. 42" above the floor

Rec. Solution: Replace hall call buttons

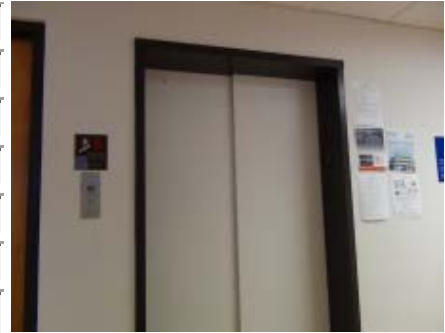
Field Date: 11/3/2015 Report Date: 11/16/2015 Barrier #: 39D
 Bldg Name: Pharmacy Building Reference Dwg: 4 of 6
 Location: Floor 3 - Elevator
 X Coordinate: N/A Y Coordinate: N/A
 Barrier Area: Elevators
 Barrier Type: Visual Car Position indicator
 Code: 2010 ADAS 407.4.8
 References:

Barrier Description: Visual car position indicator does not show the position of the elevator in the hoistway

Barrier Severity: 2 Recommended Cost Est: \$2,750.00 Facility Function: Public Status: Open

Rec. Solution: Replace car controls

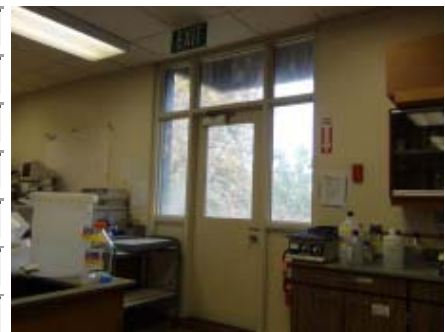
Field Date: 11/3/2015 Report Date: 11/16/2015 Barrier #: 40A
 Bldg Name: Pharmacy Building Reference Dwg: 4 of 6
 Location: Floor 3 - North Exit Stairway
 X Coordinate: N/A Y Coordinate: N/A
 Barrier Area: Signage
 Barrier Type: Tactile Exit Signs - Stairway
 Code: Performance Standard
 References:

Barrier Description: Door leading directly into an exit stairway lacks tactile exit sign

Barrier Severity: 2 Recommended Cost Est: \$250.00 Facility Function: Public Status: Open

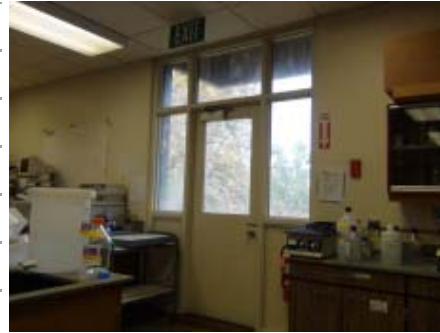
Code: 2010 ADAS 404.2.8.1

Barrier Description: Door closer lacks min. 5 second sweep period or does not stop 5" from door frame

Barrier Severity: 2 Recommended Cost Est: \$250.00 Facility Function: Public Status: Open

Rec. Solution: Replace closer or provide automatic door opening device

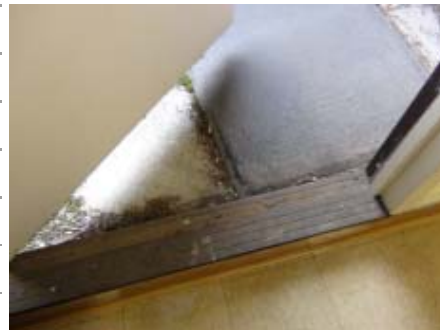
Code: 2010 ADAS 404.2.5

Barrier Description: Door/Gate threshold exceeds 1/2" in height

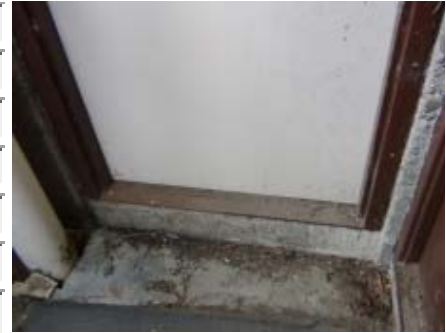
Field Date: 11/3/2015 Report Date: 11/16/2015 Barrier #: 40H
 Bldg Name: Pharmacy Building Reference Dwg: 4 of 6
 Location: Floor 3 - North Exit Stairway
 X Coordinate: N/A Y Coordinate: N/A
 Barrier Area: Doors or Gates
 Barrier Type: Threshold - Ramp
 Code: 2010 ADAS 404.2.5
 References:

Barrier Description: Door/Gate threshold exceeds 1/2" in height

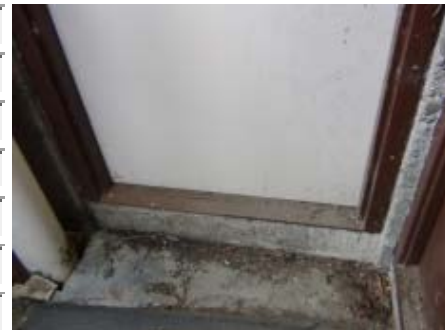
Field Date: 11/3/2015 Report Date: 11/16/2015 Barrier #: 40I
 Bldg Name: Pharmacy Building Reference Dwg: 4 of 6
 Location: Floor 3 - North Exit Stairway
 X Coordinate: N/A Y Coordinate: N/A
 Barrier Area: Doors or Gates
 Barrier Type: Clear Width
 Code: 2010 ADAS 404.2.3
 References:

Barrier Description: Clear width passage through door, sliding/folding door or gate is not min. 32"

Rec. Solution: Replace door or gate and frame

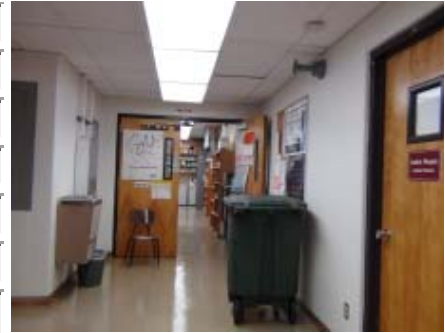
Field Date: 11/3/2015 Report Date: 11/16/2015 Barrier #: 41A
 Bldg Name: Pharmacy Building Reference Dwg: 5 of 6
 Location: Floor 4 - Central Corridor
 X Coordinate: N/A Y Coordinate: N/A
 Barrier Area: Signage
 Barrier Type: Permanent Room/Space - Tactile Characters
 Code: 2010 ADAS 216.2
 References:

Barrier Description: No tactile characters at sign identifying permanent rooms and spaces with visual signs

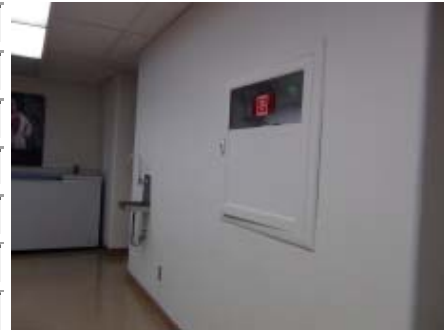
Field Date: 11/3/2015 Report Date: 11/16/2015 Barrier #: 41B
 Bldg Name: Pharmacy Building Reference Dwg: 5 of 6
 Location: Floor 4 - Central Corridor
 X Coordinate: N/A Y Coordinate: N/A
 Barrier Area: Alarms
 Barrier Type: Fire Extinguisher - Side Reach
 Code: 2010 ADAS 308.2.2
 References:

Barrier Description: Fire extinguisher forward or side reach exceeds 48"

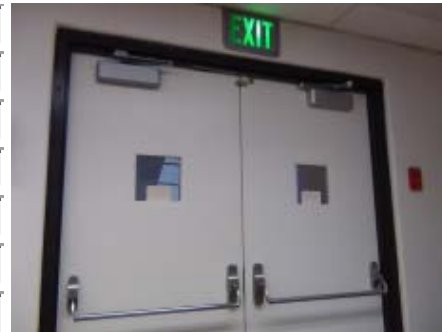
Field Date: 11/3/2015 Report Date: 11/16/2015 Barrier #: 42A
 Bldg Name: Pharmacy Building Reference Dwg: 5 of 6
 Location: Floor 4 - Northeast Exit Stairway
 X Coordinate: N/A Y Coordinate: N/A
 Barrier Area: Signage
 Barrier Type: Tactile Exit Signs - Passage
 Code: Performance Standard
 References:

Barrier Description: Exit thru an exit enclosure/exit passageway lacks tactile exit sign

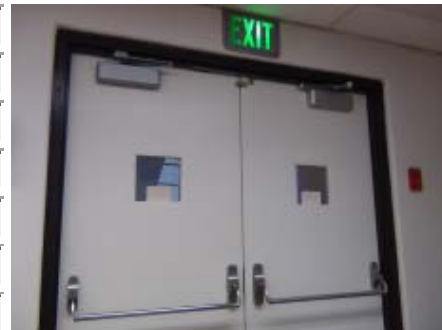
Field Date: 11/3/2015 Report Date: 11/16/2015 Barrier #: 42B
 Bldg Name: Pharmacy Building Reference Dwg: 5 of 6
 Location: Floor 4 - Northeast Exit Stairway
 X Coordinate: N/A Y Coordinate: N/A
 Barrier Area: Doors or Gates
 Barrier Type: Vision Lights - Existing
 Code: 2010 ADAS 404.2.11
 References:

Barrier Description: View panels in or adjacent to doors or gates not max. 43" above floor or ground

Rec. Solution: Replace door/gate or vision panel

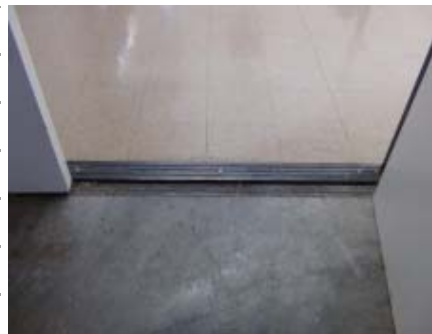
Field Date: 11/3/2015 Report Date 11/16/2015 Barrier #: 42E
 Bldg Name: Pharmacy Building Reference Dwg: 5 of 6
 Location: Floor 4 - Northeast Exit Stairway
 X Coordinate: N/A Y Coordinate: N/A
 Barrier Area: Doors or Gates
 Barrier Type: Threshold - Height exceeding 1/2"
 Code 2010 ADAS 404.2.5
 References:

Barrier Description: Door/Gate threshold exceeds 1/2" in height

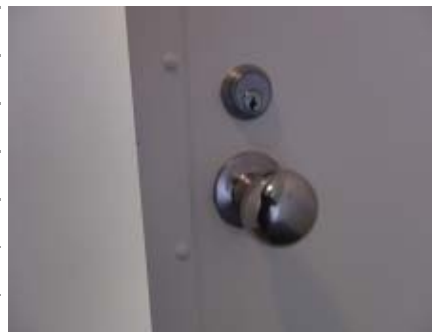
Field Date: 11/3/2015 Report Date 11/16/2015 Barrier #: 42F
 Bldg Name: Pharmacy Building Reference Dwg: 5 of 6
 Location: Floor 4 - Northeast Exit Stairway
 X Coordinate: N/A Y Coordinate: N/A
 Barrier Area: Doors or Gates
 Barrier Type: Hardware - Operation
 Code 2010 ADAS 404.2.7
 References:

Barrier Description: Hardware not operable with a closed fist

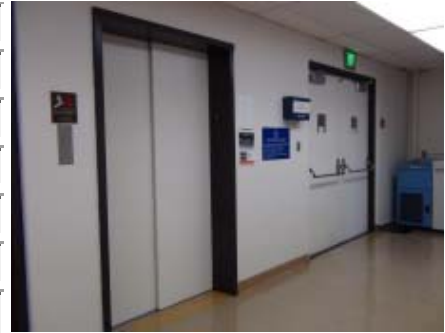
Field Date: 11/3/2015 Report Date 11/16/2015 Barrier #: 43B
 Bldg Name: Pharmacy Building Reference Dwg: 5 of 6
 Location: Floor 4 - Elevator
 X Coordinate: N/A Y Coordinate: N/A
 Barrier Area: Elevators
 Barrier Type: Hall Call Buttons
 Code: 2010 ADAS 407.4.5
 References:

Barrier Description: Hall call buttons not internally illuminated with a white light over the entire button surface

Rec. Solution: Replace hall call buttons

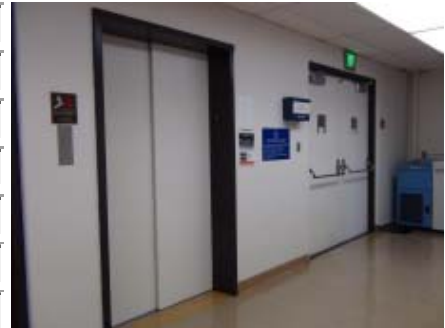
Field Date: 11/3/2015 Report Date 11/16/2015 Barrier #: 43C
 Bldg Name: Pharmacy Building Reference Dwg: 5 of 6
 Location: Floor 4 - Elevator
 X Coordinate: N/A Y Coordinate: N/A
 Barrier Area: Elevators
 Barrier Type: Emergency Sign at Call Station
 Code: Performance Standard & 2010 ADAS 703.1
 References:

Barrier Description: Sign stating "IN FIRE EMERGENCY, DO NOT USE ELEVATOR. USE EXIT STAIRS" not provided with tactile information

Rec. Solution: Replace sign

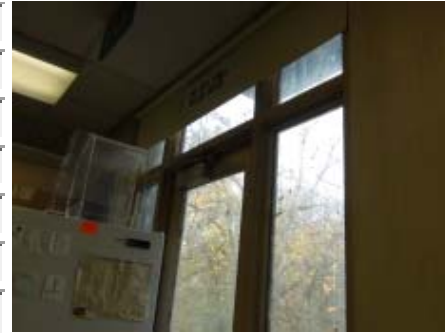
Field Date: 11/4/2015 Report Date 11/16/2015 Barrier #: 44A
 Bldg Name: Pharmacy Building Reference Dwg: 5 of 6
 Location: Floor 4 - North Exit Stairway
 X Coordinate: N/A Y Coordinate: N/A
 Barrier Area: Signage
 Barrier Type: Tactile Exit Signs - Stairway
 Code: Performance Standard
 References:

Barrier Description: Door leading directly into an exit stairway lacks tactile exit sign

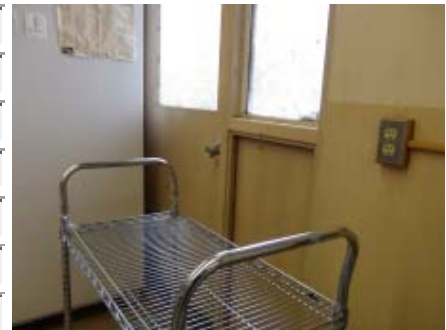
Field Date: 11/4/2015 Report Date 11/16/2015 Barrier #: 44B
 Bldg Name: Pharmacy Building Reference Dwg: 5 of 6
 Location: Floor 4 - North Exit Stairway
 X Coordinate: N/A Y Coordinate: N/A
 Barrier Area: Doors or Gates
 Barrier Type: Hardware - Operation
 Code: 2010 ADAS 404.2.7
 References:

Barrier Description: Hardware not operable with a closed fist

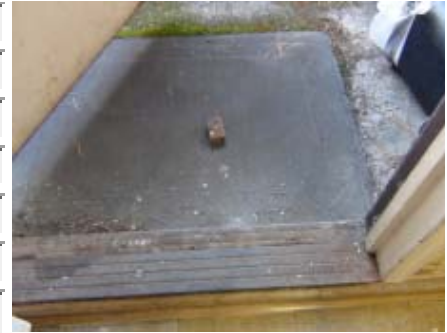
Field Date: 11/4/2015 Report Date: 11/16/2015 Barrier #: 44E
 Bldg Name: Pharmacy Building Reference Dwg: 5 of 6
 Location: Floor 4 - North Exit Stairway
 X Coordinate: N/A Y Coordinate: N/A
 Barrier Area: Doors or Gates
 Barrier Type: Threshold - Ramp
 Code: 2010 ADAS 404.2.5
 References:

Barrier Description: Door/Gate threshold exceeds 1/2" in height

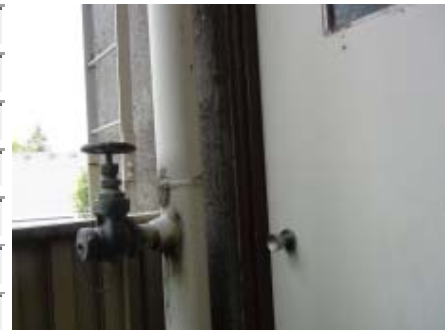
Field Date: 11/4/2015 Report Date: 11/16/2015 Barrier #: 44F
 Bldg Name: Pharmacy Building Reference Dwg: 5 of 6
 Location: Floor 4 - North Exit Stairway
 X Coordinate: N/A Y Coordinate: N/A
 Barrier Area: Stairways
 Barrier Type: Protruding Hazard
 Code: 2010 ADAS 307.2
 References:

Barrier Description: Object protrudes more than 4" into pedestrian way

Rec. Solution: Rework area to remove hazard

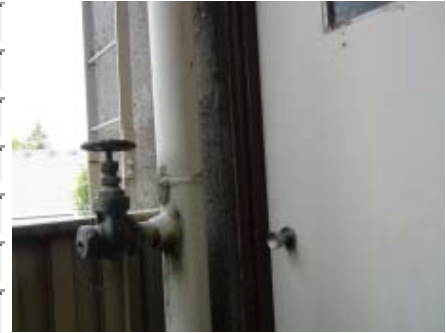
Field Date: 11/4/2015 Report Date: 11/16/2015 Barrier #: 44G
 Bldg Name: Pharmacy Building Reference Dwg: 5 of 6
 Location: Floor 4 - North Exit Stairway
 X Coordinate: N/A Y Coordinate: N/A
 Barrier Area: Doors or Gates
 Barrier Type: Hardware - Operation
 Code: 2010 ADAS 404.2.7
 References:

Barrier Description: Hardware not operable with a closed fist

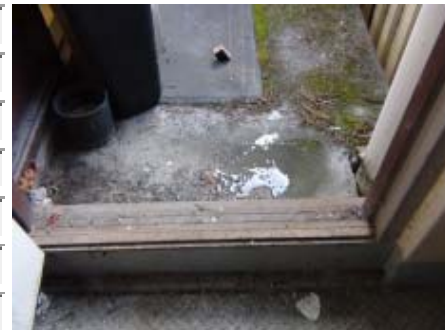
Field Date: 11/4/2015 Report Date: 11/16/2015 Barrier #: 44H
 Bldg Name: Pharmacy Building Reference Dwg: 5 of 6
 Location: Floor 4 - North Exit Stairway
 X Coordinate: N/A Y Coordinate: N/A
 Barrier Area: Doors or Gates
 Barrier Type: Threshold - Height 1/2" with Ramp
 Code: 2010 ADAS 404.2.5
 References:

Barrier Description: Door/Gate threshold bevel at max 1/2" lip exceeds 1:2 or 50% slope

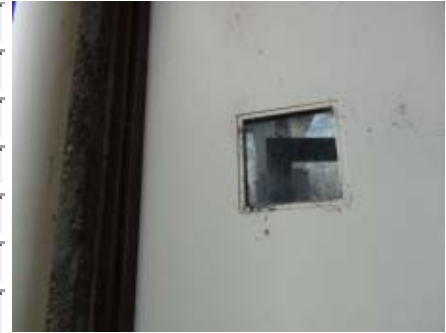
Field Date: 11/4/2015 Report Date: 11/16/2015 Barrier #: 44K
 Bldg Name: Pharmacy Building Reference Dwg: 5 of 6
 Location: Floor 4 - North Exit Stairway
 X Coordinate: N/A Y Coordinate: N/A
 Barrier Area: Doors or Gates
 Barrier Type: Door Closer - Interior Sweep Period
 Code: 2010 ADAS 404.2.8.1
 References:

Barrier Description: Door closer lacks min. 5 second sweep period or does not stop 5" from door frame

Rec. Solution: Replace or adjust existing closer

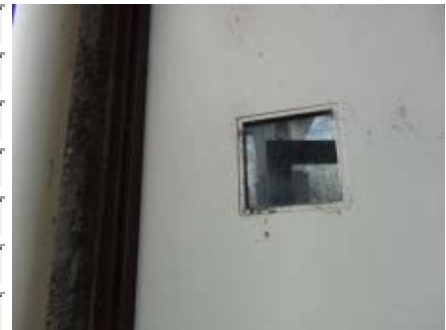
Field Date: 11/4/2015 Report Date: 11/16/2015 Barrier #: 44L
 Bldg Name: Pharmacy Building Reference Dwg: 5 of 6
 Location: Floor 4 - North Exit Stairway
 X Coordinate: N/A Y Coordinate: N/A
 Barrier Area: Doors or Gates
 Barrier Type: Vision Lights - Existing
 Code: 2010 ADAS 404.2.11
 References:

Barrier Description: View panels in or adjacent to doors or gates not max. 43" above floor or ground

Rec. Solution: Replace door/gate or vision panel

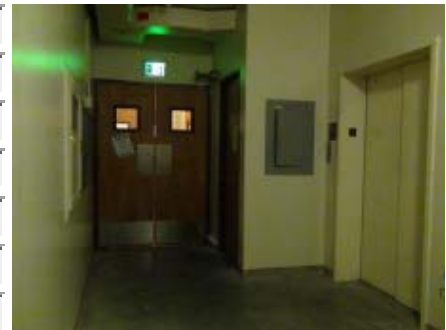
Field Date: 11/4/2015 Report Date 11/16/2015 Barrier #: 45A
 Bldg Name: Pharmacy Building Reference Dwg: 6 of 6
 Location: Floor 5 - Central Corridor
 X Coordinate: N/A Y Coordinate: N/A
 Barrier Area: Corridors
 Barrier Type: Sign - Permanent Room/Space
 Code: 2010 ADAS 703.1
 References:

Barrier Description: No sign with raised characters and Braille at permanent room or space with visual sign

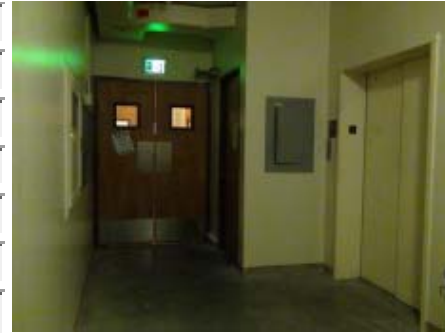
Field Date: 11/4/2015 Report Date: 11/16/2015 Barrier #: 45D
 Bldg Name: Pharmacy Building Reference Dwg: 6 of 6
 Location: Floor 5 - Central Corridor
 X Coordinate: N/A Y Coordinate: N/A
 Barrier Area: Signage
 Barrier Type: Tactile Exit Signs - Passage
 Code: Performance Standard
 References:

Barrier Description: Exit thru an exit enclosure/exit passageway lacks tactile exit sign

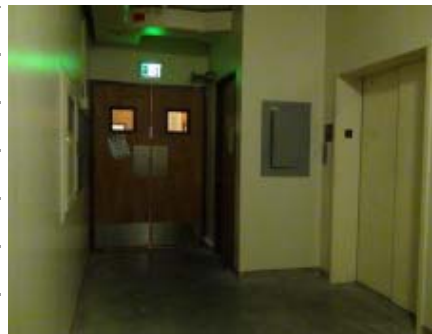
Field Date: 11/4/2015 Report Date: 11/16/2015 Barrier #: 45F
 Bldg Name: Pharmacy Building Reference Dwg: 6 of 6
 Location: Floor 5 - Central Corridor
 X Coordinate: N/A Y Coordinate: N/A
 Barrier Area: Corridors
 Barrier Type: Strobe
 Code: 2010 ADAS 702.1
 References:

Barrier Description: No strobe provided in corridor where horn is provided where fire alarm exists in building

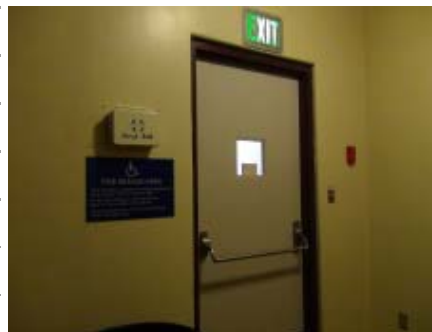
Field Date: 11/4/2015 Report Date: 11/16/2015 Barrier #: 46A
 Bldg Name: Pharmacy Building Reference Dwg: 6 of 6
 Location: Floor 5 - Northeast Exit Stairway
 X Coordinate: N/A Y Coordinate: N/A
 Barrier Area: Signage
 Barrier Type: Tactile Exit Signs - Stairway
 Code: Performance Standard
 References:

Barrier Description: Door leading directly into an exit stairway lacks tactile exit sign

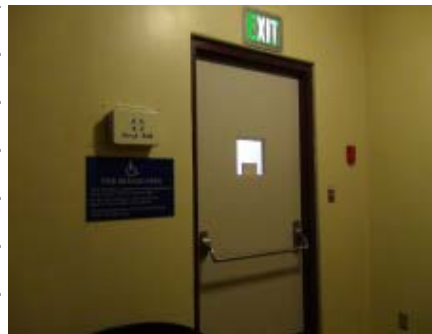
Field Date: 11/4/2015 Report Date 11/16/2015 Barrier #: 46B
 Bldg Name: Pharmacy Building Reference Dwg: 6 of 6
 Location: Floor 5 - Northeast Exit Stairway
 X Coordinate: N/A Y Coordinate: N/A
 Barrier Area: Doors or Gates
 Barrier Type: Vision Lights - Existing
 Code: 2010 ADAS 404.2.11
 References:

Barrier Description: View panels in or adjacent to doors or gates not max. 43" above floor or ground

Rec. Solution: Replace door/gate or vision panel

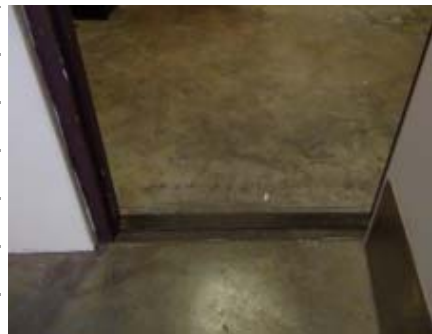
Field Date: 11/4/2015 Report Date 11/16/2015 Barrier #: 46D
 Bldg Name: Pharmacy Building Reference Dwg: 6 of 6
 Location: Floor 5 - Northeast Exit Stairway
 X Coordinate: N/A Y Coordinate: N/A
 Barrier Area: Doors or Gates
 Barrier Type: Threshold - Height exceeding 1/4" without bevel
 Code 2010 ADAS 404.2.5
 References:

Barrier Description: Door/Gate threshold exceeds 1/4" in height without a bevel

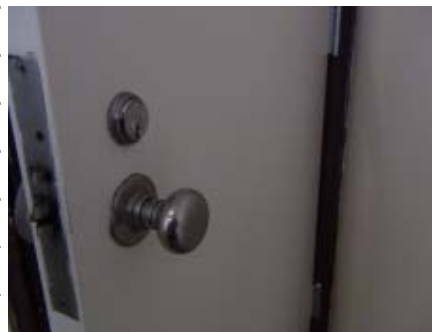
Field Date: 11/4/2015 Report Date 11/16/2015 Barrier #: 46E
 Bldg Name: Pharmacy Building Reference Dwg: 6 of 6
 Location: Floor 5 - Northeast Exit Stairway
 X Coordinate: N/A Y Coordinate: N/A
 Barrier Area: Doors or Gates
 Barrier Type: Hardware - Operation
 Code 2010 ADAS 404.2.7
 References:

Barrier Description: Hardware not operable with a closed fist

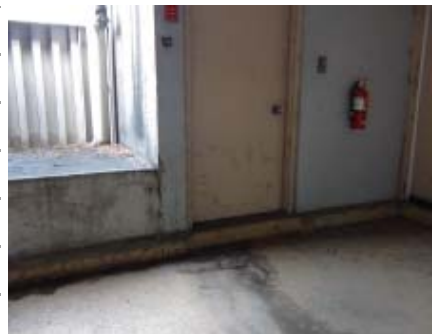
Field Date: 11/4/2015 Report Date: 11/16/2015 Barrier #: 48C
 Bldg Name: Pharmacy Building Reference Dwg: 6 of 6
 Location: Floor 5 - North Exit Stairway
 X Coordinate: N/A Y Coordinate: N/A
 Barrier Area: Doors or Gates
 Barrier Type: Threshold - Ramp
 Code: 2010 ADAS 404.2.5
 References:

Barrier Description: Door/Gate threshold exceeds 1/2" in height

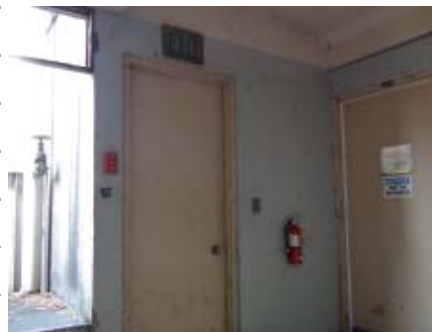
Barrier Description: Door opening force exceeds 5 lbf

Rec. Solution: Replace or adjust existing closer
