MORELAND HALL

ADA ASSESSMENT & SURVEY

Re: ADA Accessibility Survey and Assessment – Moreland Hall

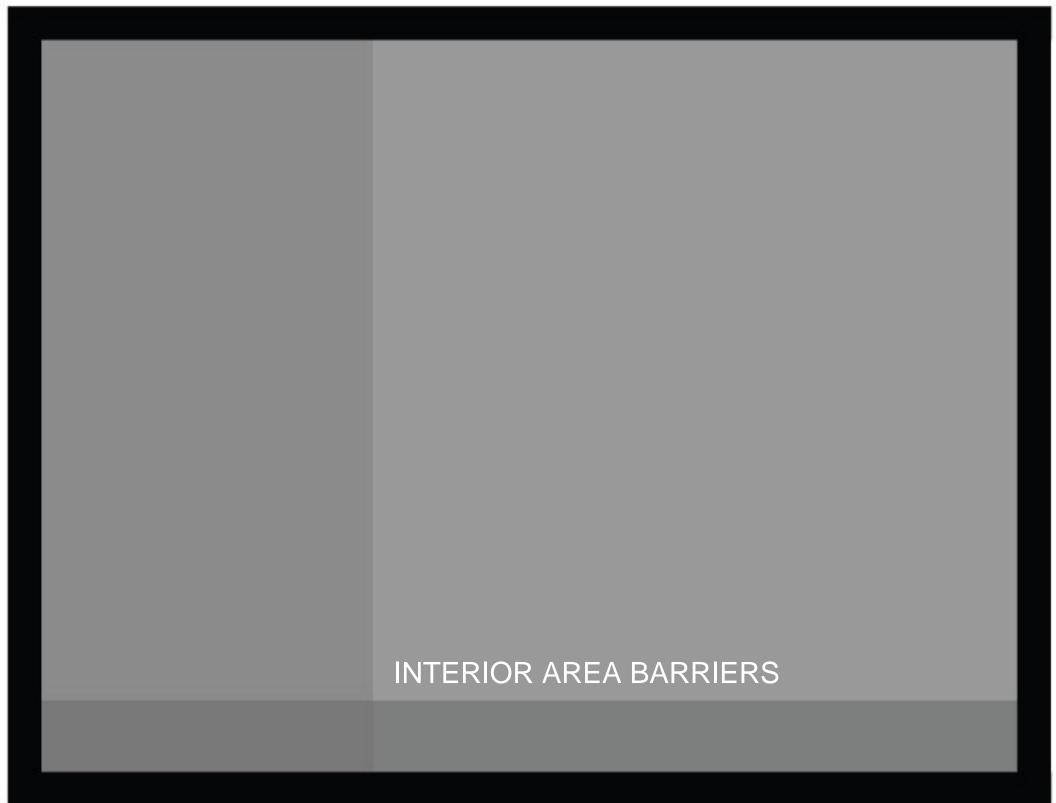
Field Date:	2/1/2017 Report Date 3/23/2017 Barrier #: 1A
Bldg Name:	Moreland Hall Reference Dwg: 2 of 5
Location:	Floor 1 - Entry Lobby L0101
X Coordinate:	N/A Y Coordinate: N/A
Barrier Area:	Signage
Barrier Type:	Permanent Room/Space - Tactile Characters
Code References:	2010 ADAS 216.2
Performance Sta	ndard: No Quantity: EACH As-built : 1
Barrier Description:	No tactile characters at sign identifying permanent rooms and spaces with visual signs
Findings:	No tactile signage provided at door within public route
Rec. Solution:	Provide accessible sign
Barrier Severity:	1 Necessary Cost Est \$250.00 Facility Function: Public Status: Open
Implementation	Priority: 2 Implementation Phase: Implementation Date:
Notes:	
Field Date:	2/1/2017 Report Date 3/23/2017 Barrier #: 1B
Bldg Name:	Moreland Hall Reference Dwg: 2 of 5
Location:	Floor 1 - Entry Lobby L0101
X Coordinate:	N/A Y Coordinate: N/A
Barrier Area:	Controls and Mechanisms
